Presidio of San Francisco BUILDING 228

Historic Structure Report

Prepared by
Garavaglia Architecture, Inc
June 2010

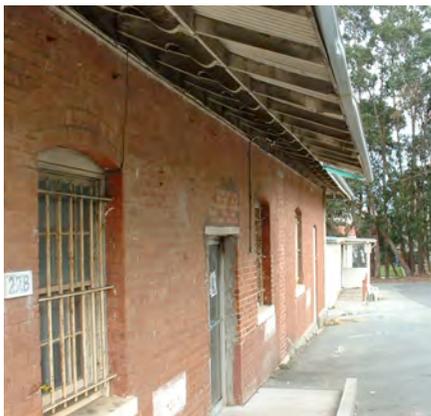
Figure 5.1 – Damaged awning

- **Damaged awning.** Building 228 is surrounded by a relatively deep roof overhang that is supported by rafter tails carved into a scroll-like pattern. On the south elevation, these rafter tails have been sistered to 2x4 boards that support a corrugated fiberglass and wood awning. Sections of the fiberglass have been removed, leaving the wood frame exposed. At the time of the site survey, one section of fiberglass was loosely hanging from the wood frame (see Figure 5.1.)

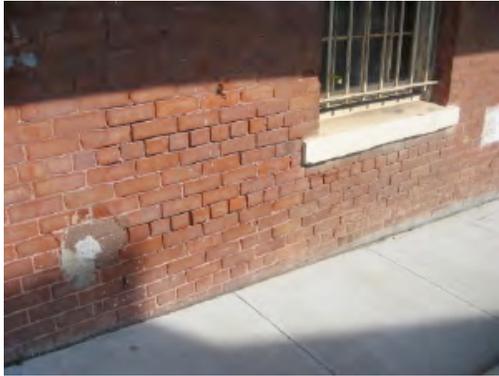
Figure 5.2 – Missing mortar.

- Missing mortar. The original tinted mortar is still extant on much of the building. However at the southwest corner of the building, there is a large section where the mortar is deteriorated and can readily be raked from the joint with a finger. While no bricks appeared loose during the survey, the probability of further deterioration is very high (see Figure 5.2.)

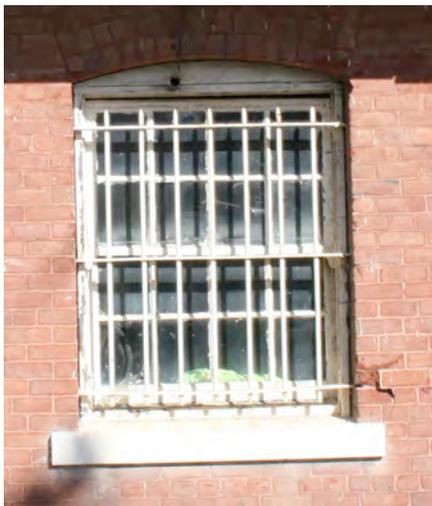
Figure 5.3 – Damaged Brick.

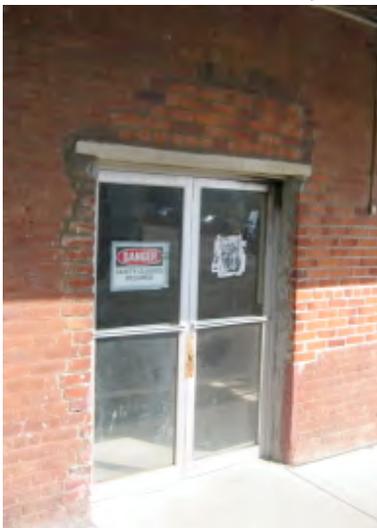
Figure 5.4 – Insensitive alterations.

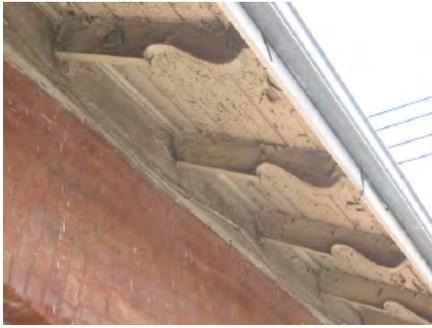
Figure 5.5 – Loose and flaking paint.

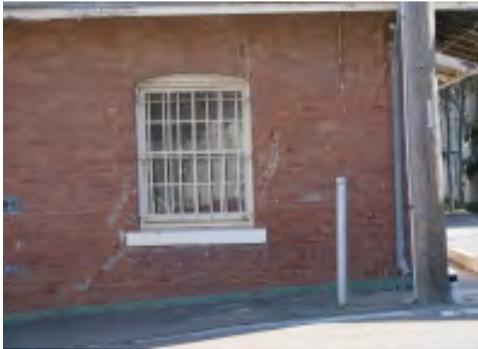
Figure 5.6 – West wall cracking.

- Cracking. The cracking along the west elevation is severe. Generally the cracks radiate from the corners of the windows, up to the top of the wall or down to grade. These

cracks have been repaired several times in the past to no avail. All range from hairline to approximately 1/4-inch to an inch or more in width and go all through the wall. The cracks are allowing moisture to penetrate the wall, loosen and degrade mortar, and undermine the integrity of the wall itself (see Figure 5.6 and Figure 5.7.)

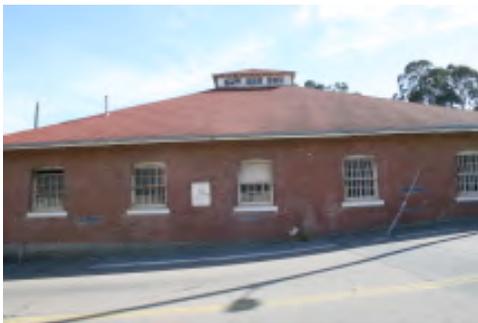
Figure 5.8 – Efflorescence.

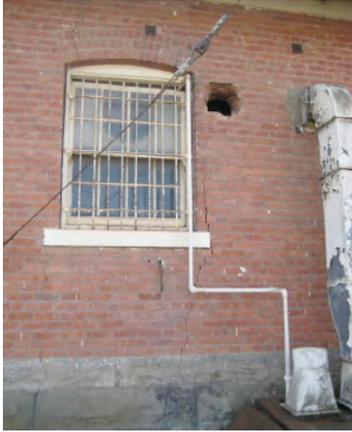
Figure 5.9 – Cracking, north wall.

- Cracking. There are significant cracks around the second window from the eastern corner of the wall. The cracks extend almost the full length of the wall, along the western edge of the window. Overall, the crack is fairly linear, through bricks and mortar joints equally, and through bricks, concrete and stone. This suggests that this is a structural failure and not the cause of seismic activity. A smaller, though still visible crack extends from the east side of the sill to the water table (see Figure 5.9.)

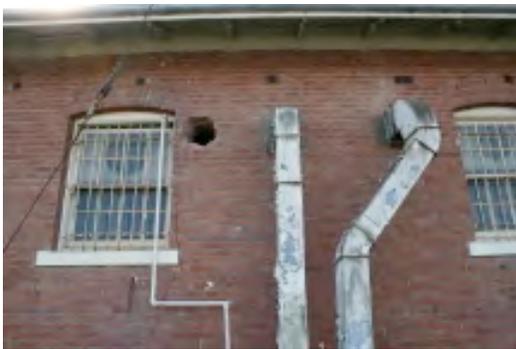
Figure 5.10 – Through wall penetrations.

- Through wall penetrations. There are a number of through wall penetrations made to vent interior machinery to the exterior. In several cases, ducting extends through the wall and connects to more equipment placed adjacent to the exterior of the north wall. None of this equipment is currently used. None of these penetrations appear to be properly sealed to prevent moisture infiltration. Currently, there is a large void (approximately six-inches in diameter) near the cracks noted above. Two other ducts protrude from the wall and are open at their ends. The remainders are small pipes or ducts connected to equipment (see Figure 5.10.)

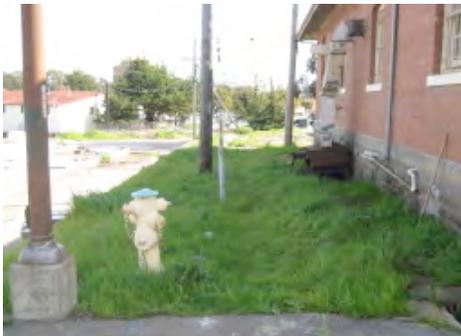
Figure 5.12 – Utility poles.

- Proximity of utility poles. Three utility poles are currently installed along the north wall between Building 288 and the retaining wall. Two are separated from Building 228 by five or more feet. However, the third is immediately adjacent to the building and is attached at the eave to the roof. The soil beneath these poles is soft and prone to settlement as water continues to move through. This is evidenced by the near constant stream of water exiting the retaining wall at the installed pipe drains. Strong winds, unstable soils and anticipated remediation work will further endanger the stability of these poles. There is a high probability of them falling and causing further damage to Building 228 and /or the retaining wall (see Figure 5.12.)

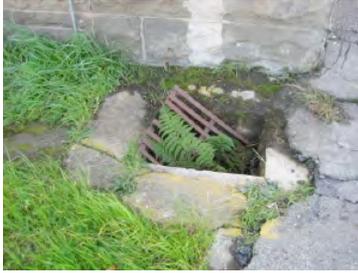
Figure 5.13 – Unmaintained storm water drain.

- Improper management of storm water. The gutters are damaged along the eaves on the north side of Building 228. Water is draining directly off the roof to the area near the sandstone watertable. This side receives little sun and is almost constantly moist during the wet season. This has caused the sandstone to chip, flack and generally deteriorate. While this condition is seen elsewhere on the

building, it is most pronounced on the North wall (see Figure 5.13 and Figure 5.14.)

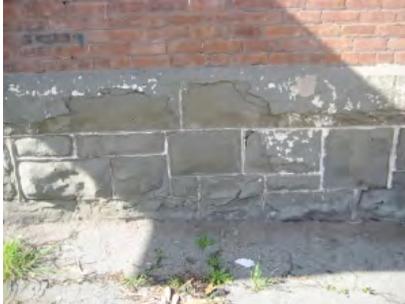
Figure 5.15 – Sandstone deterioration.

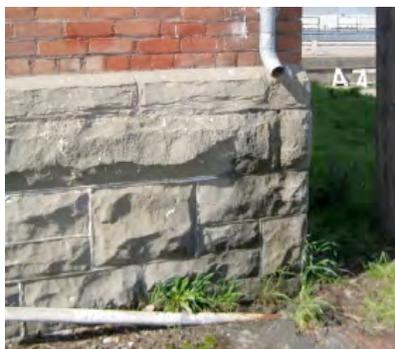
Figure 5.16 – Improper storm water drainage.

- Improper management of storm water. There are gutters on along the East roofline, however grass and plants are growing in these gutters. Their presence of plants in the gutters suggests that they are full of organic debris and no longer allow water to flow off the roof to designated drainage locations. Where the gutters are functional, they drain to downspouts that deposit the water immediately adjacent to the building. These areas show moisture damage in the form of stained brick and stone and loss of mortar (see Figure 5.16.)

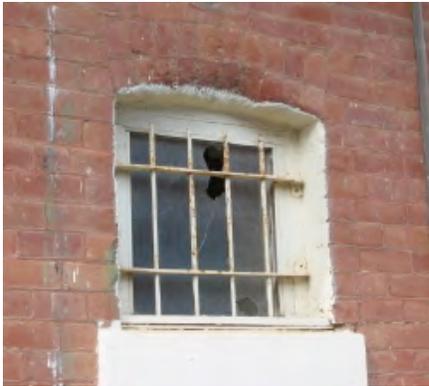
Figure 5.17 – Brick damage.

- Brick damage. The brick header above the small window to the south of the east entry has been worn into a curved surface profile. This may be the result of earlier modifications to accommodate a pipe or vent in this

location. The size and shape of this window and its sill differs significantly from others on the building, suggesting that it originally served a different purpose or was located in an area with particular requirements for adjacent venting or lighting. Care should be taken to prevent this compromised brick surface from further deterioration (see Figure 5.17.)

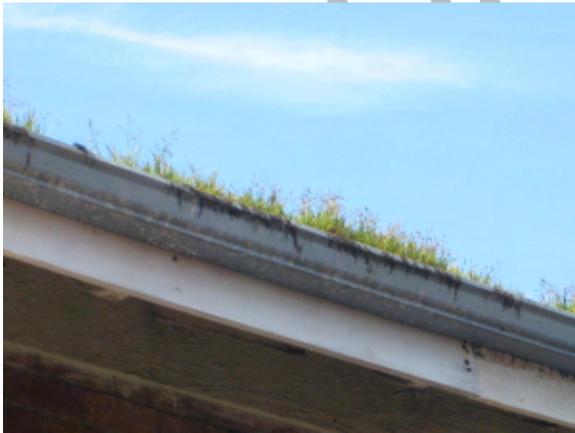
Figure A11. East elevation biogrowth in the gutter.

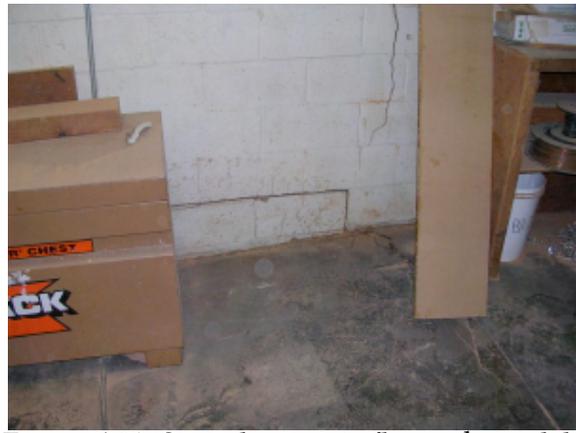
Figure A18. Scored concrete floor where slab has dropped at the center of the west wall.

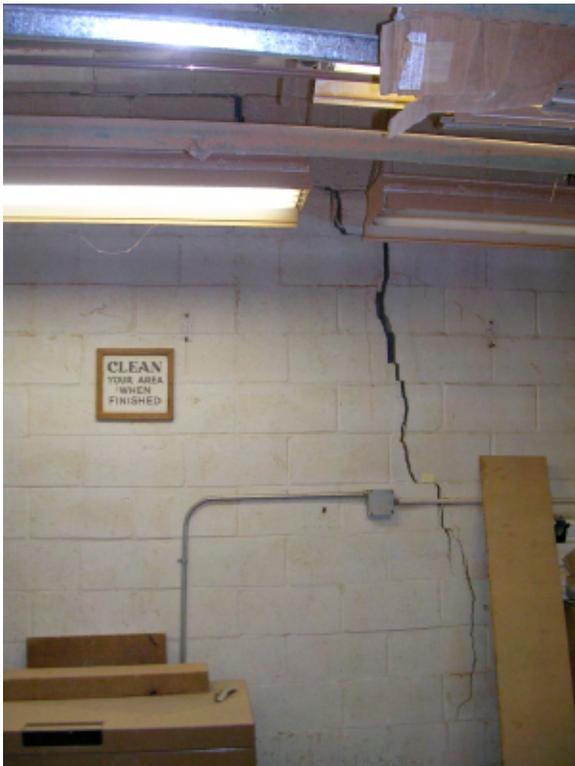
Figure A23. Large crack in concrete block partition wall, looking north.

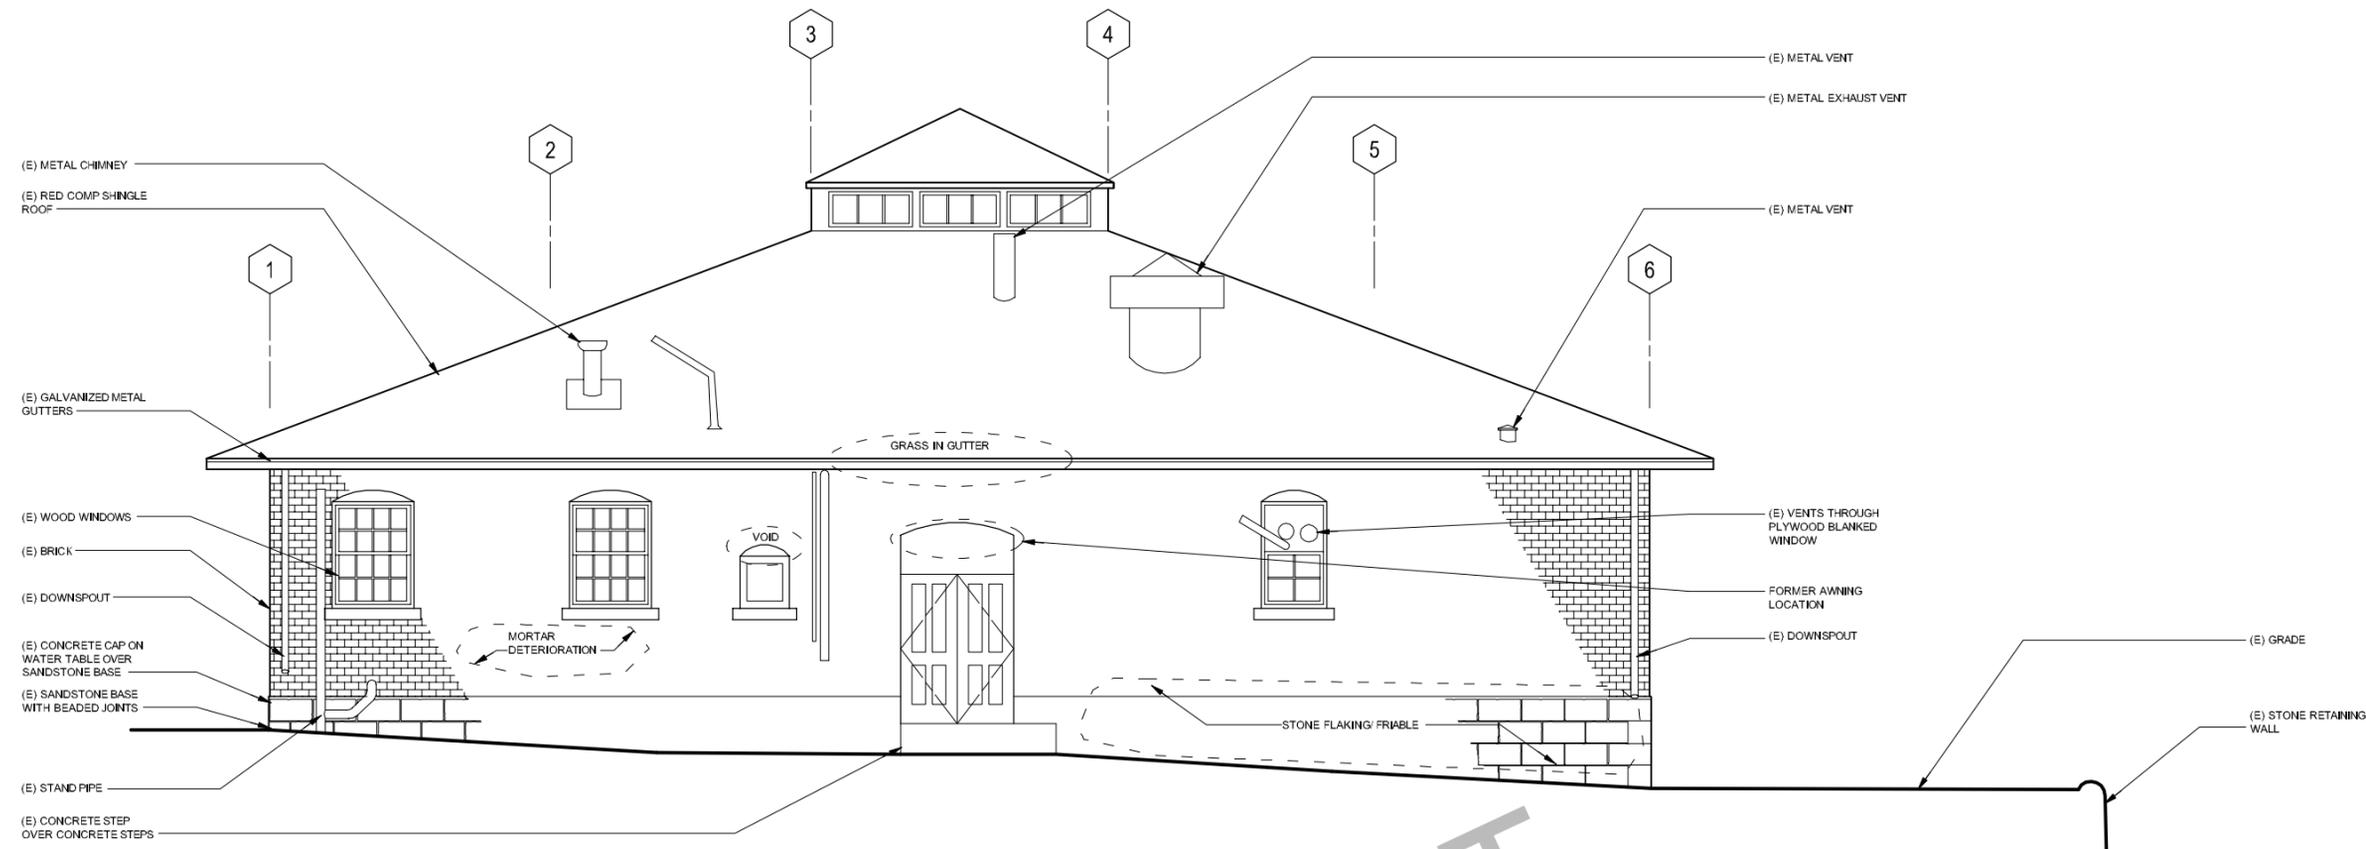
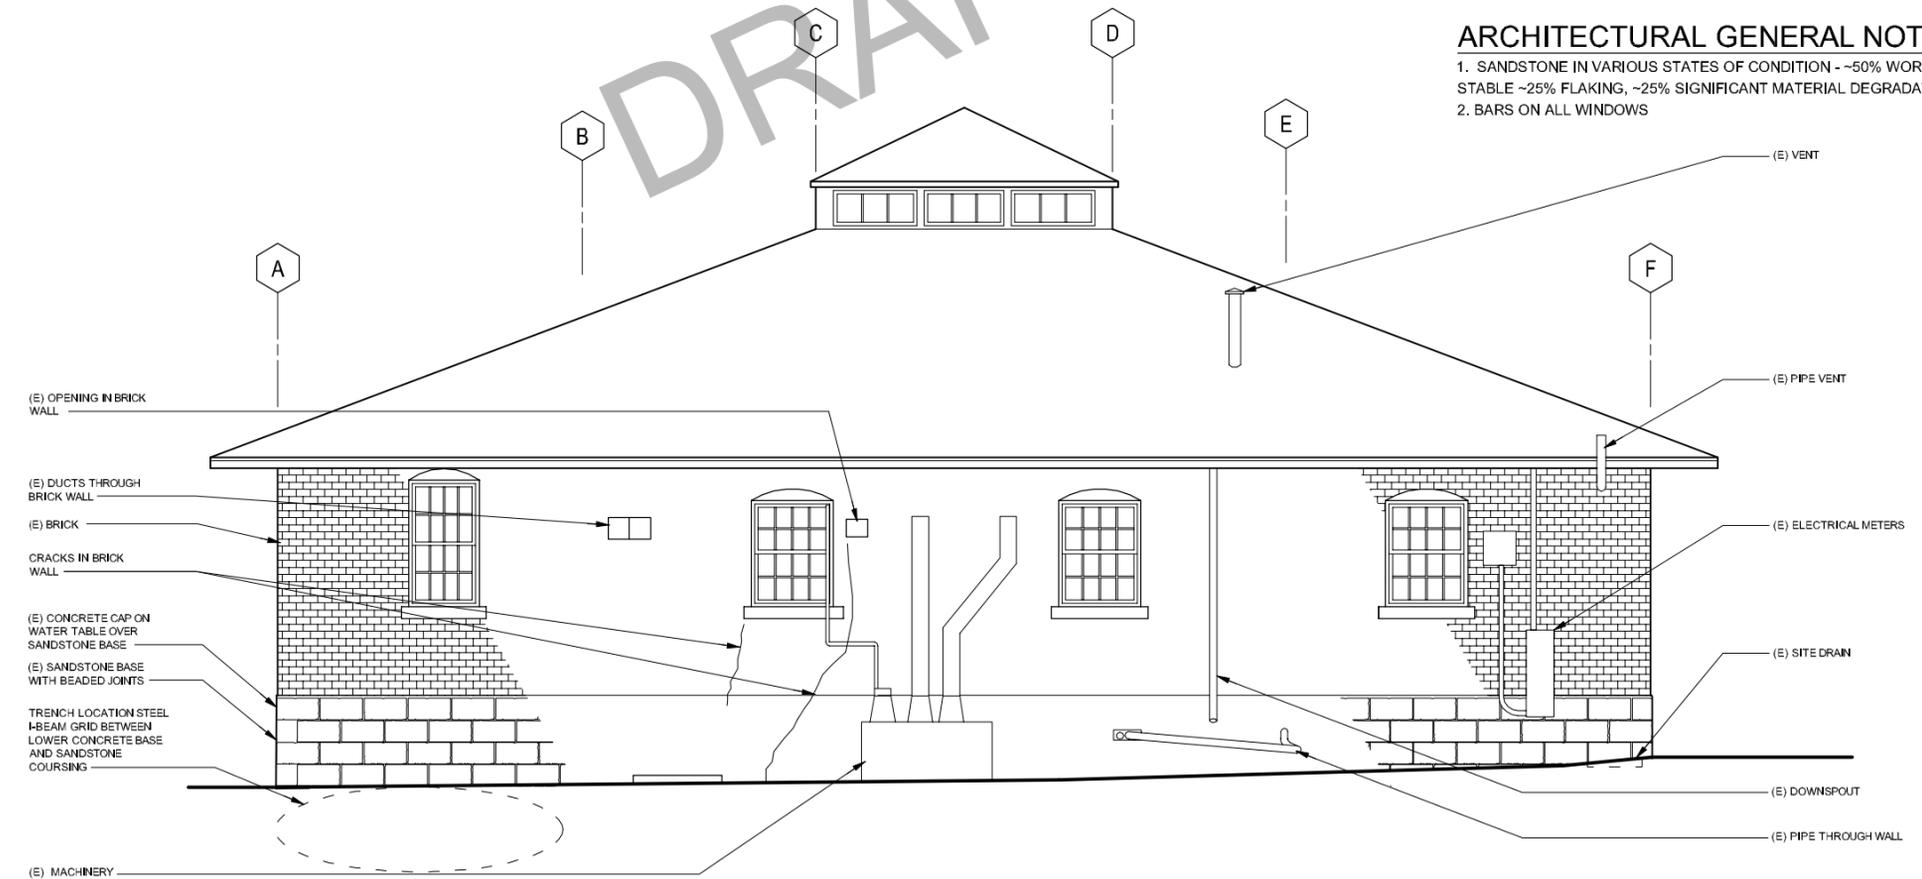
EXT. ELEVATIONS
 BUILDING 228
 (E) NORTH & EAST

ARCHITECTURAL GENERAL NOTES
 1. SANDSTONE IN VARIOUS STATES OF CONDITION - ~50% WORN BUT STABLE ~25% FLAKING, ~25% SIGNIFICANT MATERIAL DEGRADATION.
 2. BARS ON ALL WINDOWS

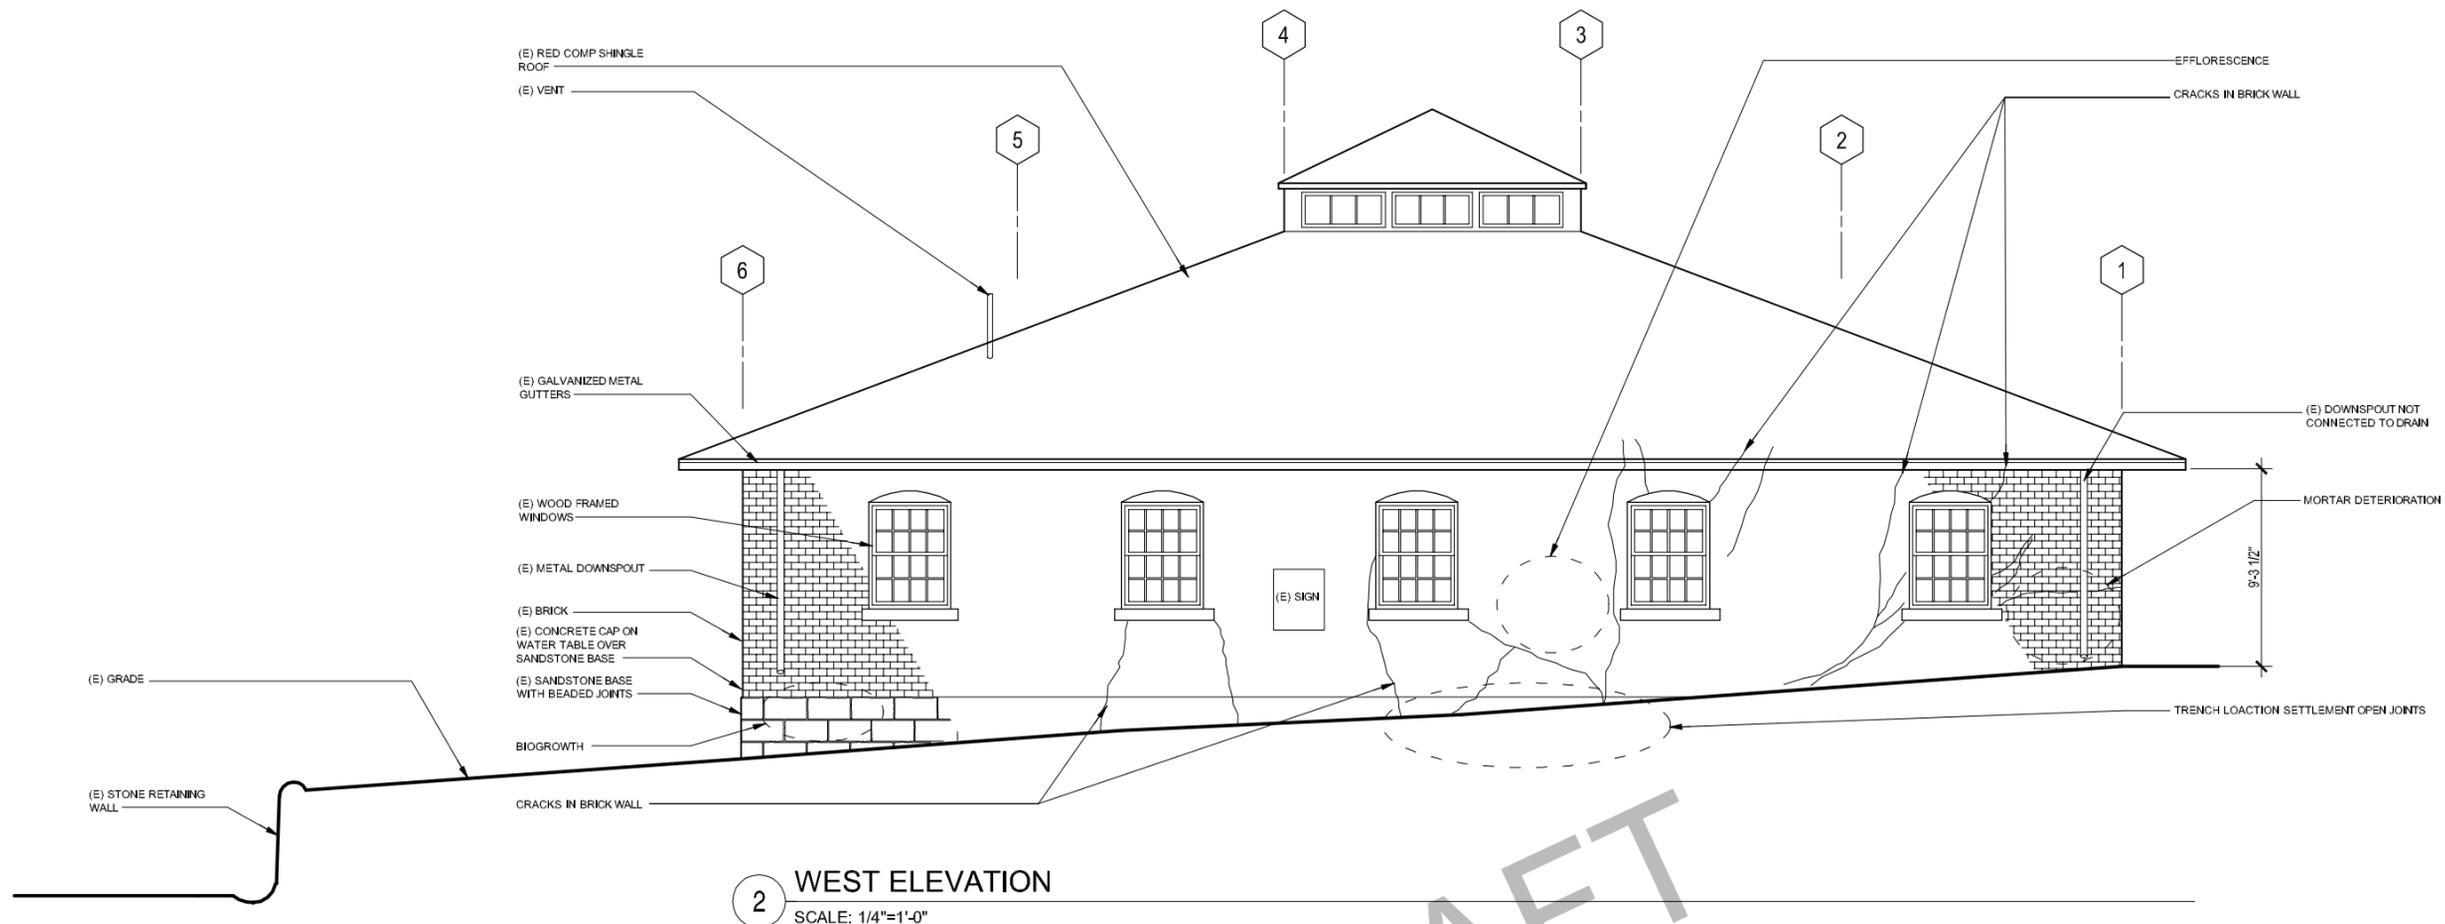
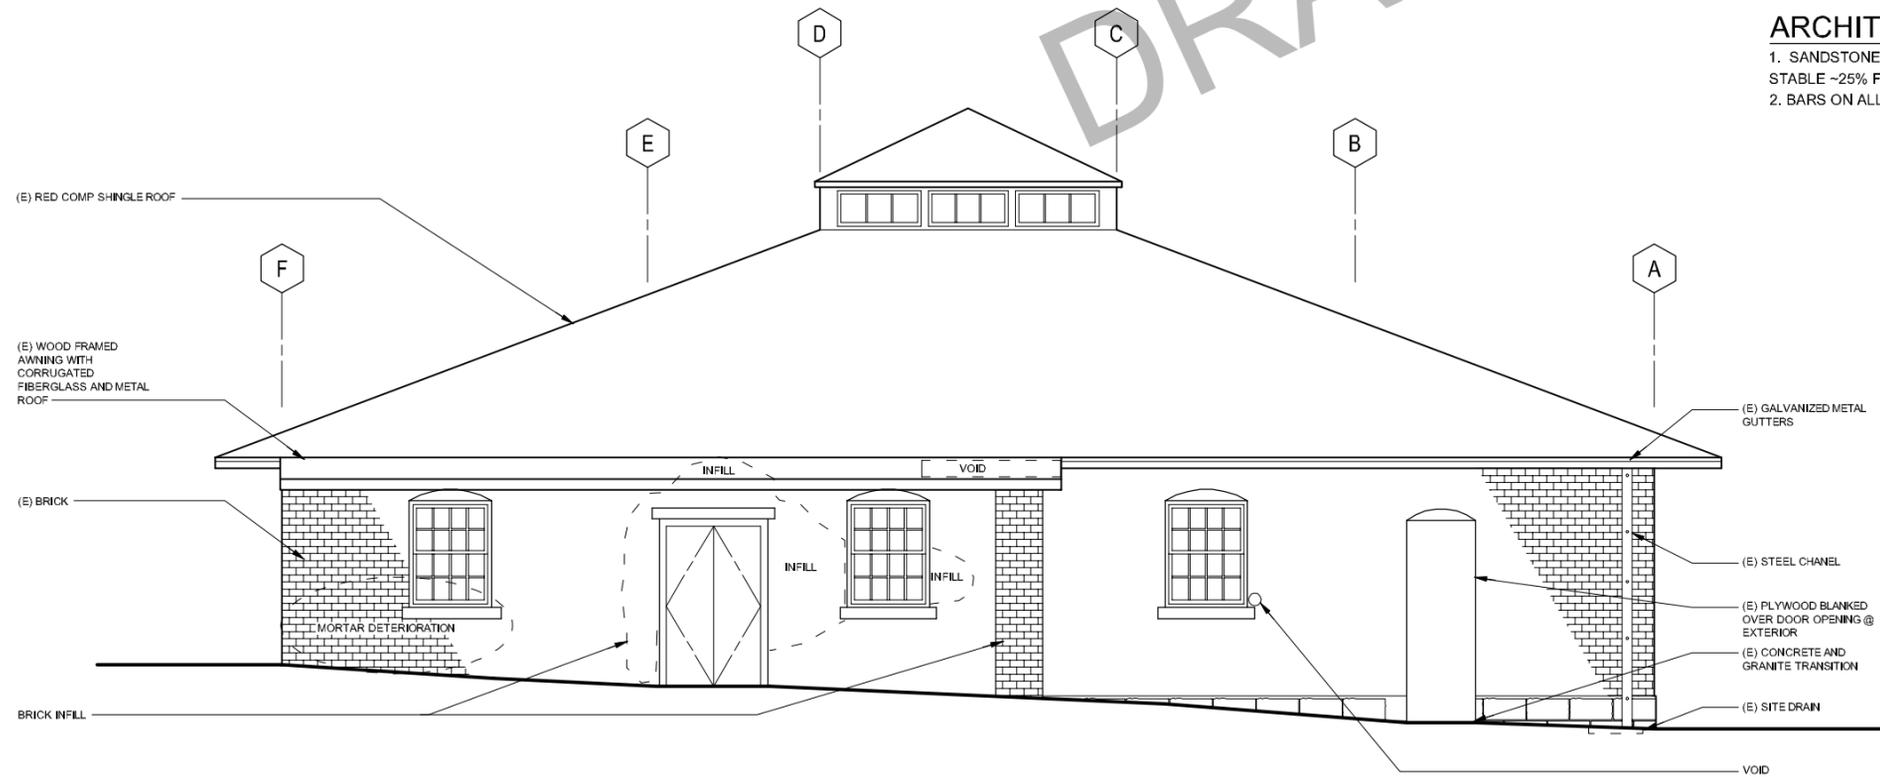
EXT. ELEVATIONS
 BUILDING 228
 (E) SOUTH & WEST

- SANDSTONE IN VARIOUS STATES OF CONDITION - ~50% WORN BUT STABLE - ~25% FLAKING, ~25% SIGNIFICANT MATERIAL DEGRADATION.
- BARS ON ALL WINDOWS
