GEOTECHNICAL DESIGN REPORT

ROUTE: 07-LA-1-PM 82.8/83.3

File: 07-LA-01-PM51.6/KP83.07
EA 07-4L2201
Escondido Beach Landslide

Subject: Geotechnical Design Report

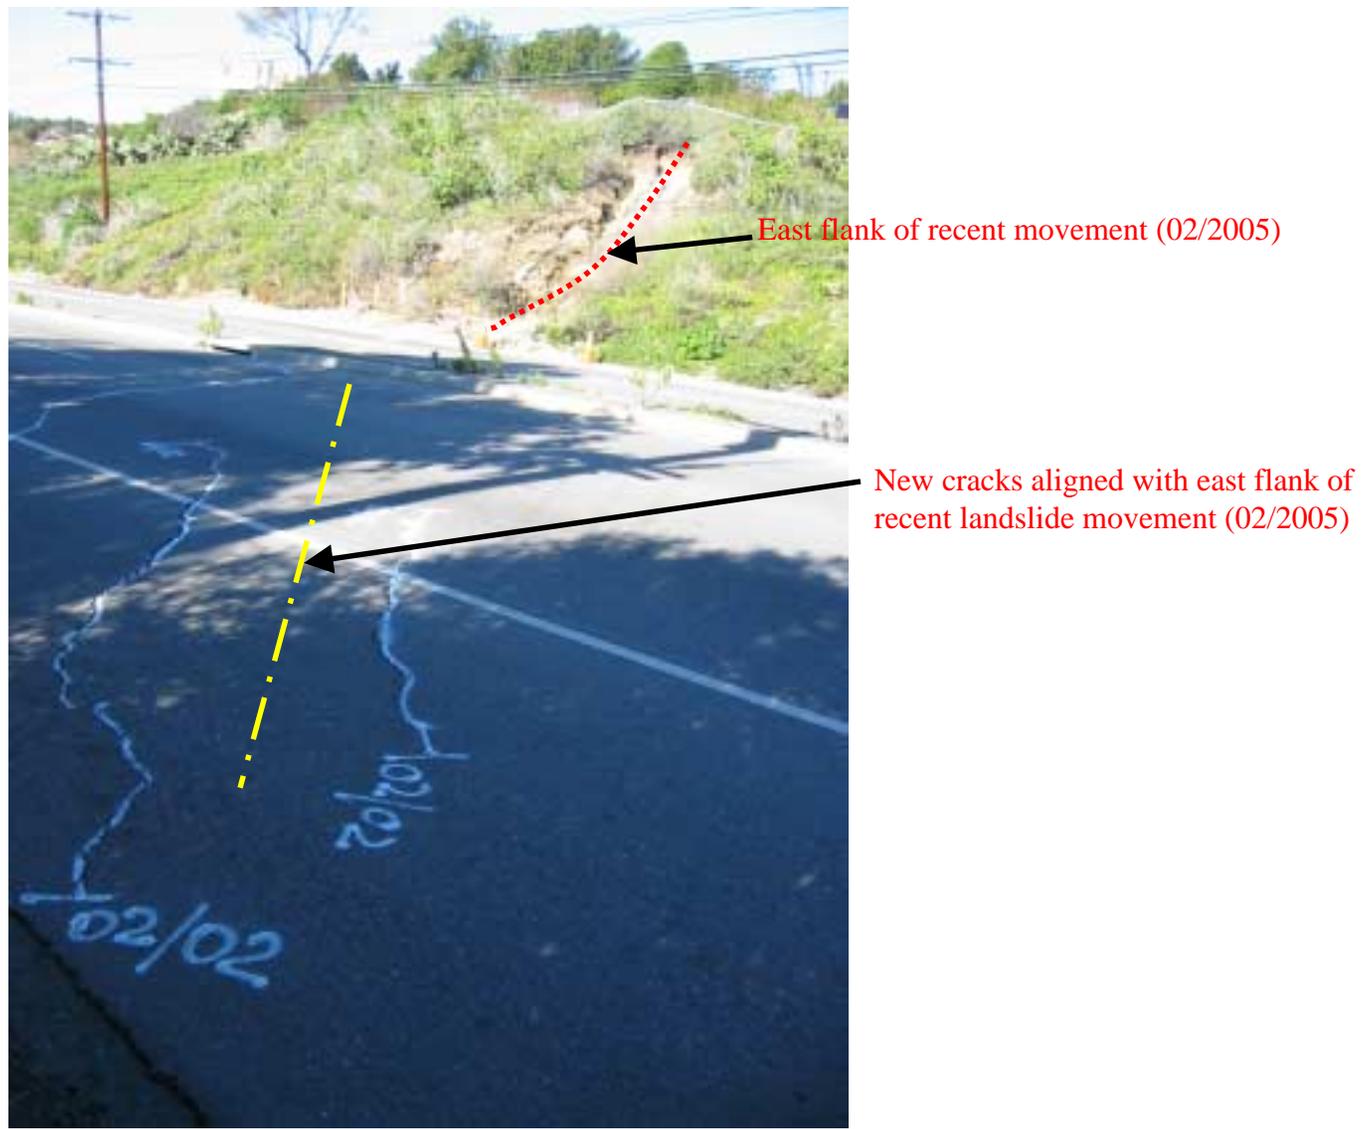
Cracks on highway pavement were observed during a February, 2005 inspection, as shown in the attached photographs (Figure 3a and 3b). These photographs show that a series of curvilinear cracks have developed at the top of the slope primarily in Lane No. 2 of the

eastbound Pacific Coast Highway (Figure 2, Feature 2). A distinct curvilinear scarp has formed and a maximum vertical separation of about 50 mm across the scarp was measured during the site inspection. The vertical separation was only 6 to 10 mm in July 2002.

Approximately 20 mm additional movement along the shallow shear zone was observed due to the rainstorm, which resulted in a cumulative movement of 47 mm since the installation of the slope indicator. This shallow shear zone is affecting primarily the eastbound lanes and reflects the widening of the pre-existing pavement cracks (Figure 3a), and subsidence of eastbound lane No.2.

Figure 3a: Showing pavement cracks aligned with the east flank of the recently reactivated old landslide (February 2005).

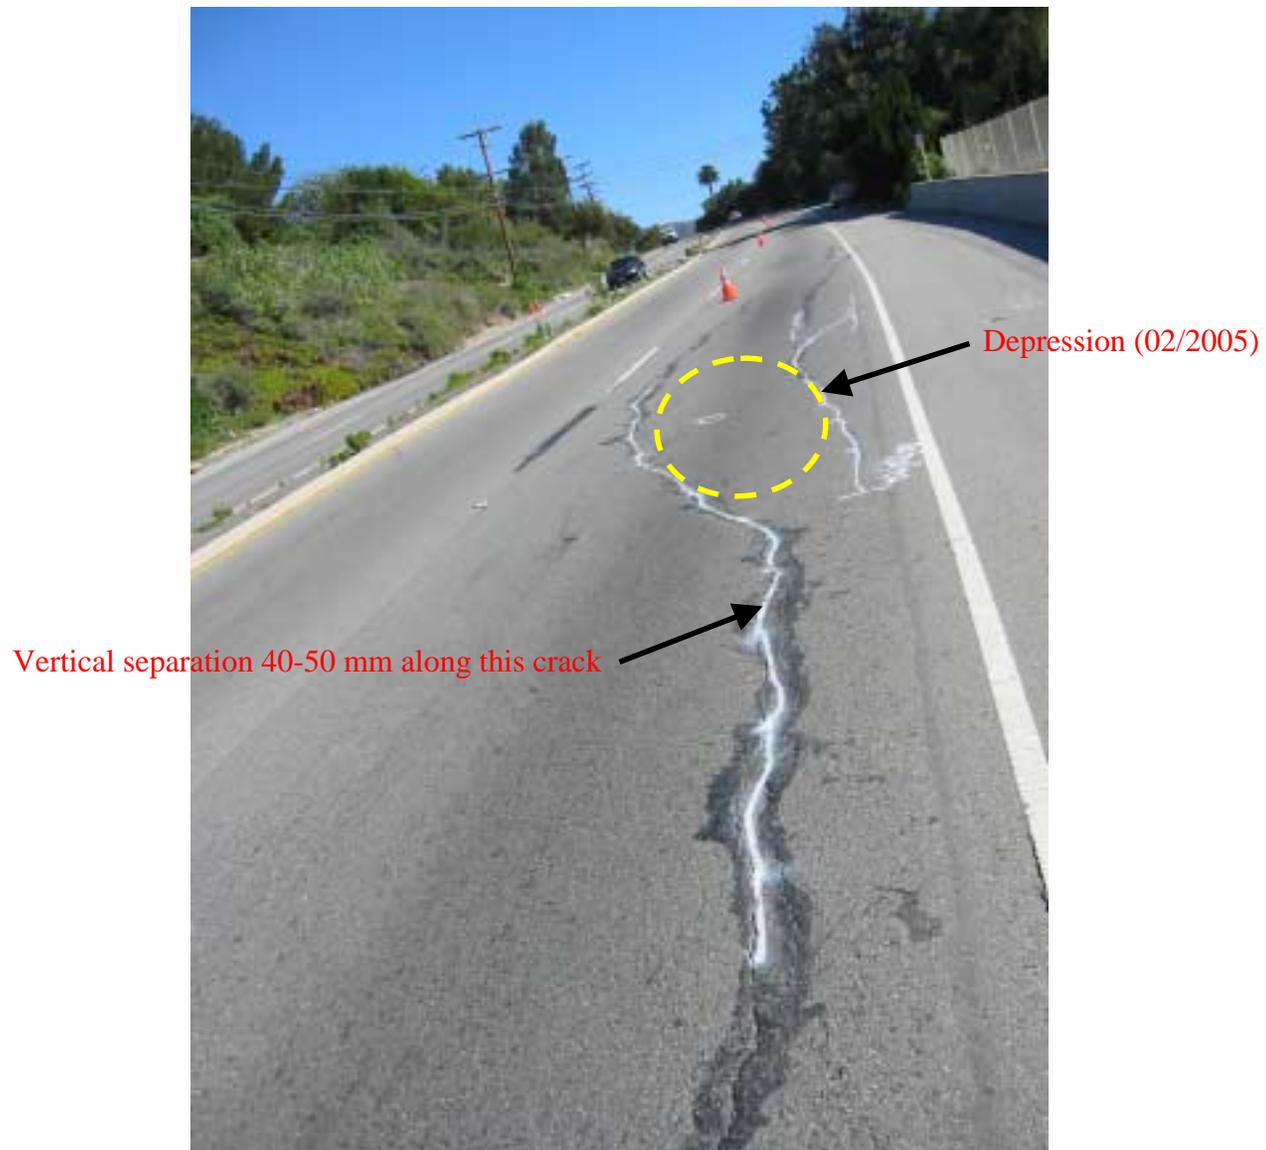
Minor cracking in Lanes 1 and 2, which was observed in early 2002 at the eastern end of the affected area has propagated further towards the east. In addition, minor cracks crossing Lanes 1 and 2 of the westbound highway were also observed in the same area during the site inspection in February 2005.

Figure 3b: Pre-existing cracks on the eastbound side of the highway that have widened (February 2005)

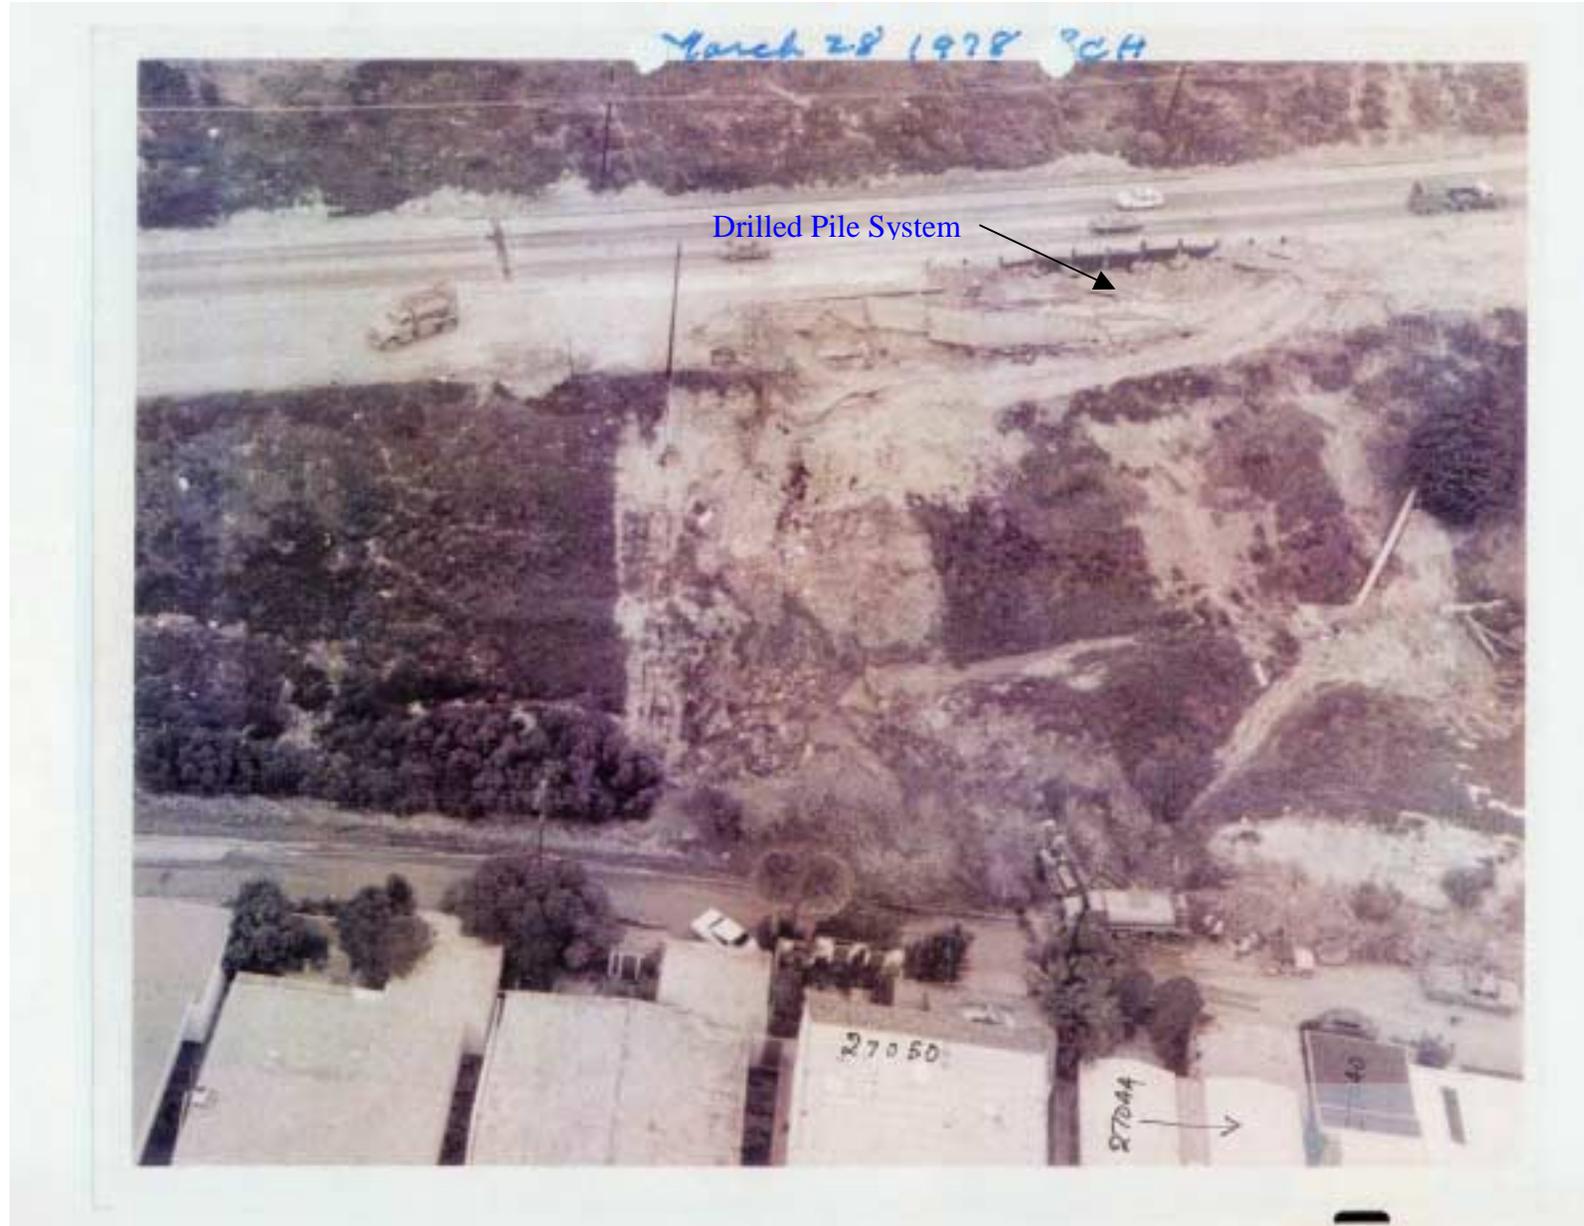
Figure 5: Drilled Pile system installed in 1978

During mid March 1978 a drilled pile system was installed on the North side of the median to protect the northbound lanes (Figure 5). The system consisted of 250 mm x 250 mm H beams in 600 mm diameter drilled holes at 3 m centers and filled with concrete. The pile tip elevation was about 10.7 m below highway grade. Wood lagging was placed between the piles. During late March 1978, six 40 mm diameter slotted PVC horizontal drains were installed into the slide mass from Malibu Cove Colony Road. These drains initially drained at 20,000 gallons per day and by mid April 1978 the flow rate had decreased to 2300 gallons per day (last reported May 16, 1978). Two slope indicators were installed during mid April 1978. These were read weekly upto May 12, 1978. The slope indicator readings along with observations on survey stakes indicated that movement had slowed with no gross change during the three-week period ending May 5, 1978 [2].

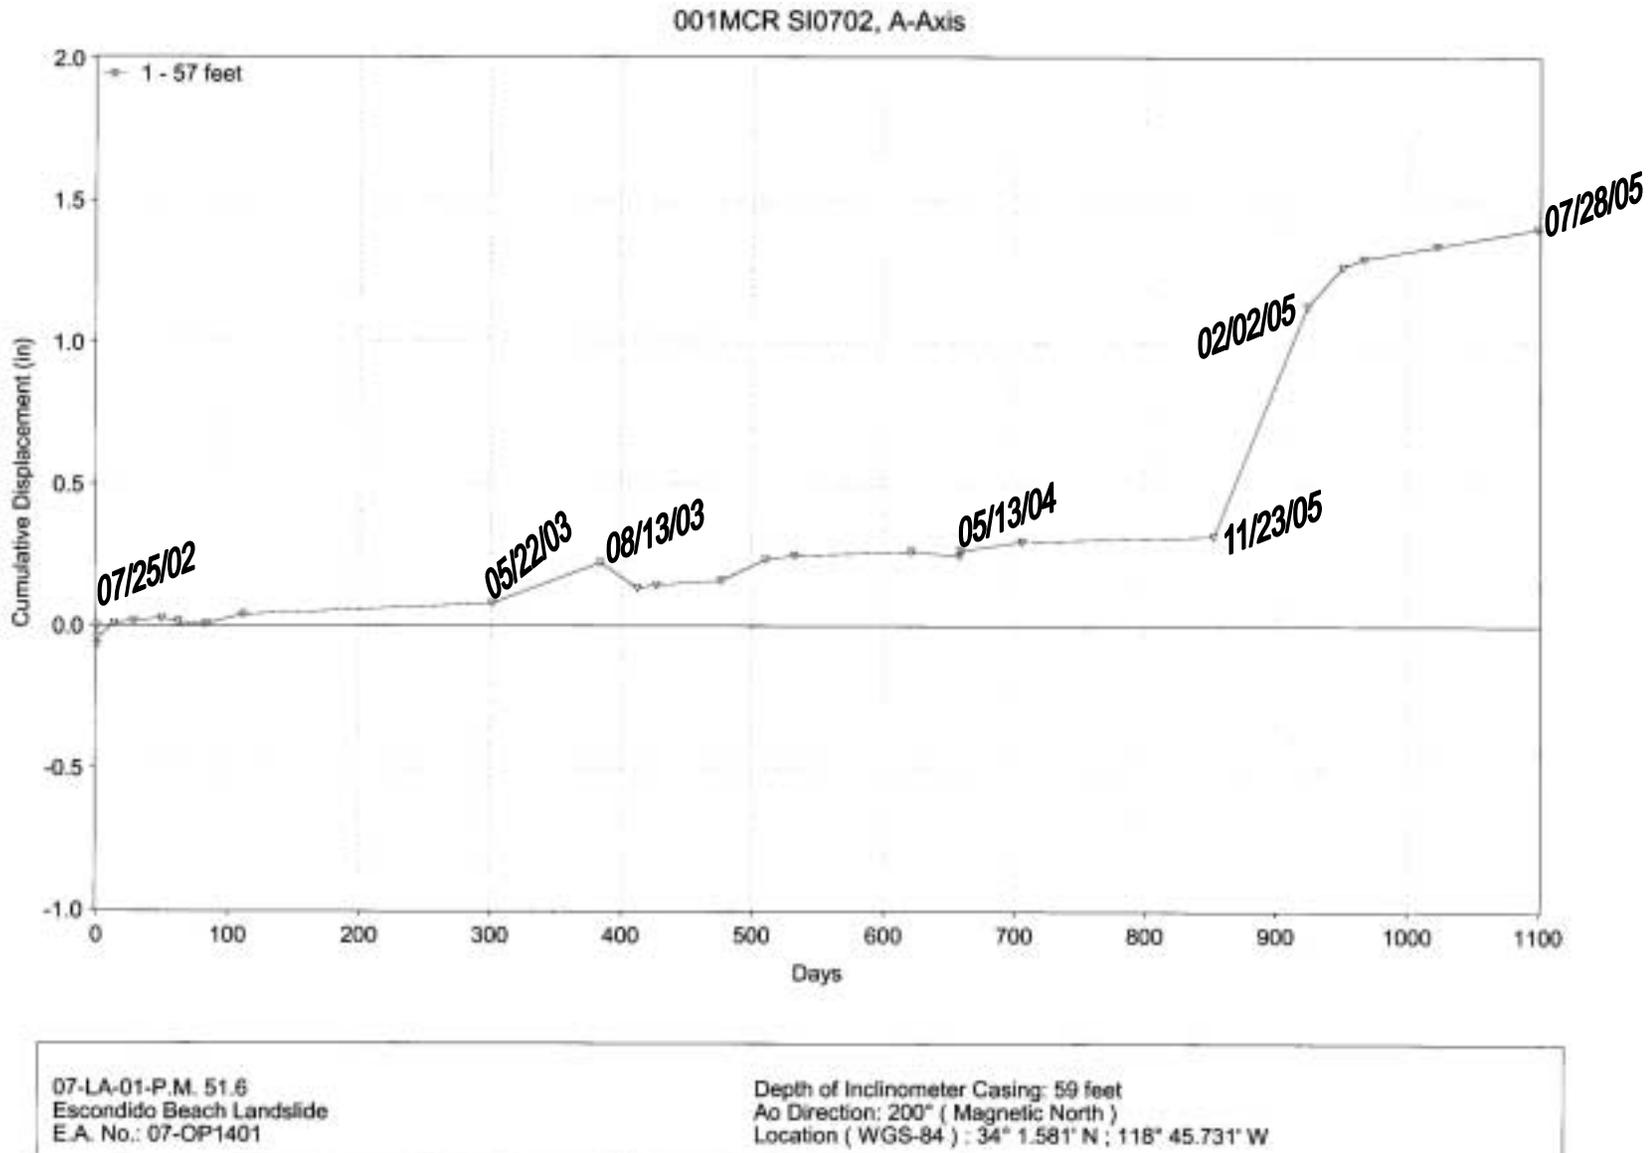
Figure 8: Time Series plot for Inclinerometer SI_07_02

Slope Indicator Data Analysis prior to December 2004: Based on the available data from SI_07_02 and SI_08_02 it appeared that movement was occurring along a planar surface with a steep head scarp at or just below the highway elevation (Figure 6a). The slope inclinometer data did not suggest deep-seated movement. The highway fill constructed during the emergency repair of March-April 1978 moved down and outwards along with the highly disturbed Modelo Formation materials on the down-slope side. Instability at the

Slope Indicator Data Analysis after December 2004: Slope indicator data collected between December 2004 and March 2005 showed an increase in movement due to the winter storm (Figure 8). Readings of the two slope indicators, SI's 0702 and 0802, within the area of concern showed (1) significant increase of movement along the existing shallow shear zone at SI_0702, and (2) a newly detected deep-seated movement along a deeper shear zone at SI_0802 (Figures 9 and 10). According to the slope indicator readings, the shallow shear zone is about 5.2 m below the highway and the deep-seated shear zone is about 13.5 m below the highway

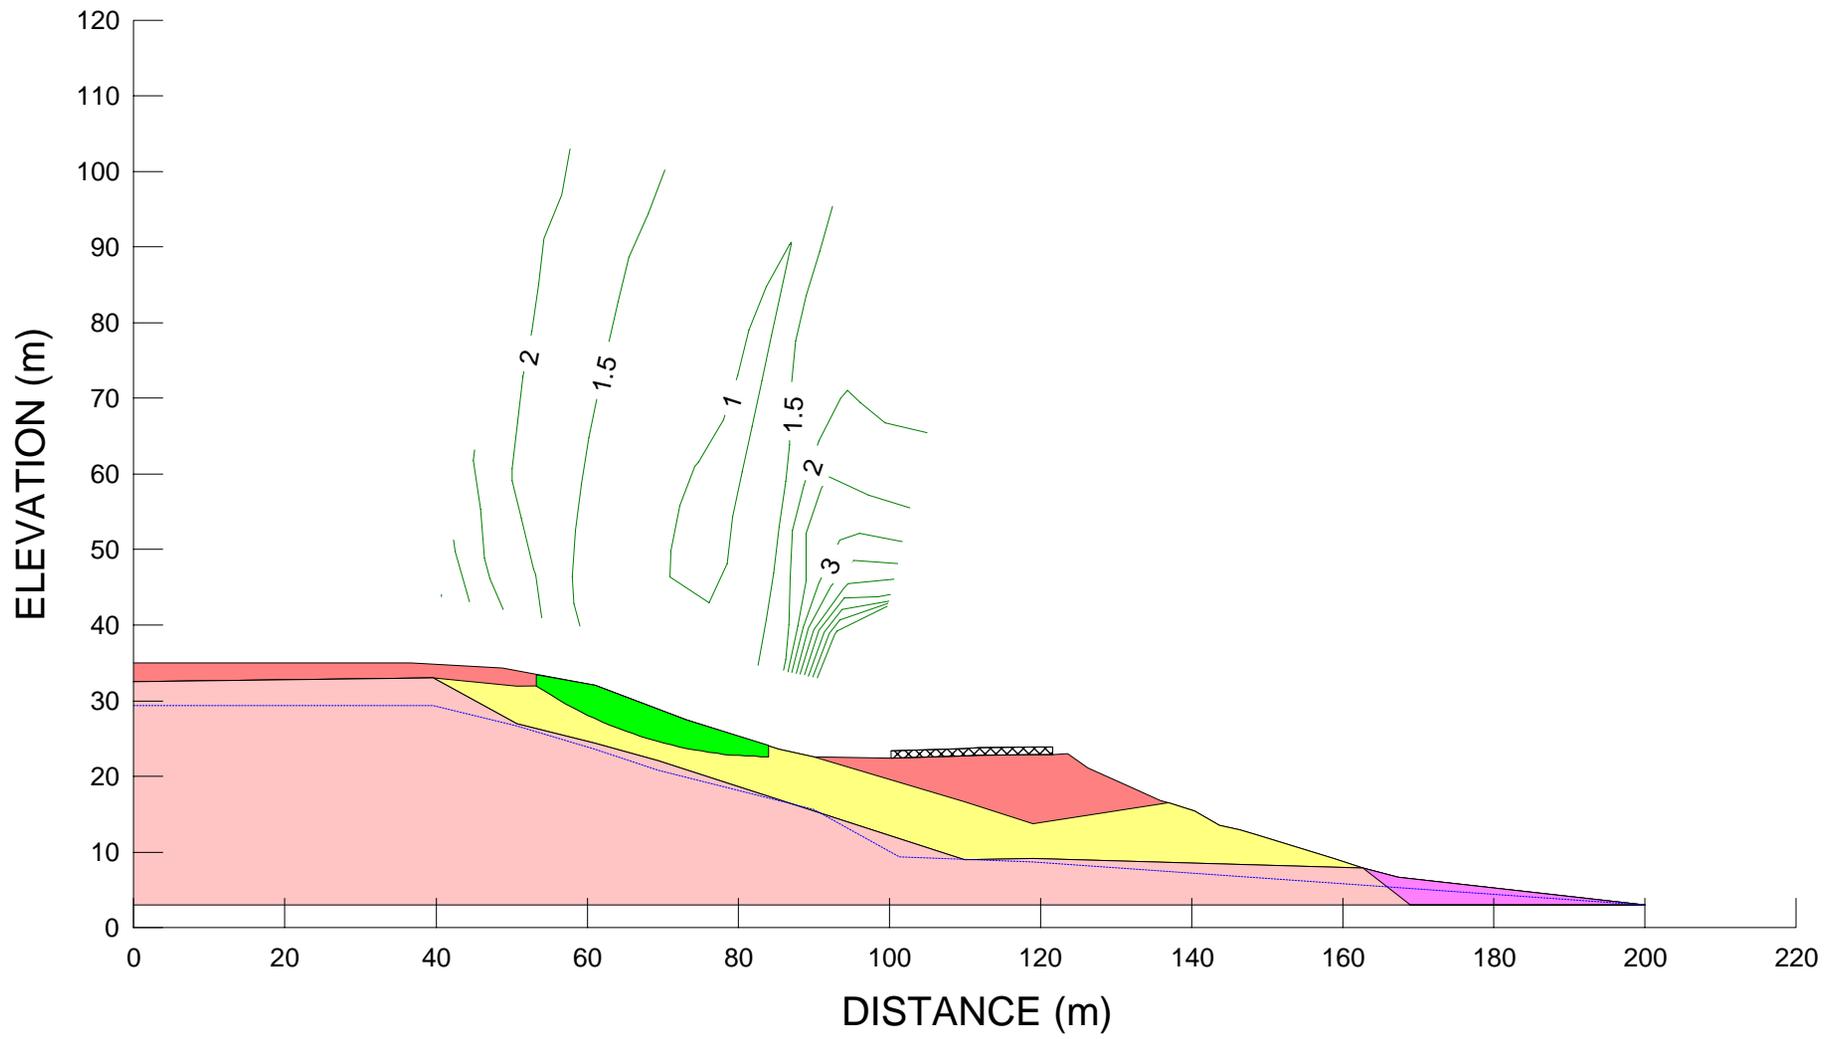
Figure 11: Stability Analyses of Upper Slope

A series of stability analyses were performed to model the observed slope distress on both sides of the highway (Table 3, Case 1 and 2). A separate analysis was also run to analyze stability of the entire slope encompassing the affected area on both sides of the highway (Case 3). These analyses were performed using the SLOPE/W software (Geoslope Inc.). The first two runs (Case 1 and 2) were performed to back calculate soil properties with incipient failure (Factor of Safety (FOS) ≤ 1 , along a failure surface defined approximately on the basis of the observed depths of movement and visible cracking on the eastbound

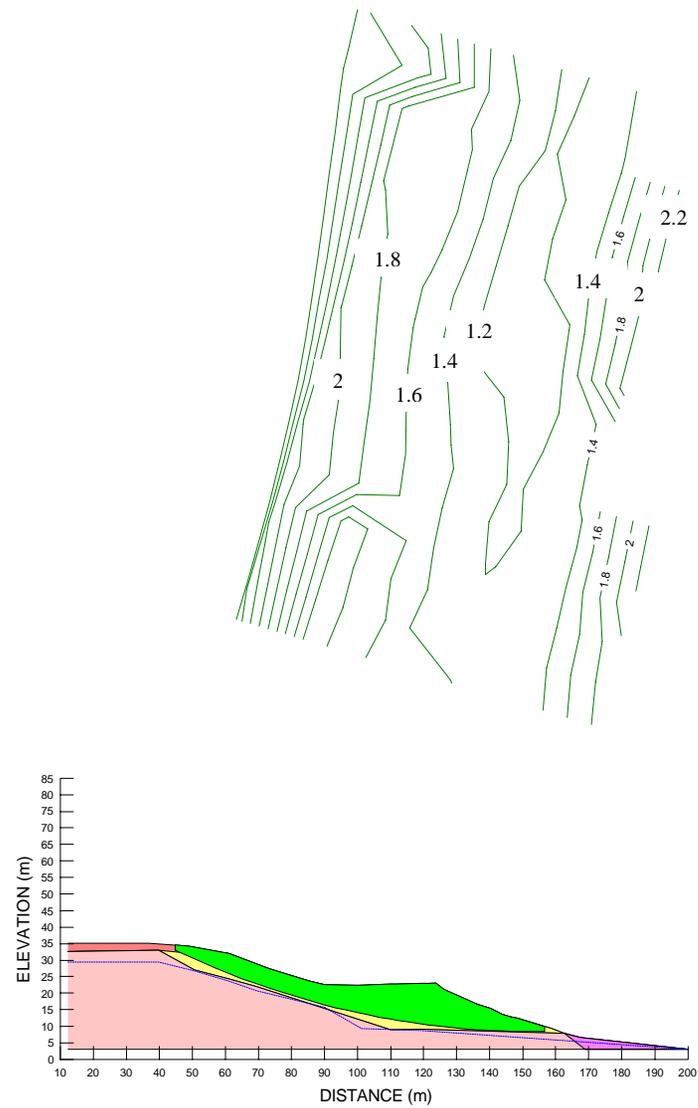
Figure 13: Stability Analyses of Upper & Lower Slope

and westbound sides of the highway (Figure 3a, 3b). Case 3 models the recent movement observed in SI_0802 at a depth of 13.5 m, using the back calculated soil properties from Case 1 and 2. A piezometric surface was entered into the models based on observed ground water table and data from previous explorations [6]. Case 3 indicates that the entire slope has a Factor of Safety close to unity.
