**ASBESTOS CONTAINING MATERIALS AND
LEAD-BASED PAINT SURVEY REPORT
REPLACE WATSON WASH, BRIDGE NO. 54-0805L
08-SBD-40 PM R105.2/R106.5
SAN BERNARDINO COUNTY, CALIFORNIA
PN: 08-000-201020 (EA#0N5500)
TASK ORDER #19
CONTRACT 08A2047**

**CALIFORNIA DEPARTMENT OF TRANSPORTATION, DISTRICT 8
464 WEST FOURTH STREET, 6TH FLOOR
SAN BERNARDINO, CALIFORNIA 92401-1400**

September 9, 2013

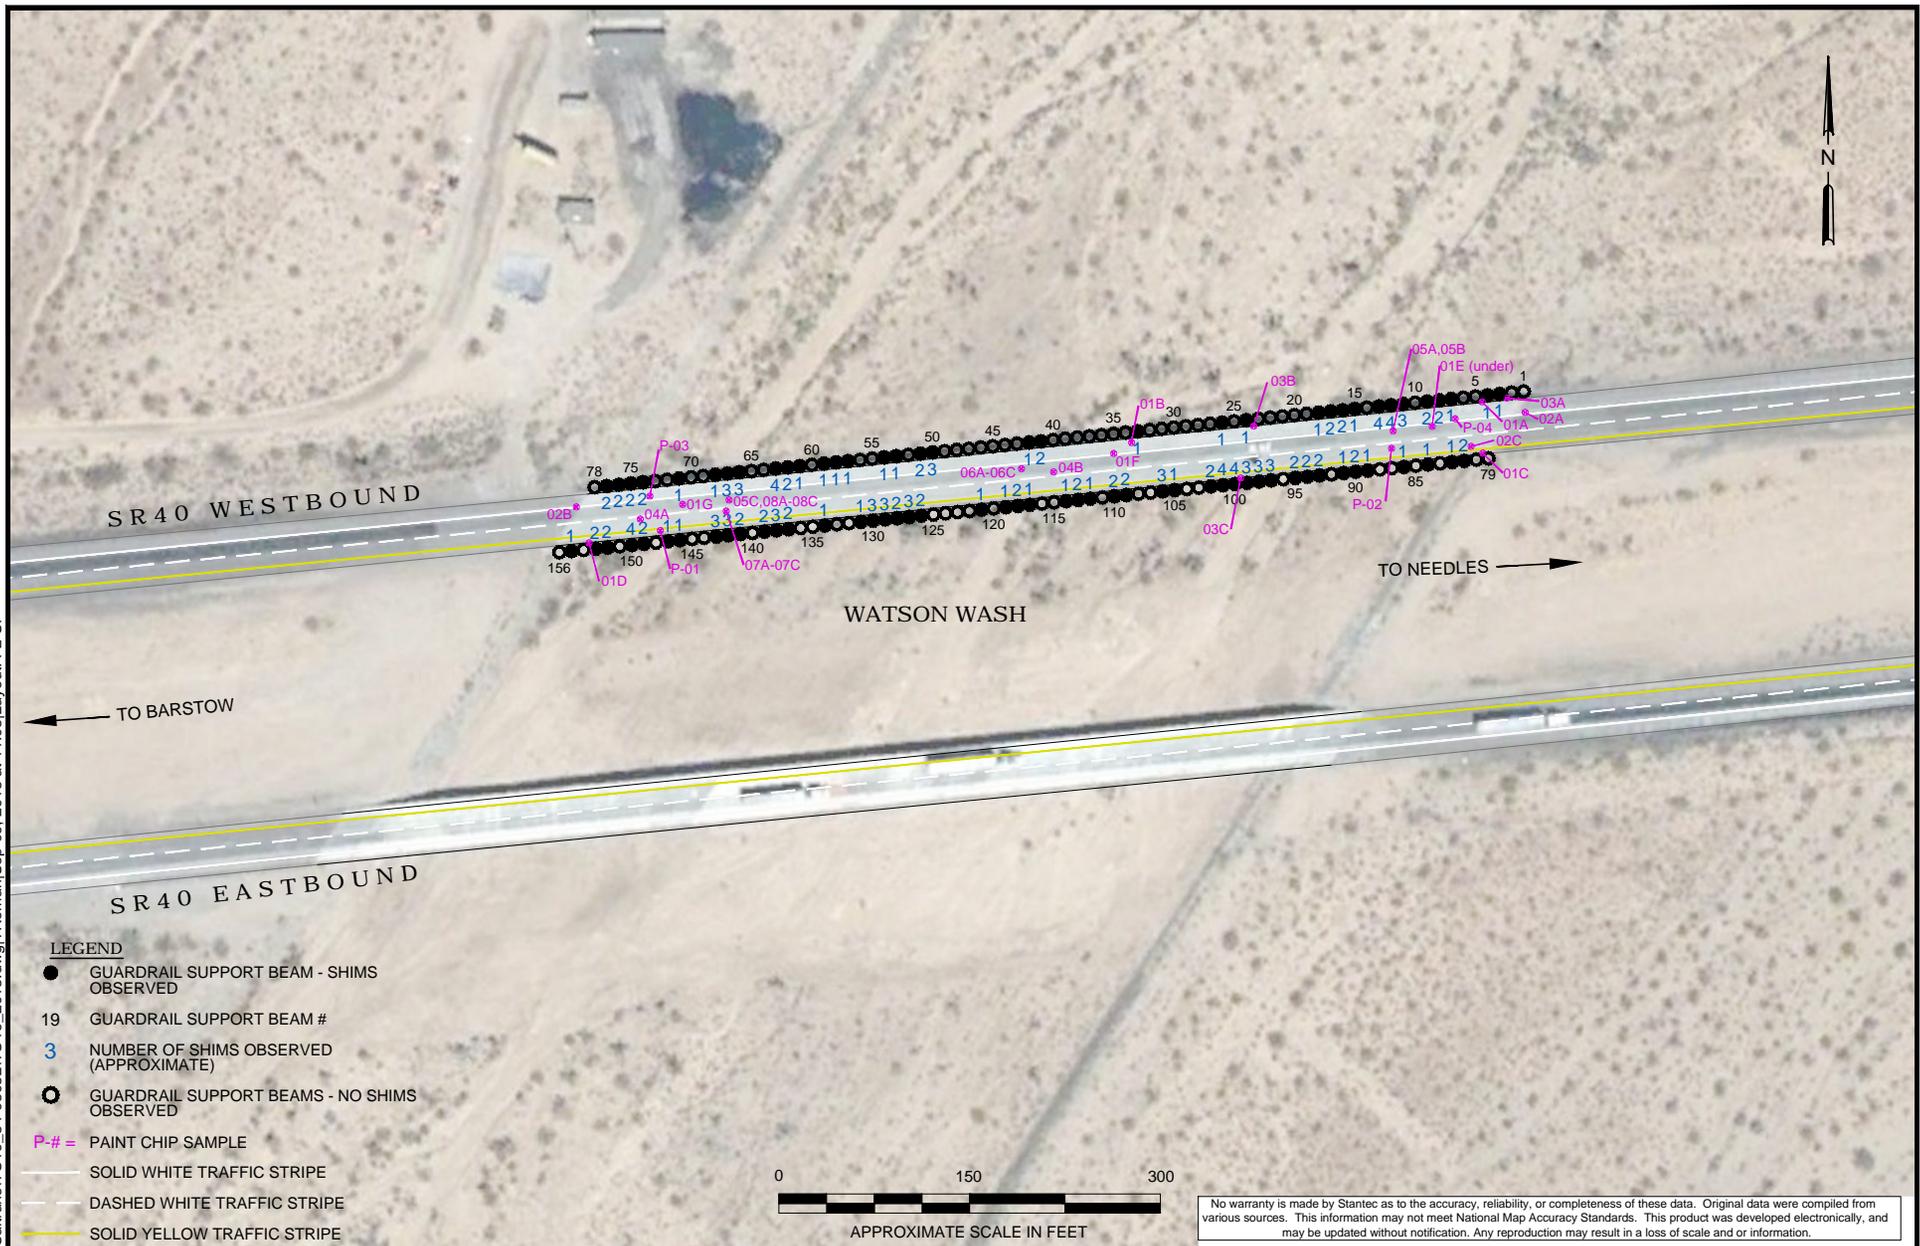
- GUARDRAIL SUPPORT BEAM - SHIMS OBSERVED
- 19 GUARDRAIL SUPPORT BEAM #
- 3 NUMBER OF SHIMS OBSERVED (APPROXIMATE)
- GUARDRAIL SUPPORT BEAMS - NO SHIMS OBSERVED
- P-# = PAINT CHIP SAMPLE
- SOLID WHITE TRAFFIC STRIPE
- - - DASHED WHITE TRAFFIC STRIPE
- SOLID YELLOW TRAFFIC STRIPE

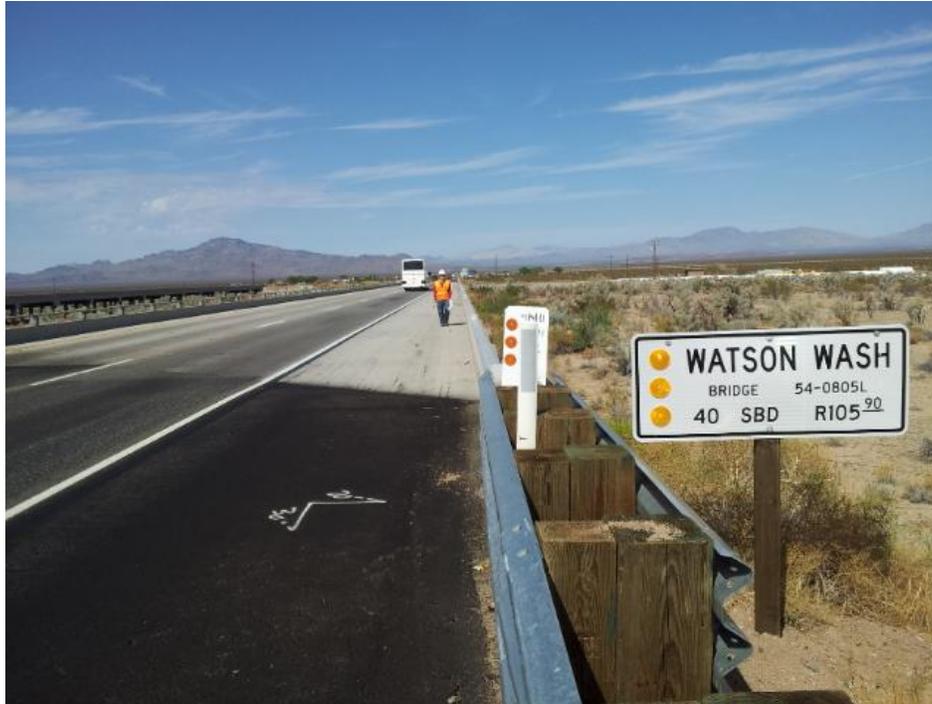
Photograph No. 1

VIEW OF WATSON WASH BRIDGE SIGN AND BRIDGE, FACING WEST.

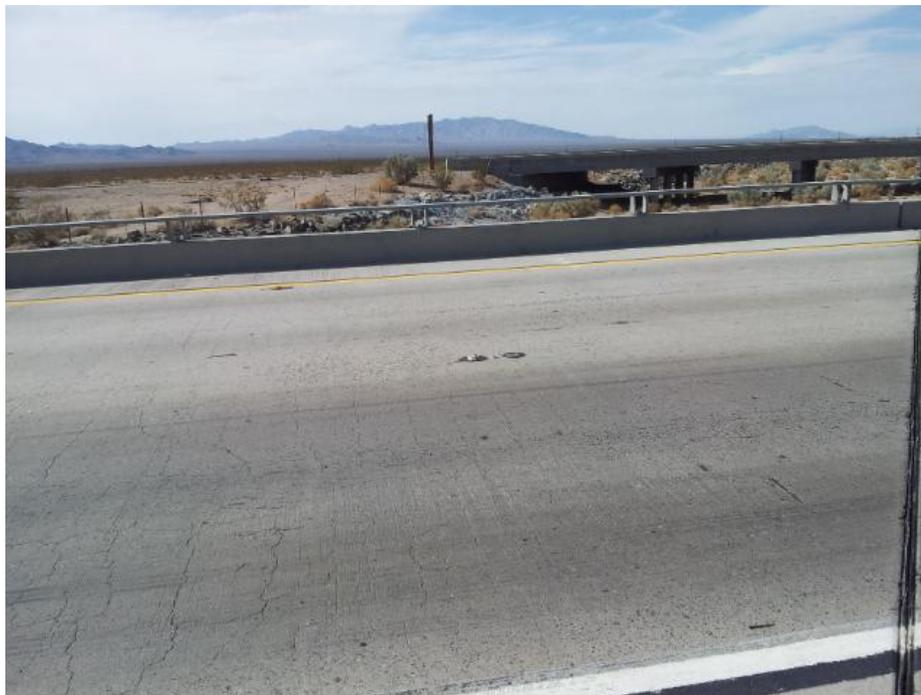
Photograph No. 2

VIEW OF WHITE STRIPE, REFLECTOR MASTIC, AND YELLOW STRIPE.

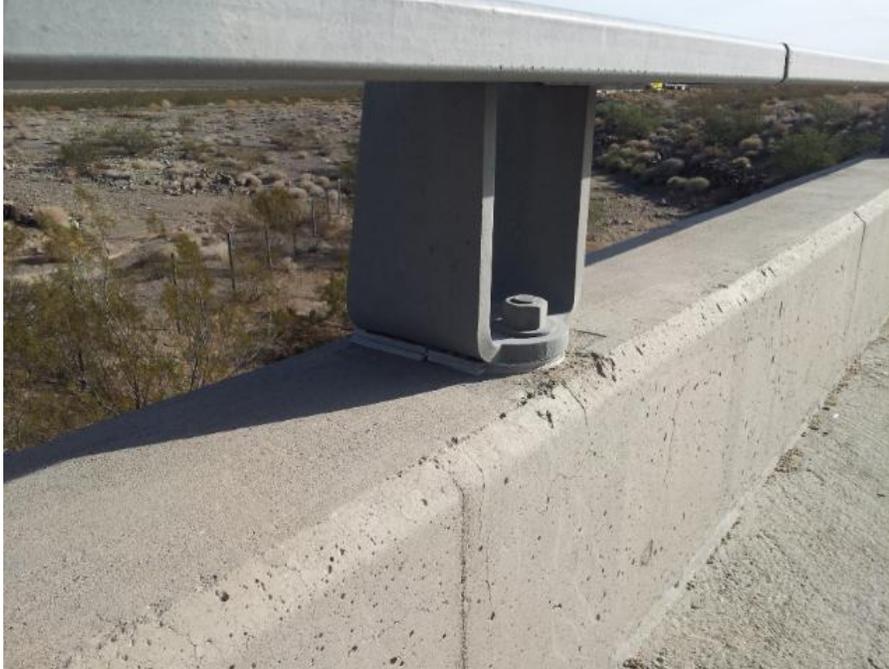
Photograph No. 3

- **Leveling Shims**
 - Three samples representing approximately 157 leveling shims were found to contain 75 percent asbestos.
 - Leveling shims measured approximately 8 inches by 8 inches.
 - The leveling shims represent a total estimated area of approximately 69.8 square feet of asbestos containing material.
 - In current state, considered to be Category II non-friable ACM. However, during demolition the shims may become friable.

ACM HAZARD ASSESSMENT							
Material Description	S/T/M*	Material Location	F/NF**	Condition Code***	Accessibility	Potential for Disturbance	Quantity on Each Bridge
Watson Wash Bridge (54-0805L)							
Leveling Shims	M	Beneath Guardrail Posts	F	Good	Low (Located Beneath Guardrails)	HIGH (Removal, Demolition, Maintenance)	~69.8 square feet

The leveling shims appeared to be in good condition at the time of the survey, however, if the shims are disturbed during construction activities, they should be classified and handled as a RACM due to the high probability of becoming crumbled, pulverized, or reduced to a powder by the forces expected to act on the material in the course of demolition or construction. It should be noted however that the asbestos survey was limited to accessible materials only. If demolition of the Watson Wash Bridge includes removal of on-site portions of underground utilities, evaluation of the asbestos content of these components must be performed prior to the removal process. Suspect materials identified in these locations are assumed positive for asbestos until sampling and analysis indicates otherwise. If during the course of a demolition project suspect ACMs are discovered that are not included within this report, those materials are to be assumed positive for asbestos unless additional sampling, analysis and/or assessment indicates otherwise. Asbestos abatement work should be performed in accordance with California Code of Regulations (CCR), Title 8, Section 1529 (Asbestos in Construction Standard). Submission of this report will be required for compliance with the NESHAP in accordance with MDAQMD Rule 306.

PHOTOGRAPH OF GUARDRAIL LEVELING SHIM. SHIMS WERE FOUND TO CONTAIN 75% CHRYSOTILE ASBESTOS AND THEREFORE CONSIDERED AN ACM.

- Any generated ACM wastes should be disposed as hazardous asbestos waste.

- ACM abatement is required by a licensed ACM abatement contractor prior to renovation, refurbishing, or demolition activities. The abatement contractor's responsibilities include,
 - Removal and disturbance of ACMs in accordance with Cal-OSHA requirements. (e.g.; CCR Title 8, Section 341.9 and 1529).
 - Segregation and disposal at a landfill permitted to accept hazardous RACM waste.
 - Compliance with all other local, state and federal regulations and requirements associated with the disturbance, management, handling and disposal of ACM.
 - The amount of ACM that may be generated during bridge demolition activities is approximately 69.8 square feet. Notification to the MDAQMD is required for all demolitions regardless of the ACM square footage. The contractor is required to comply with all other MDAQMD and other agency notifications and requirements for demolition and construction.

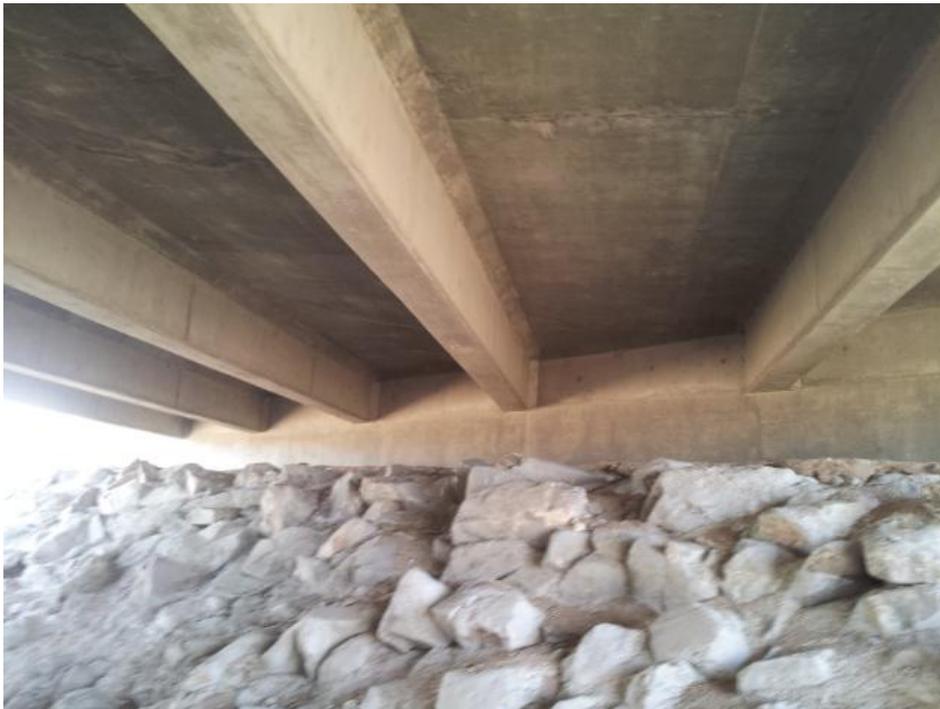
Photograph No. 4

VIEW OF THE ABUTMENT, BELOW THE EAST END OF THE BRIDGE.

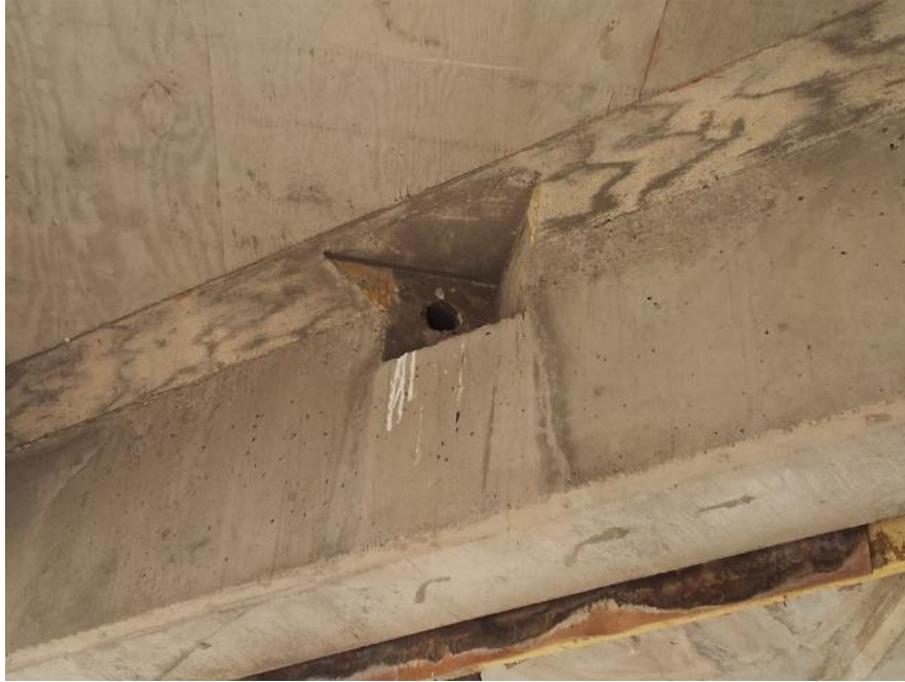
Photograph No. 5

VIEW OF DRAIN LINE AND EXPANSION FELT BOARD OBSERVED AND SAMPLED BELOW THE BRIDGE DECK.
