Evaluation Of Compaction Grouting

DIVISION OF STRUCTURES AND ENGINEERING SERVICES
TRANSPORTATION LABORATORY
RESEARCH REPORT

FINAL REPORT

EVALUATION OF COMPACTION GROUTING
07-Ora-57 PM 21.5/22

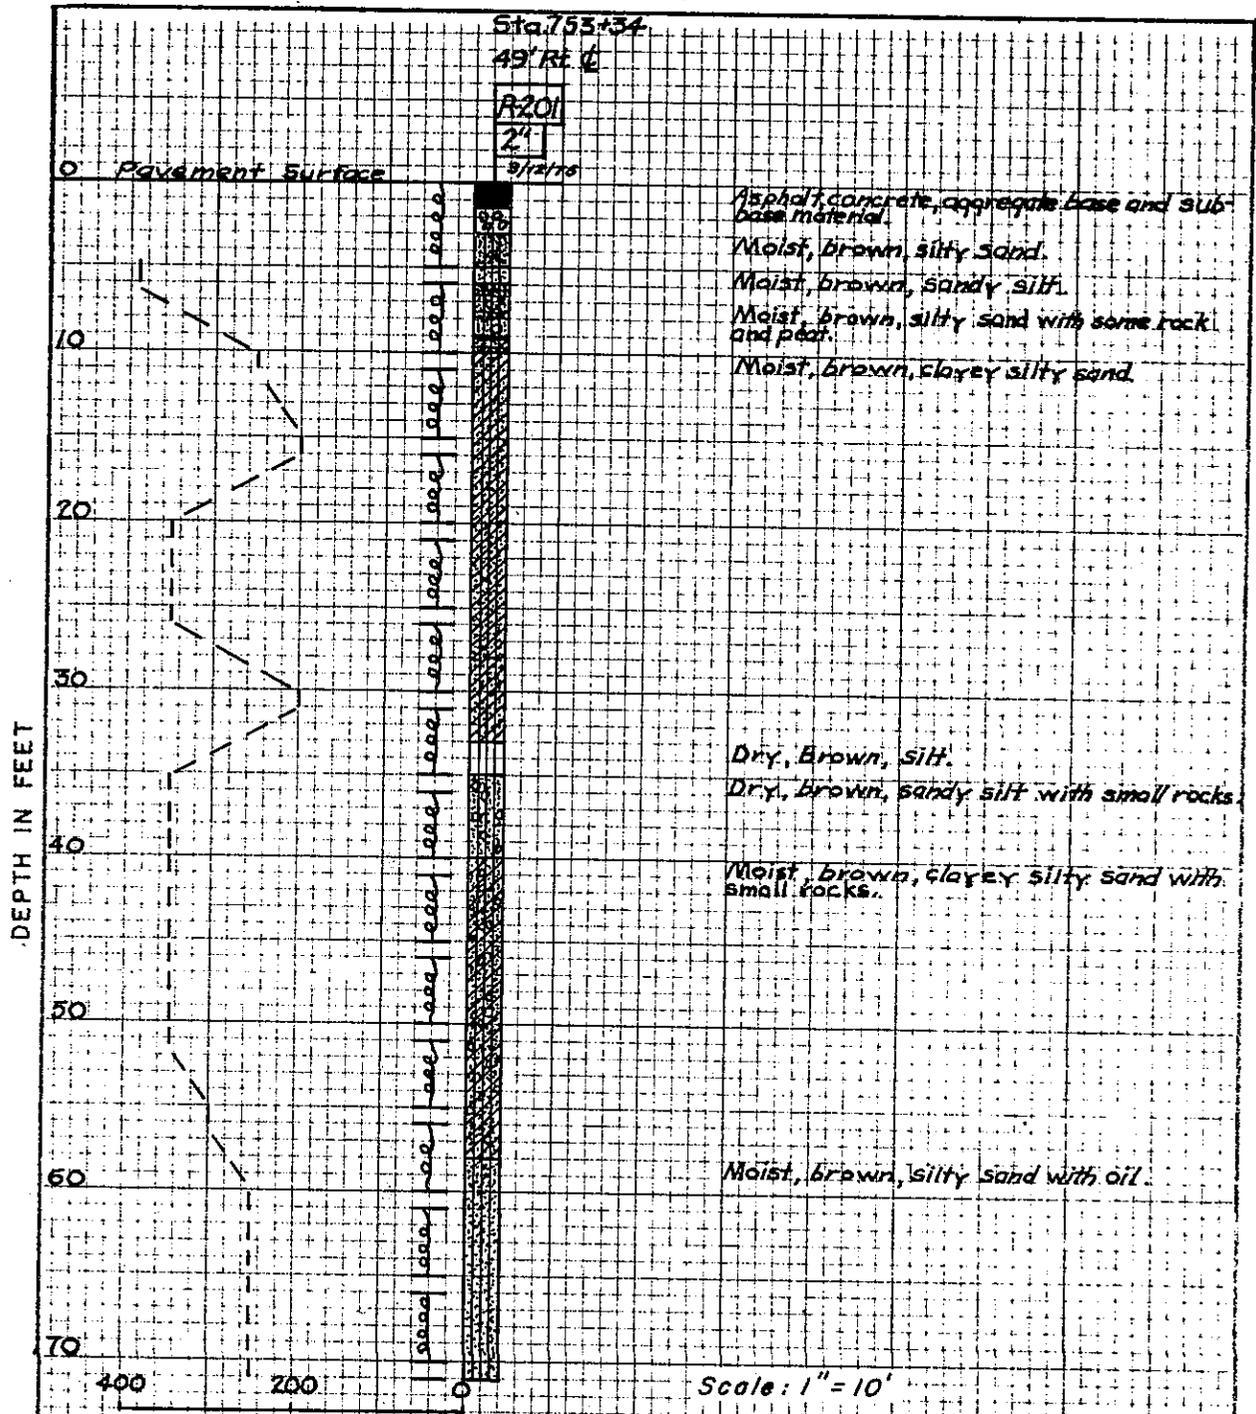
Fig. 5

Grouting for test hole No. 1 (Boring R-201, Figure 5) began from the bottom up at a depth of about 55 feet below the pavement surface. An air packer 1-1/4 inch inside diameter (Photo 6) was lowered into the hole and expanded under pressure to conform with and seal the hole at a depth of 55 feet. A 3 inch diameter hose was used to pump the grout from the mixing hopper through the drill rod stem to the point of application below the packer which was 3 feet in length. The grout slump was estimated at 2 inches. The grout was pumped until refusal was achieved. No pretreatment of the hole was performed before grouting.

The average time to deliver the first three batches was four minutes with pressures of 300 to 400 psi. A 23 minute delay was encountered following the third batch when the packer ruptured. A new packer was installed, however, the test hole refused to accept anymore fresh grout at the previous depth. The packer was then raised to a depth of 20 ft below the pavement surface. Two additional batches of grout were pumped into the hole averaging 3 minutes per batch at pressures of 150 psi. The packer was then raised to the 15 foot depth and five additional batches were pumped averaging 5 minutes per batch at 175 psi

pressure until refusal was achieved. Pavement surface elevations taken before and after grouting in the vicinity of the test hole showed no significant change that would indicate pavement heave. Total delivery time for the 10 batches was 3-1/2 hours.

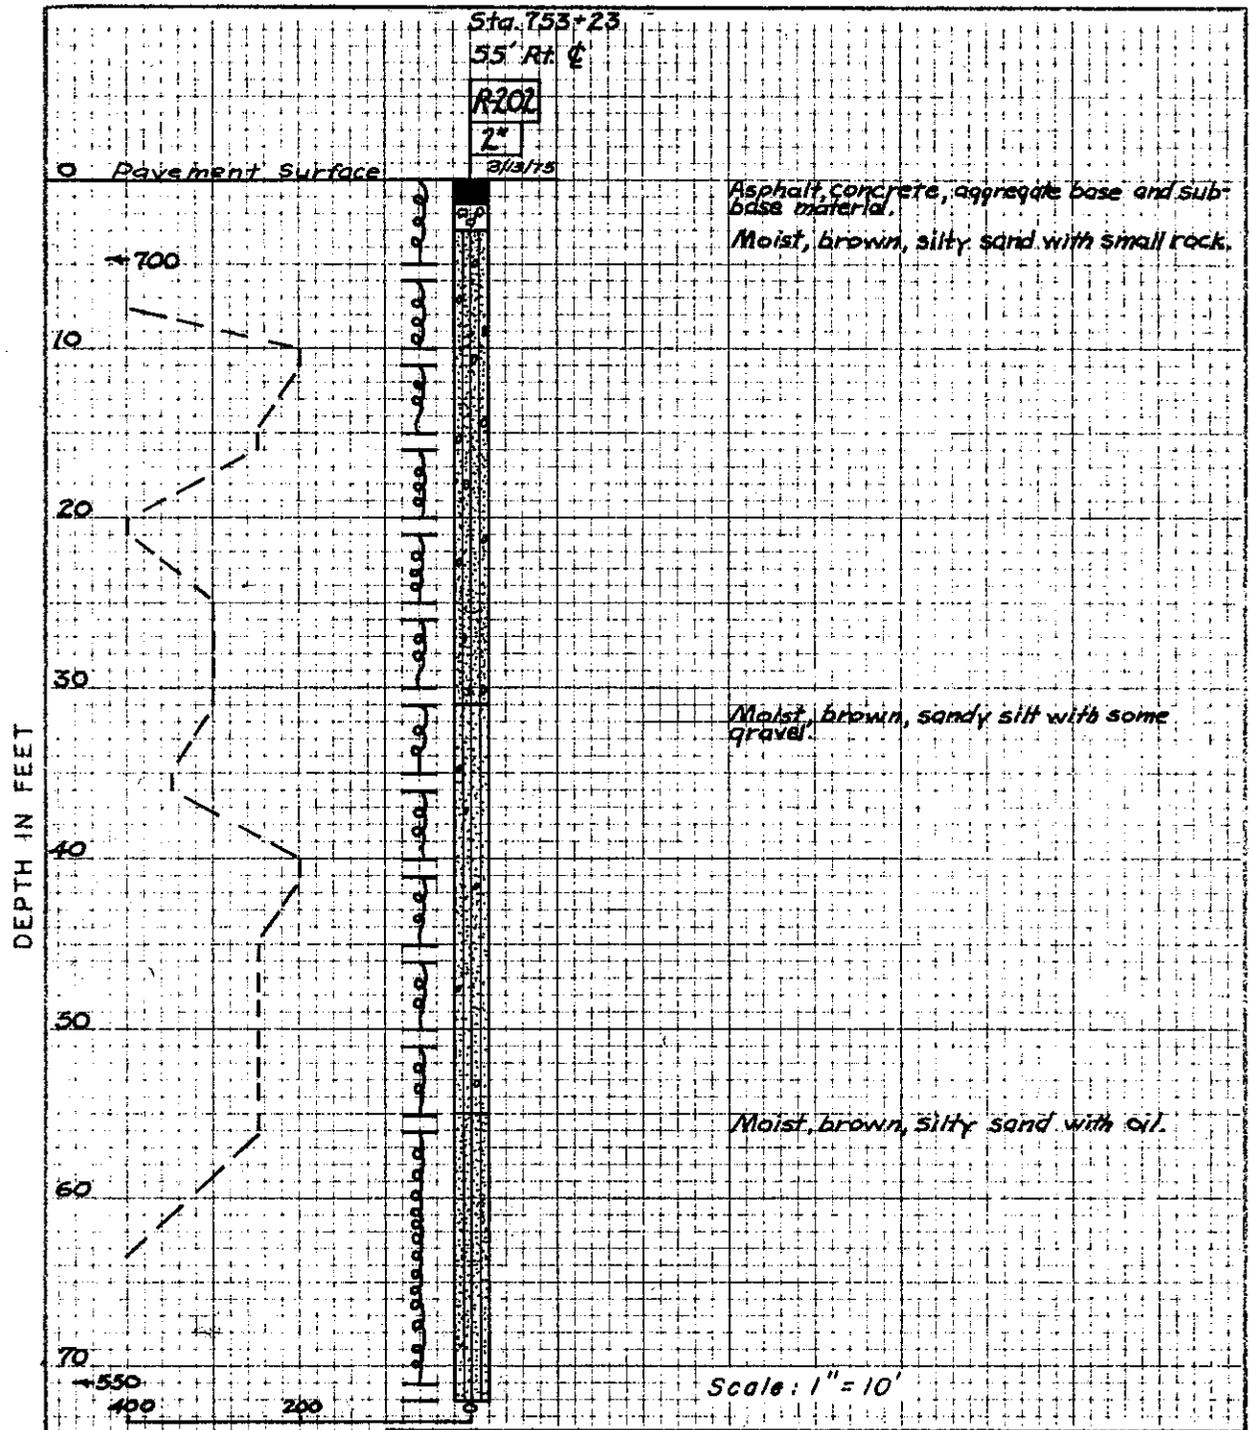
Fig. 6

Test Hole No. 2 (Boring R-202, Figure 6) required two hours to complete the compaction grouting operation because the packer ruptured during inflation. A total of 6 batches equal to 22.8 ft³ was forced into the hole. The packer was set at a depth of 55 feet for the first two batches, 50 feet for the next two batches and 45 feet for the fifth batch. The sixth batch was set at 20 feet. Average grouting pressures were 150 psi.

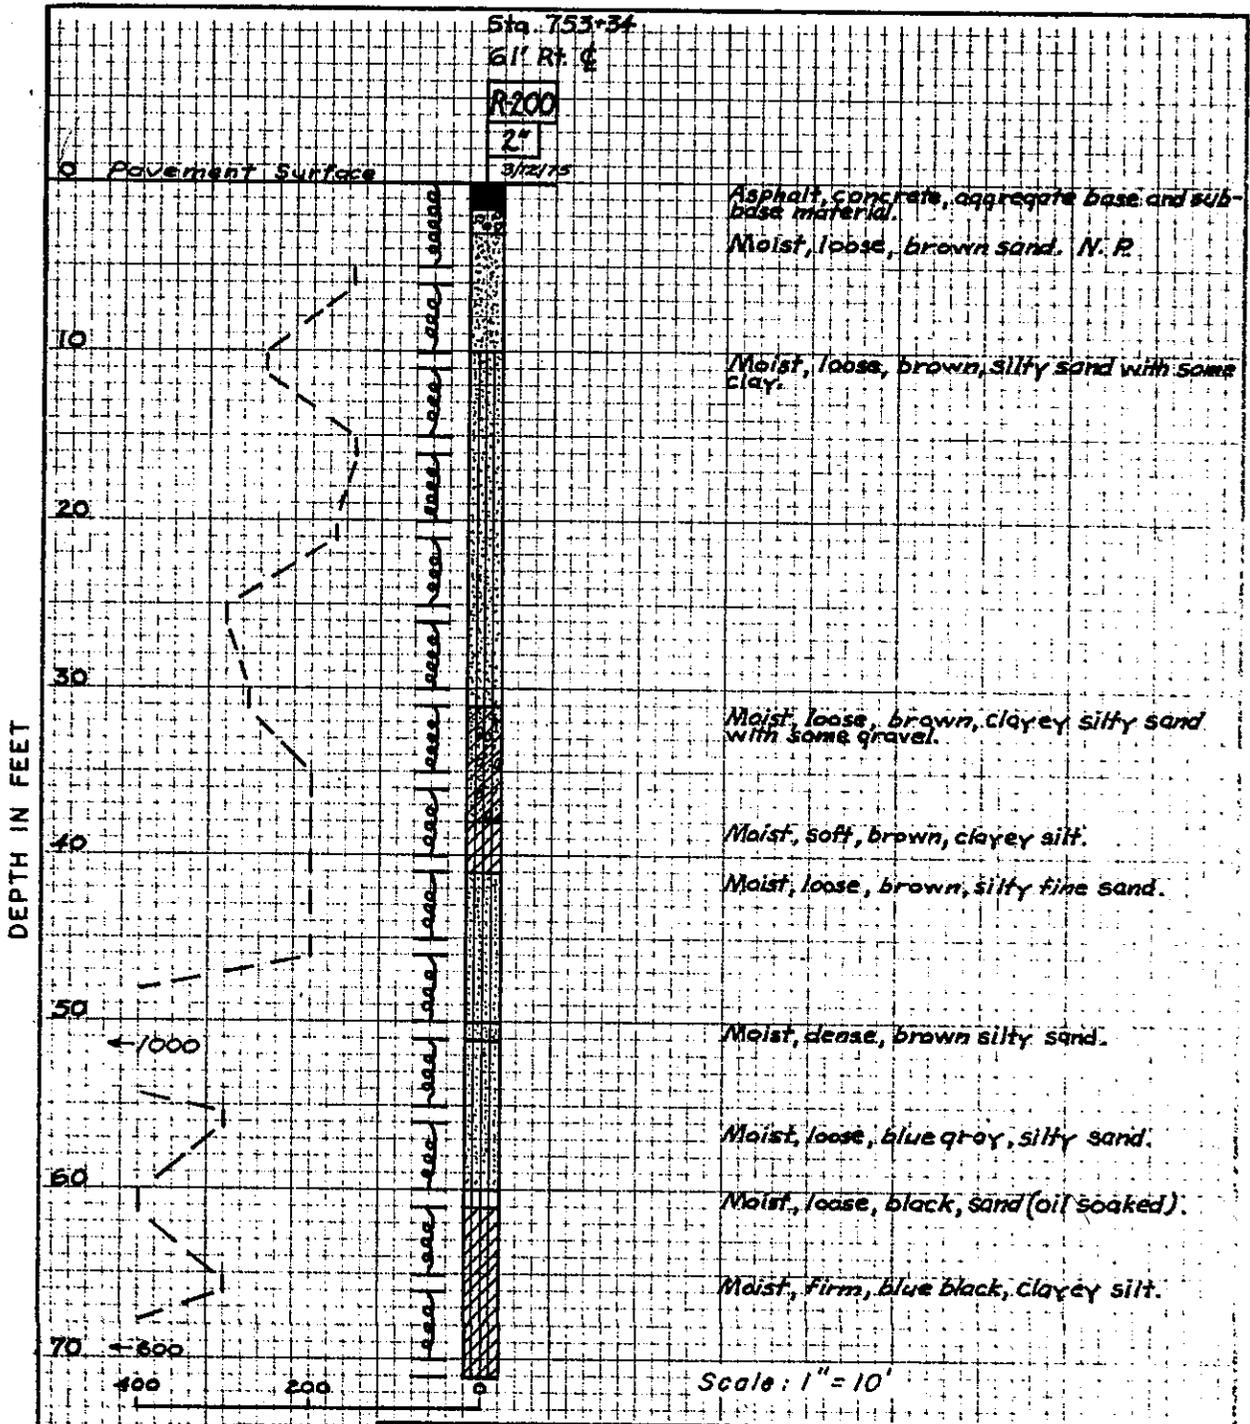
Fig. 7

Test Hole No. 3 (Boring R-200, Figure 7) required 1-1/2 hours to complete using the packer which was shortened to 2 feet (Photo 7). A total of nine batches were forced into the hole. The packer was set at a depth of 22 feet for the first three batches and grouting pressures of 100 to 300 psi were obtained. Each batch required about 3 minutes for delivery. The packer was reset at 16 foot depth for the next two batches which were pumped until refusal was reached. Pressures of 300 psi and total delivery time of 10 minutes was required. The packer was placed near the pavement surface for the last four batches and pumping continued until pavement heave was noticeable. Pressures of 150 to 300 psi were required. Total delivery time for the last four batches was 30 minutes.

The 3 ft length of packer proved to be of inadequate length to seal the hole and prevent the grout from overflowing above the packer. Overflow can cause difficulty in packer recovery if the pressure grouting is delayed during pumping.

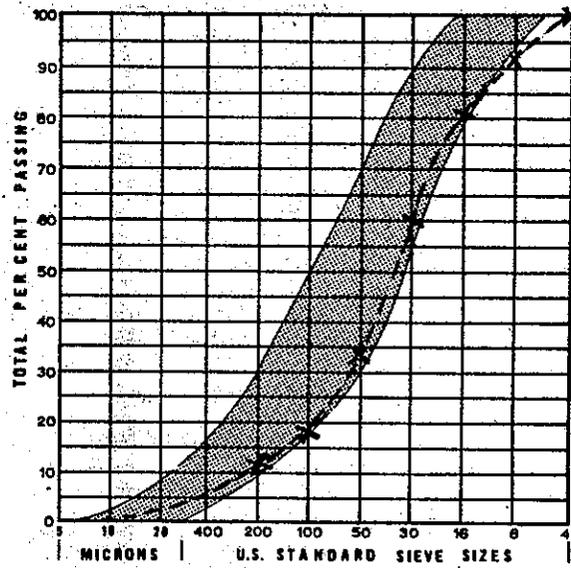
A plot of the combined "as used" grading for the sand and diatomite earth is shown in Figure 9 which presents the preferred gradation limits reported by Warner and Brown(4) for a fine sand aggregate. The diatomite was included in the mix to improve pumpability.

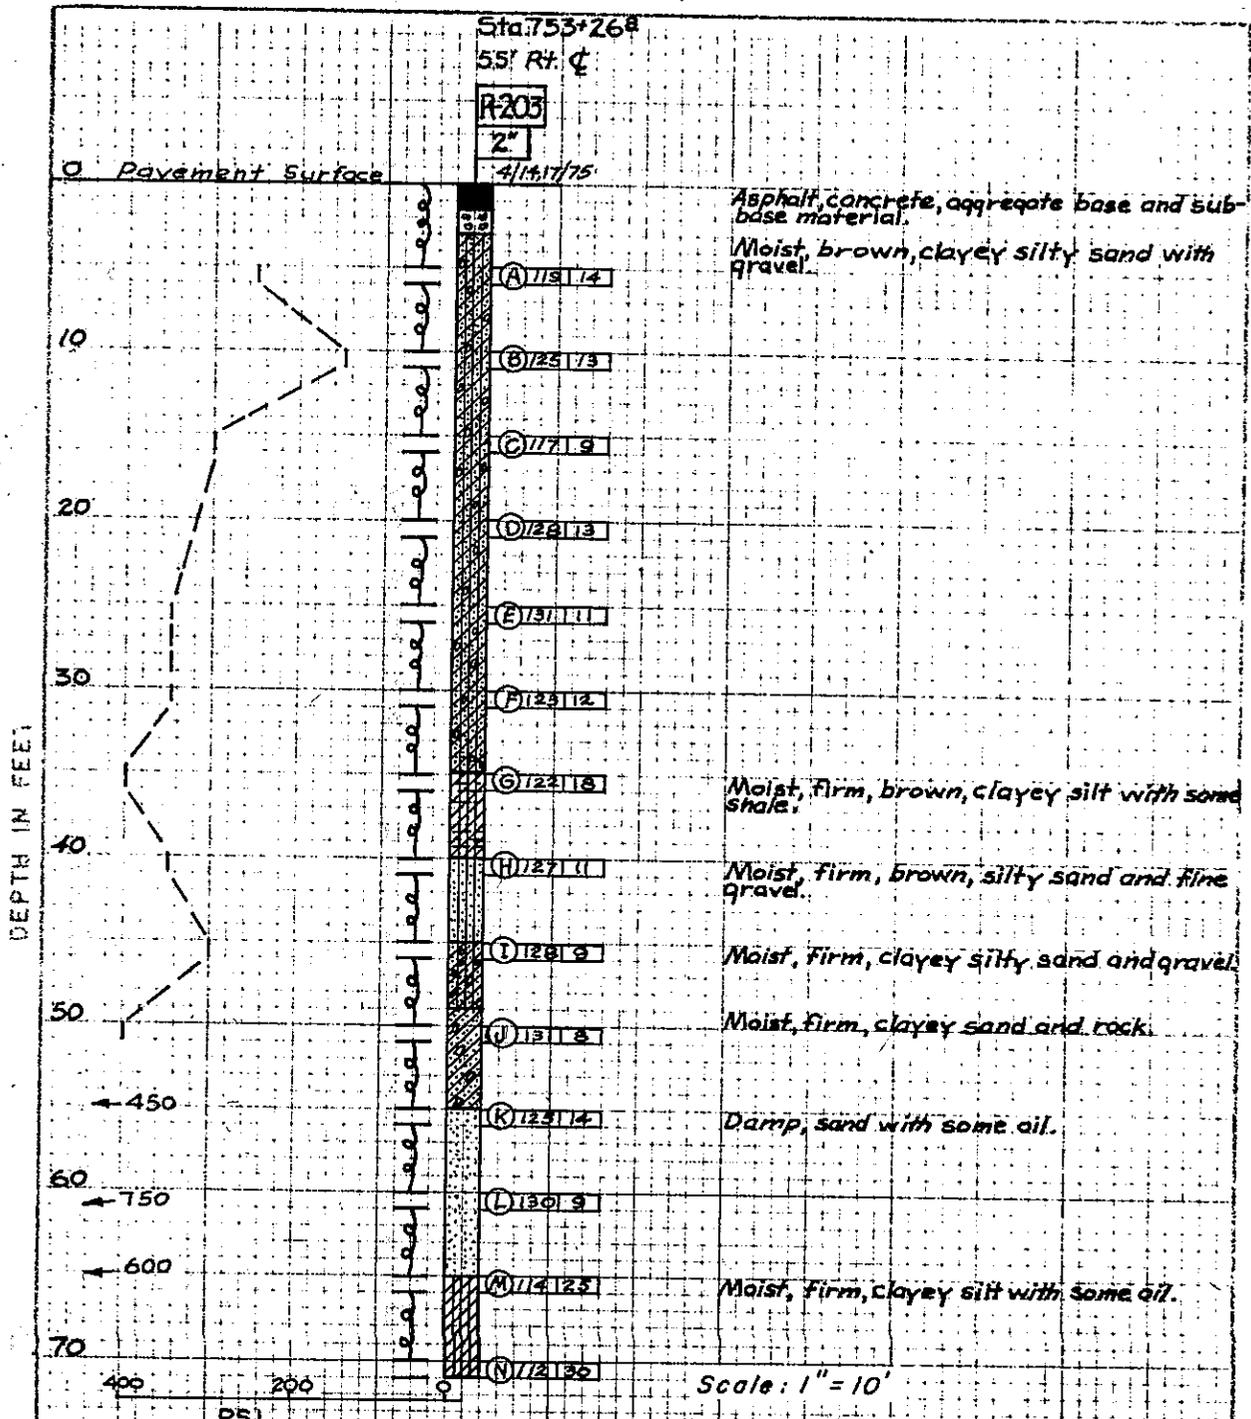
Fig. 13

Soil densities representative of the after condition were obtained in borings R-203, R-204 and R-205 (Figures 13, 14 and 15) which are located within or near the test grid pattern. A comparison of these densities with those representing the before condition can be made by inspection of Table 1. A review of these data again indicates the difficulty in making a valid comparison to establish improvement in density. However, if boring 15 is considered representative of the before condition, since it is located nearest to the test area, some density improvement is indicated.

When the soil densities in boring R-203 are compared with those in boring R-204, an average increase of about 1 lb/ft³ is

suggested for boring R-204 over boring R-203. Both borings are located within the test grid. Boring R-203 is located 3.8 ft from grout test hole 2 (boring R-202) and boring R-204 is 5.5 ft out from grout test hole 2 and possibly within the influence of all three grout test holes (refer to Figure 8). No before density measurements were obtained for the grout test holes (borings R-200, R-201 and R-202).
