Project No. 33211

Report on Skid Resistance Characteristics of Thermoplastic Stripes

June 1965

State of California
Department of Public Works
Division of Highways
Materials and Research Department

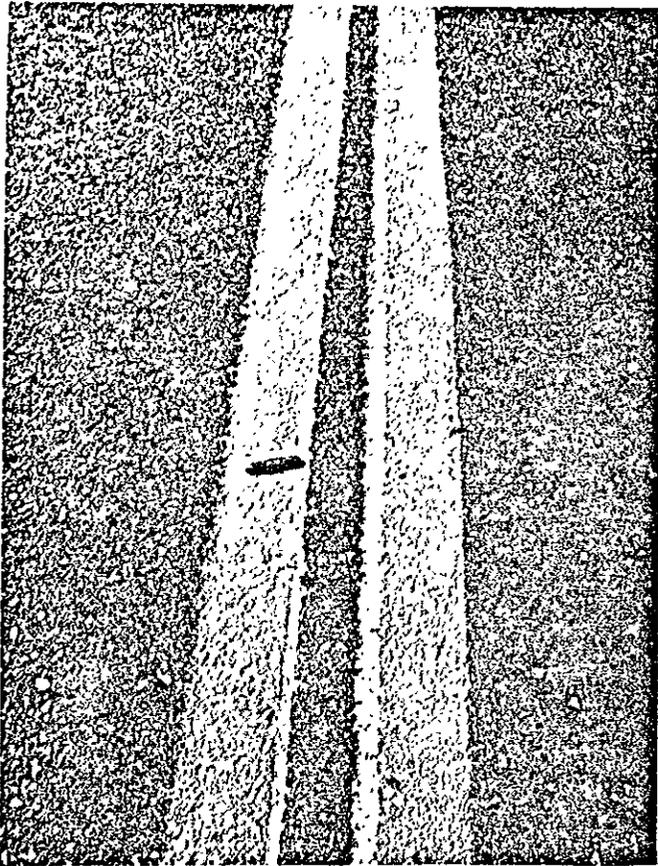
As shown in Table A the skid resistance test results of the thermoplastic stripe are all well below this tentative minimum requirement. Skid resistance test results of the normal painted stripes are quite variable and at two locations the average values are above the minimum requirement. The average values obtained on the 8" wide normal painted stripe are below the minimum requirement both in the tangent and curve test areas. It is apparent from these tests that the frictional resistance of a normal painted stripe is dependent on initial pavement surface texture. Therefore, the skid resistance characteristics of painted stripe are dependent on the amount of pavement surface texture remaining after painting which in turn is controlled by initial surface texture and quantity of paint applied.

Close up of double paint stripes in tangent test area. Note the rough pavement texture and the fact that road surface texture is showing through the paint film.

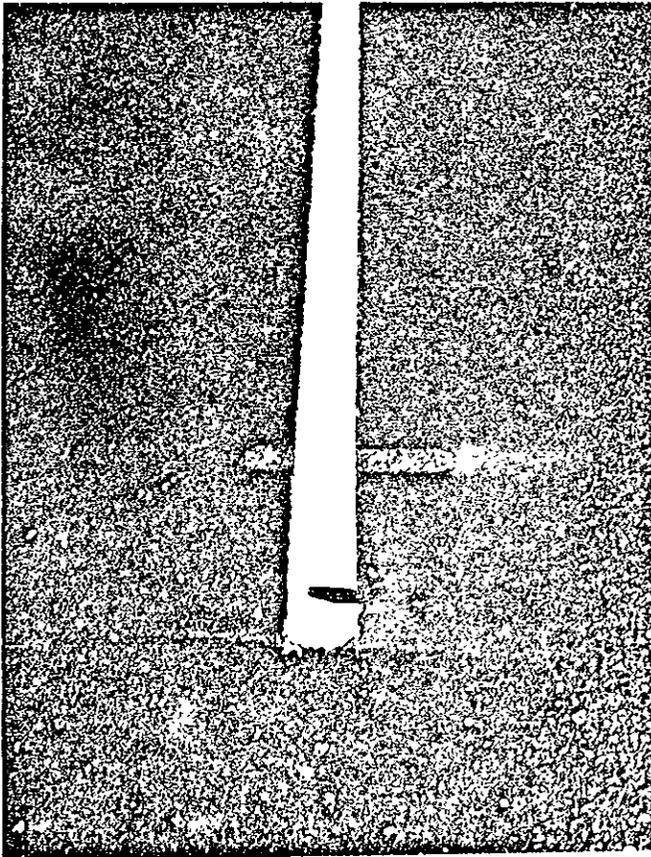
Close up of single 4" wide thermosplastic stripe. Note the rough pavement surface texture does not show through this thick coating.

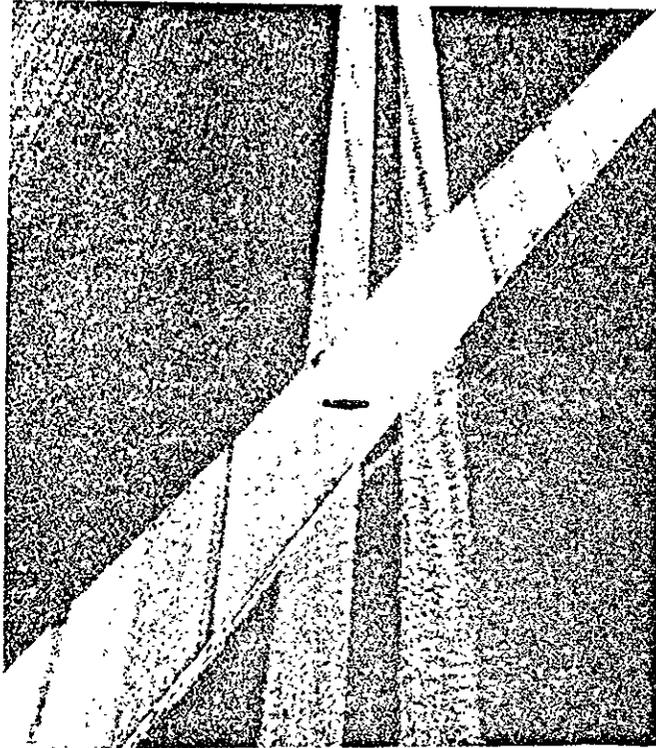
Close up of yellow paint stripe in curve section. The surface texture of this pavement was much smoother than the tangent sections and the paint film had a tendency to fill the surface texture of the pavement.

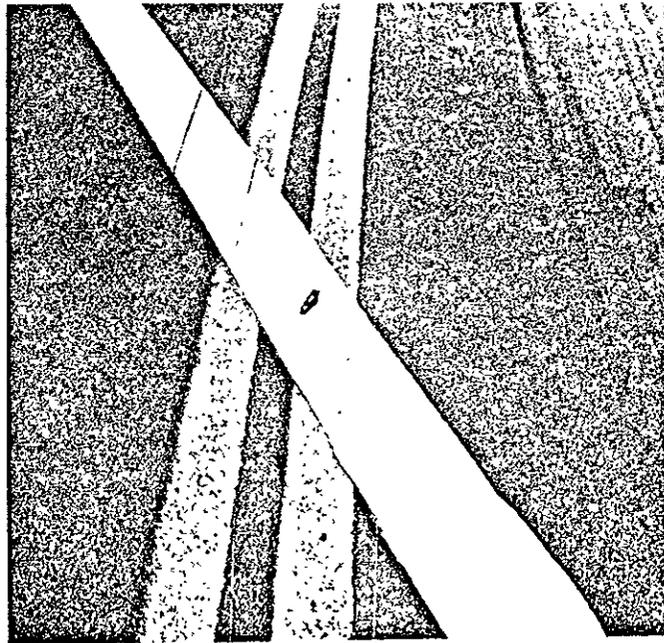
Close up of thermoplastic stripe in curve section.

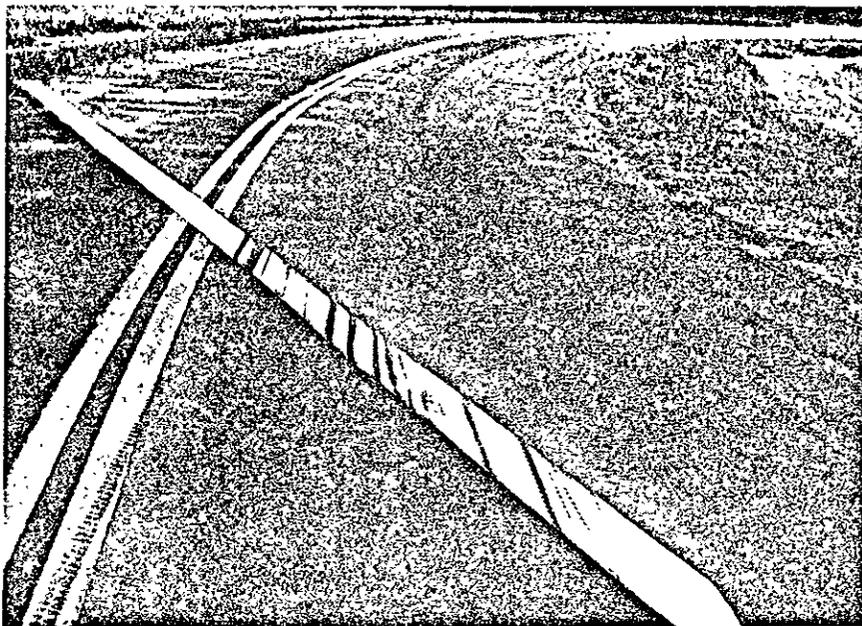
Driver reaction and visual observations of the weaving tests indicated no apparent difference in driver control between the thermoplastic and painted stripes. There was definitely more tire noise when the vehicle passed over the thermoplastic stripe. In the stopping tests with two side wheels on the stripe the vehicle stopped relatively straight regardless of stripe type, however, there appeared to be a greater deposit of black rubber on the thermoplastic stripe.

Showing tire deposits over thermoplastic stripe caused during dry tests. Note that in general the tire deposits on the black pavement and over the stripe follow in the same line which indicates that no skid problem involving the stripes would exist during dry weather.
