Technical Studies

State Route 68/Corral de Tierra Road Intersection Improvement Project

Monterey County, California
05-MON-68-PM 12.8/13.2
Project ID: 05-0000-0085 (05-0H8230)

VISUAL IMPACT ASSESSMENT

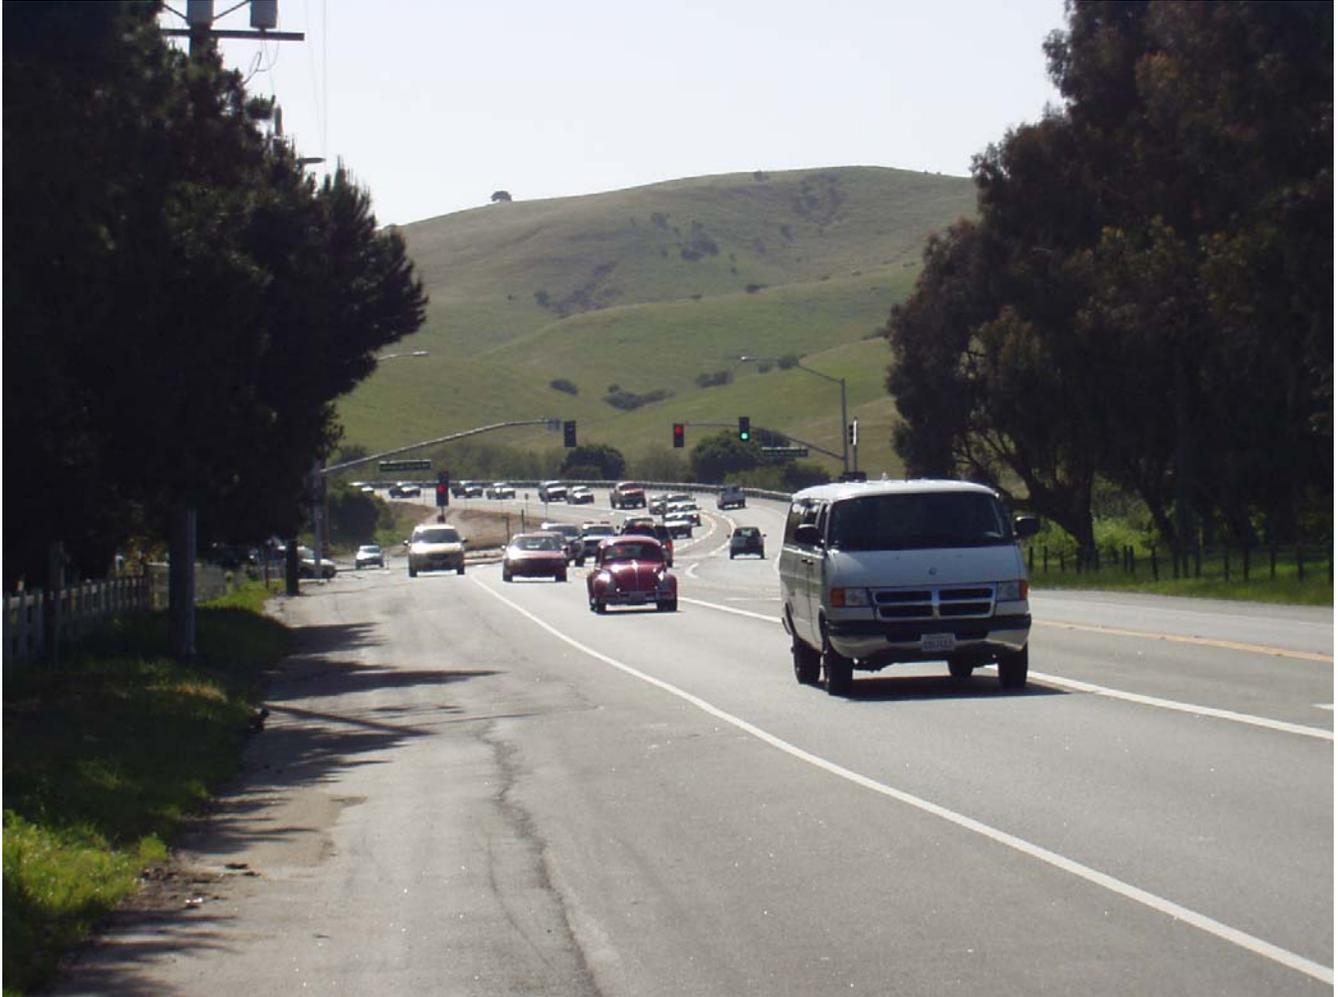
FIGURE 2

Looking west at the Corral de Tierra Road intersection from south shoulder of State Route 68.

View from SR-68 Looking West

Figure 2 shows the existing view looking west along SR-68 from the ~~south~~ north shoulder of of SR-68.

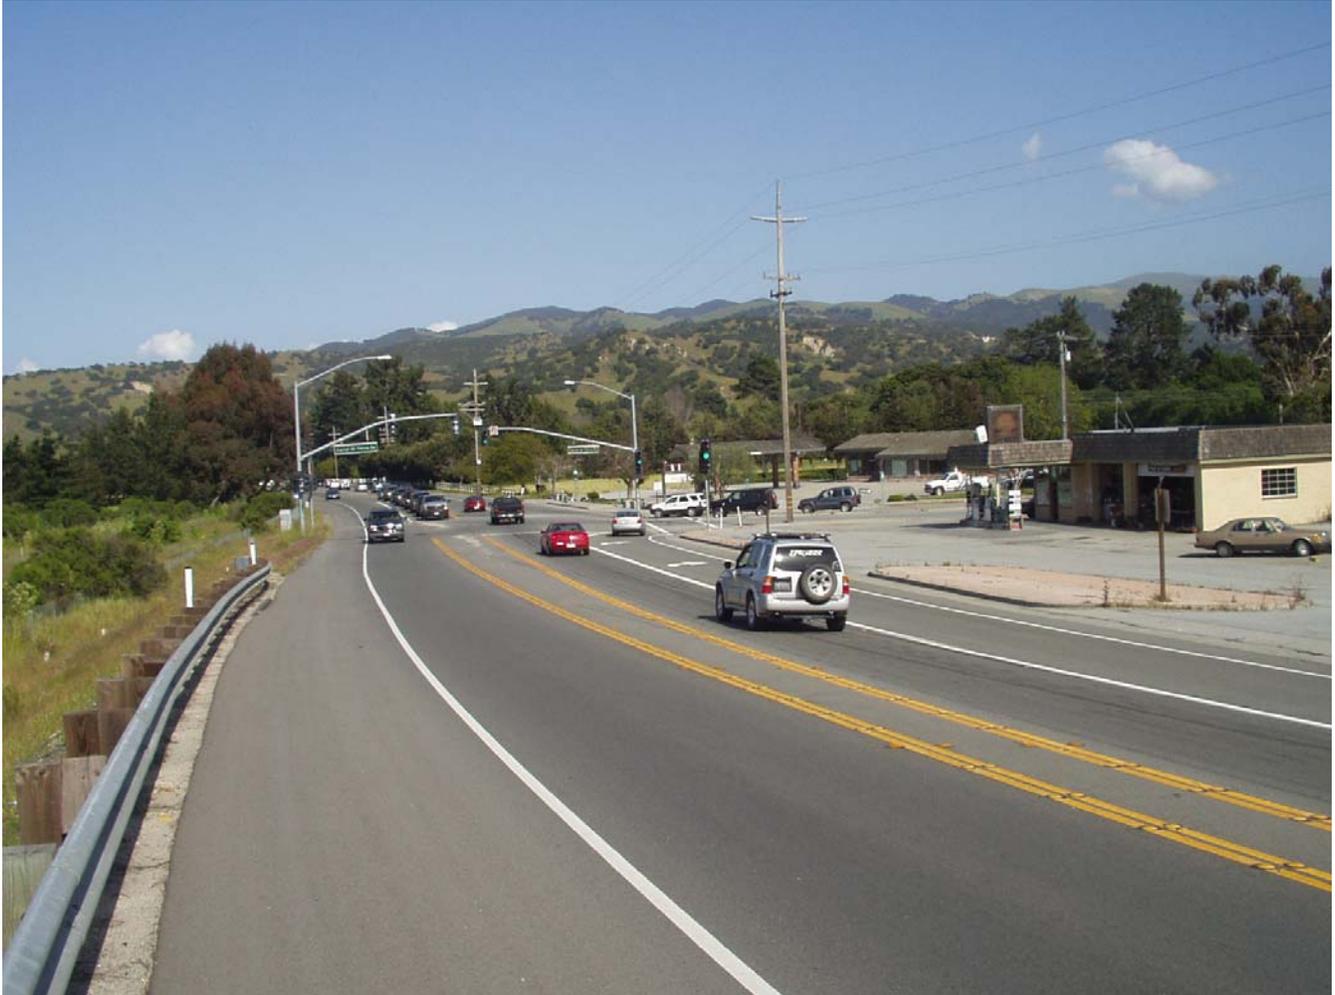
FIGURE 3

Looking east at the Corral de Tierra Road intersection from north shoulder of State Route 68.

View from SR-68 Looking East

Key View 2. In Key View 2 (Figure 3), the road would be widened shifting the existing pavement to the north (left side of the photograph). A guardrail along the north side of SR-68, as can be seen in Key View 2, would be relocated or replaced to accommodate the wider road in that location. The increase in the amount of pavement/roadway is minimal and while it would have a slight impact on the road’s visual quality, it would not change the existing overall visual character and experience for observers. Therefore, implementation of the proposed project is not anticipated to result in adverse visual impacts from this key view.

Guardrails. The guardrail along the north side of SR-68, west of the intersection, would be relocated or replaced to accommodate the wider road in this location. The relocated or new guardrail would be erected with metal posts. The posts will be darkened to reduce glare and reflectivity. Darkening any new guardrail posts will also make them consistent with other programmed projects in the area.

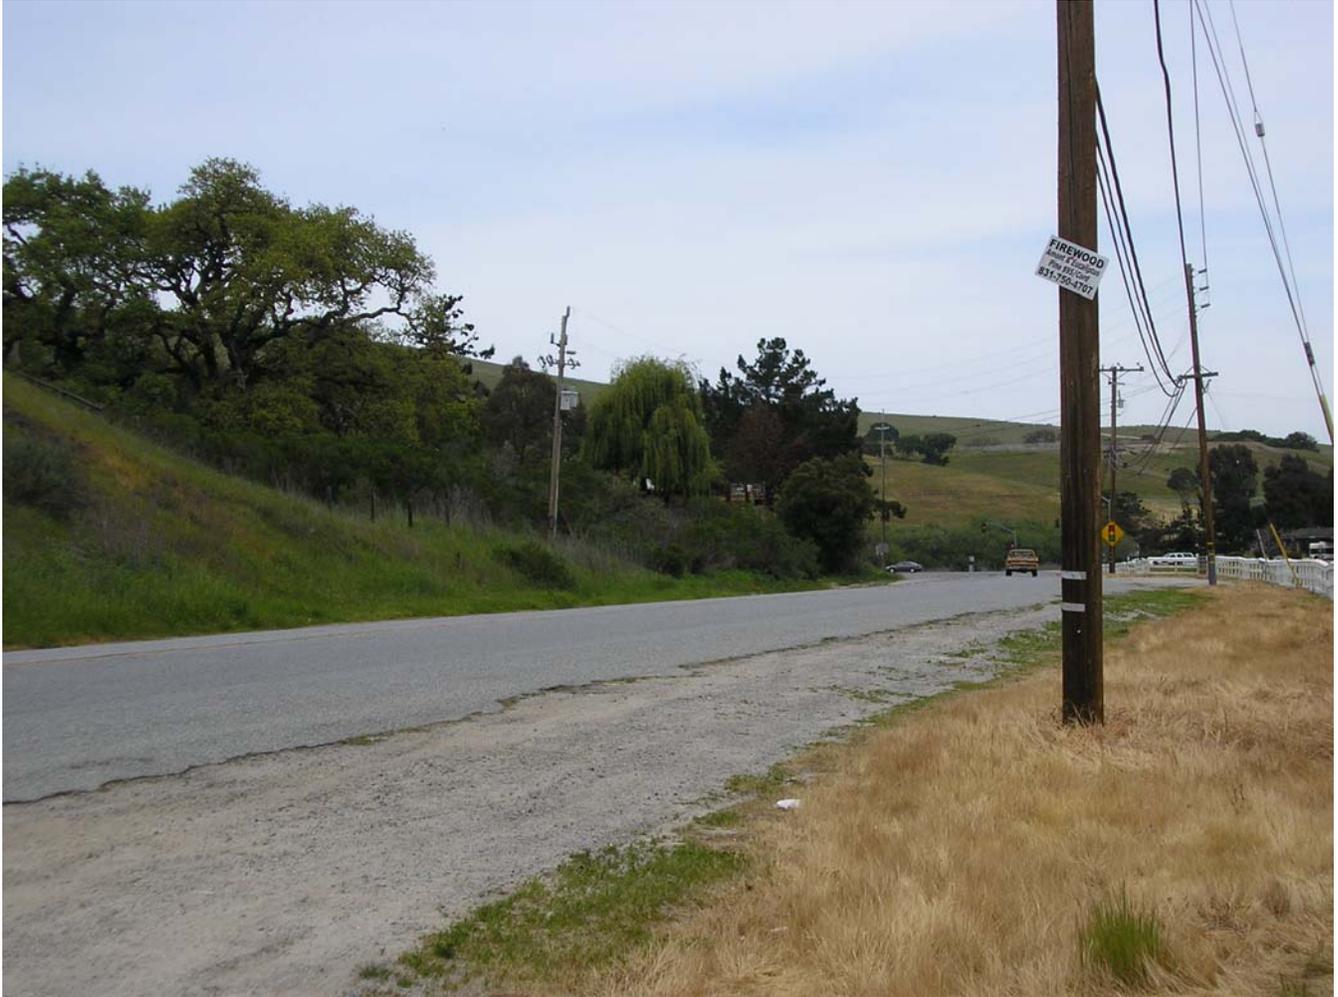
FIGURE 4

Looking north toward the Corral de Tierra Road/SR-68 intersection from Corral de Tierra Road.

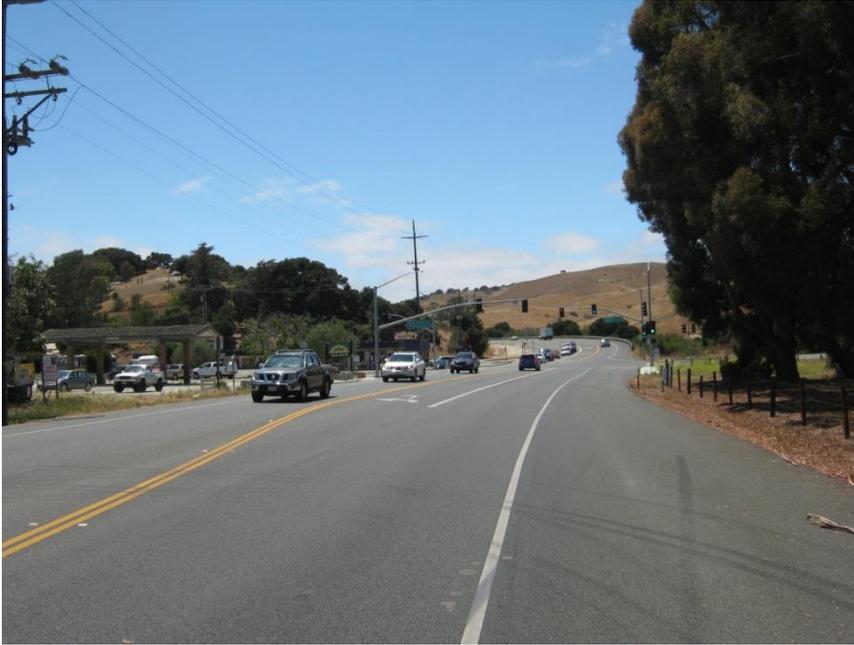
Figure 2, looking west at the Corral de Tierra Road intersection from south shoulder of State Route 68, has been replaced with the following photo and revised caption "Looking west at the Corral de Tierra Road intersection from the north shoulder of State Route 68":

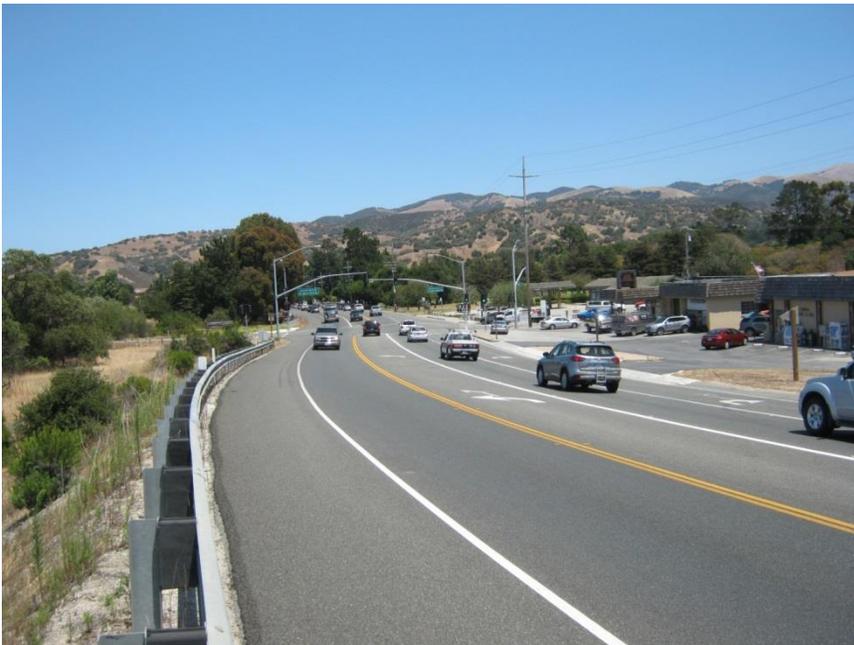
Figure 3, looking east at the Corral de Tierra Road intersection from north shoulder of State Route 68, has been replaced with the following photo:

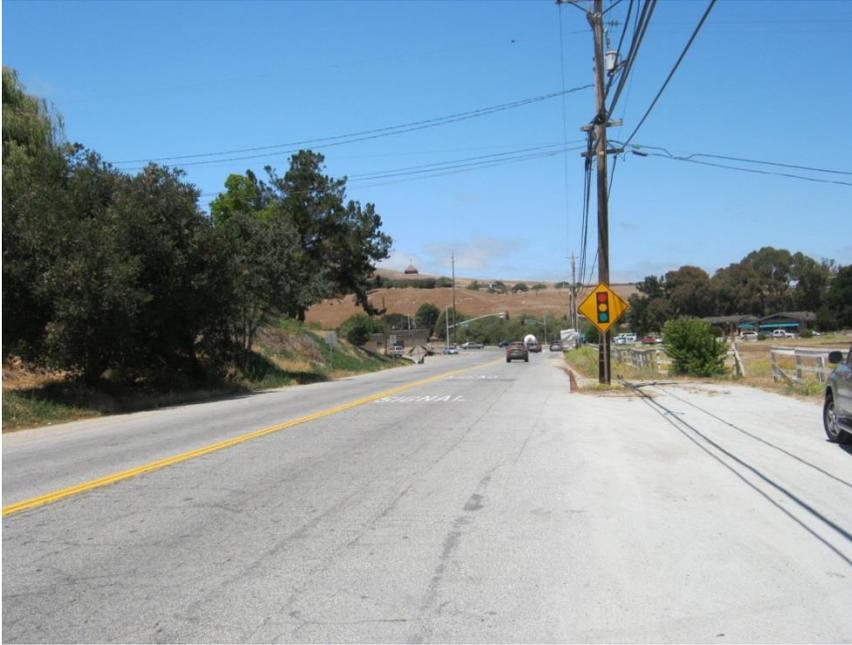
Figure 4, looking north toward the Corral de Tierra Road/SR-68 intersection from Corral de Tierra Road, has been replaced with the following photo:

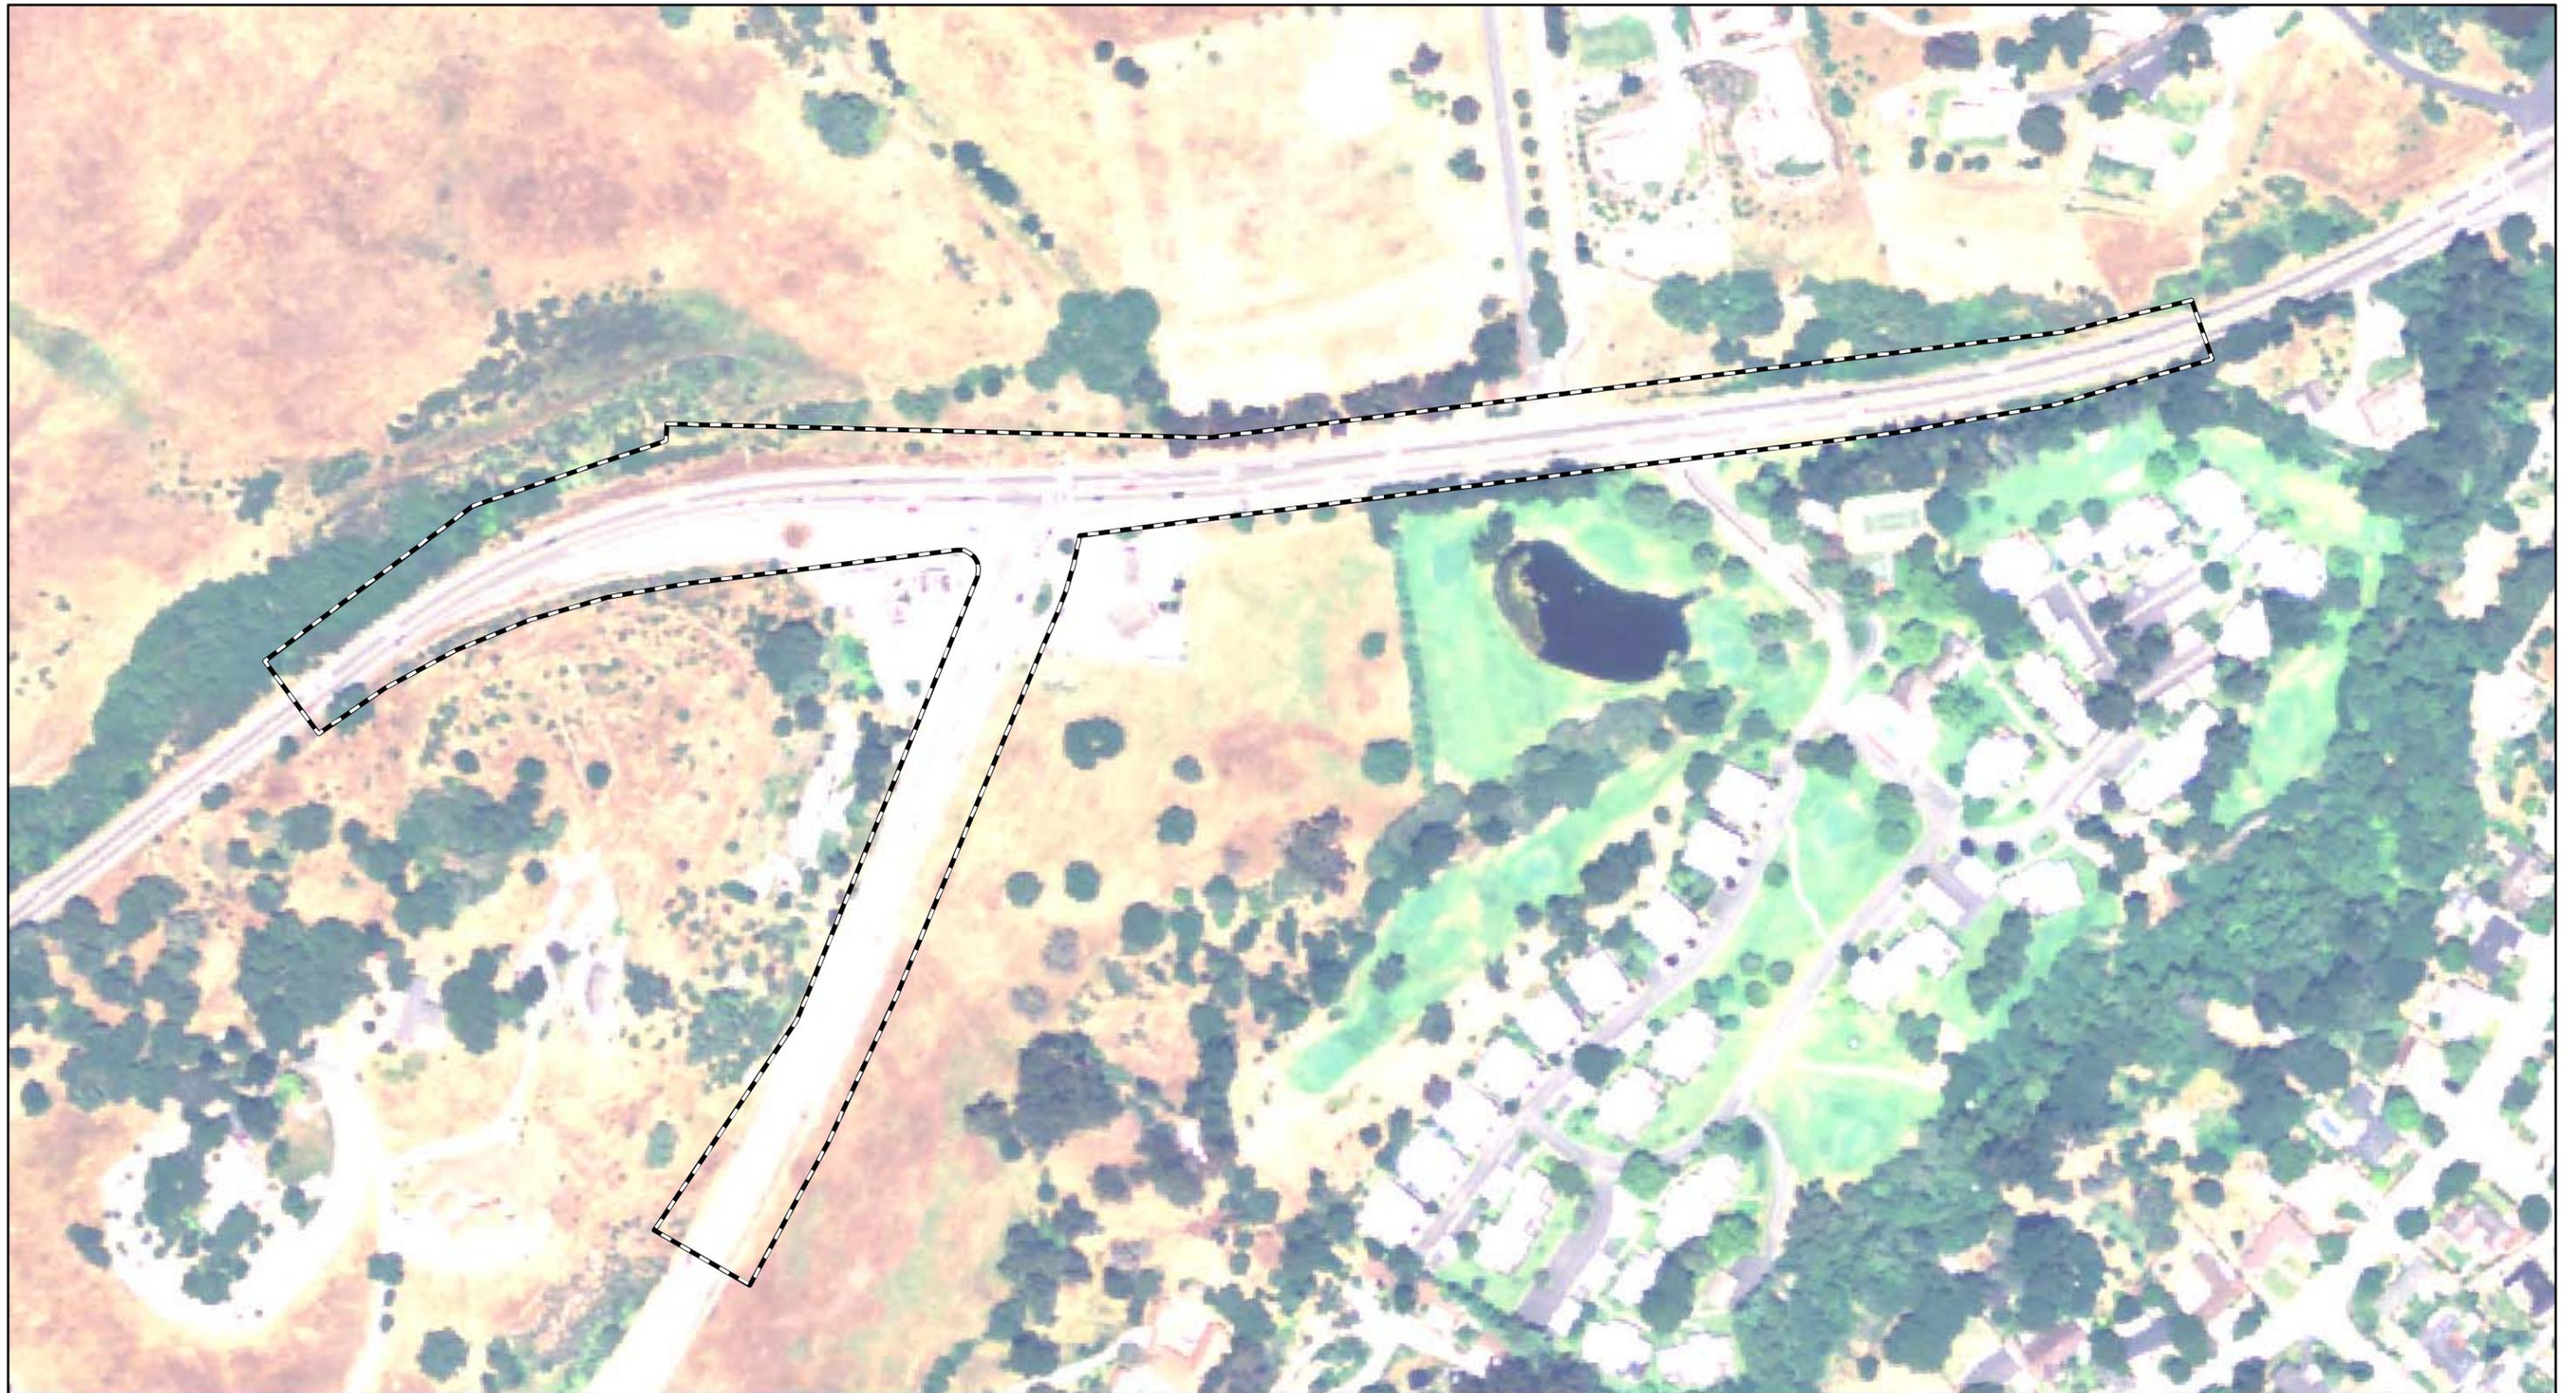
FIGURE 3

Prior to conducting any field studies, the limits of the Biological Study Area (BSA) were established, as shown in Figure 3. The BSA, totaling approximately 9.48 acres, consists of the project footprint, existing roadways, cut/fill slopes, and access and staging areas, etc. The BSA also includes lands beyond the footprint that could potentially be affected by project construction and/or were determined necessary to inventory in order to perform an adequate analysis of project impacts.

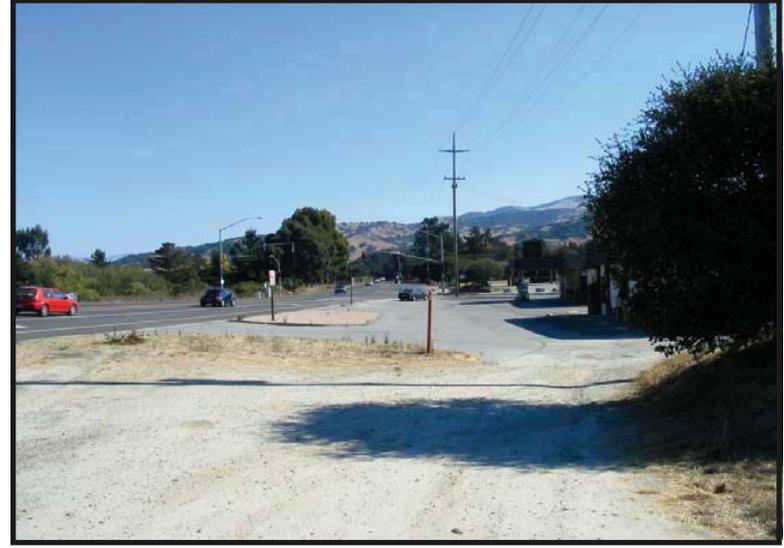
View east from SR-68 (southwest shoulder).

The majority of the BSA consists of paved roads (SR-68 and Corral de Tierra Road) and other developed lands. Some native plant communities also occur in the BSA, but are generally limited to areas along the edges of the BSA, mostly north of SR-68 at the west end of the BSA. The BSA is mostly flat, sloping gently to the northeast. The elevation is approximately 300 ft above mean sea level. Figure 4 includes representative photos of the BSA.

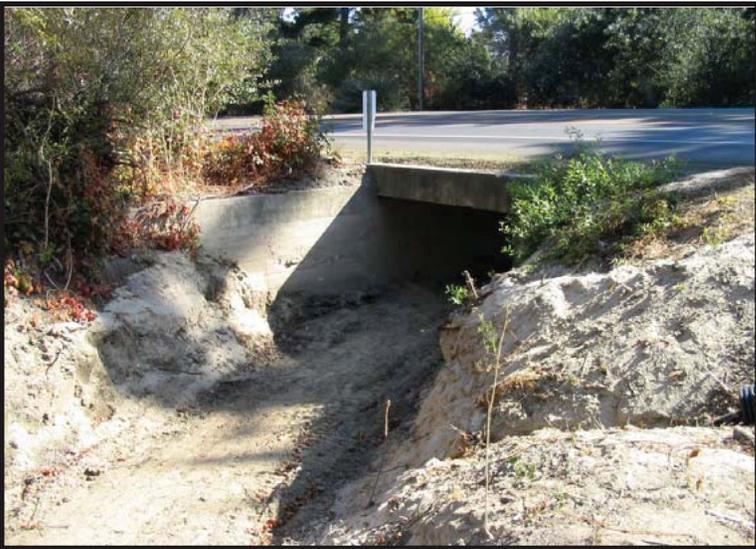
FIGURE 4

View of ephemeral tributary culvert under SR-68.

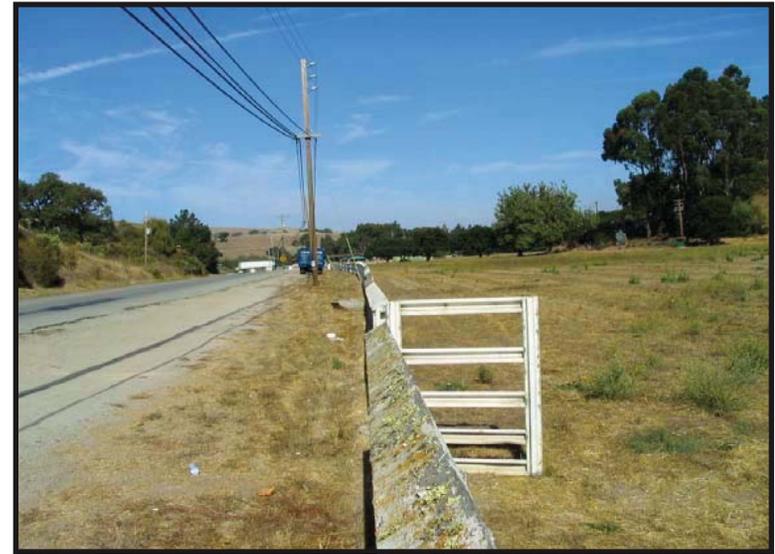
Looking north along Corral De Tierra Road.

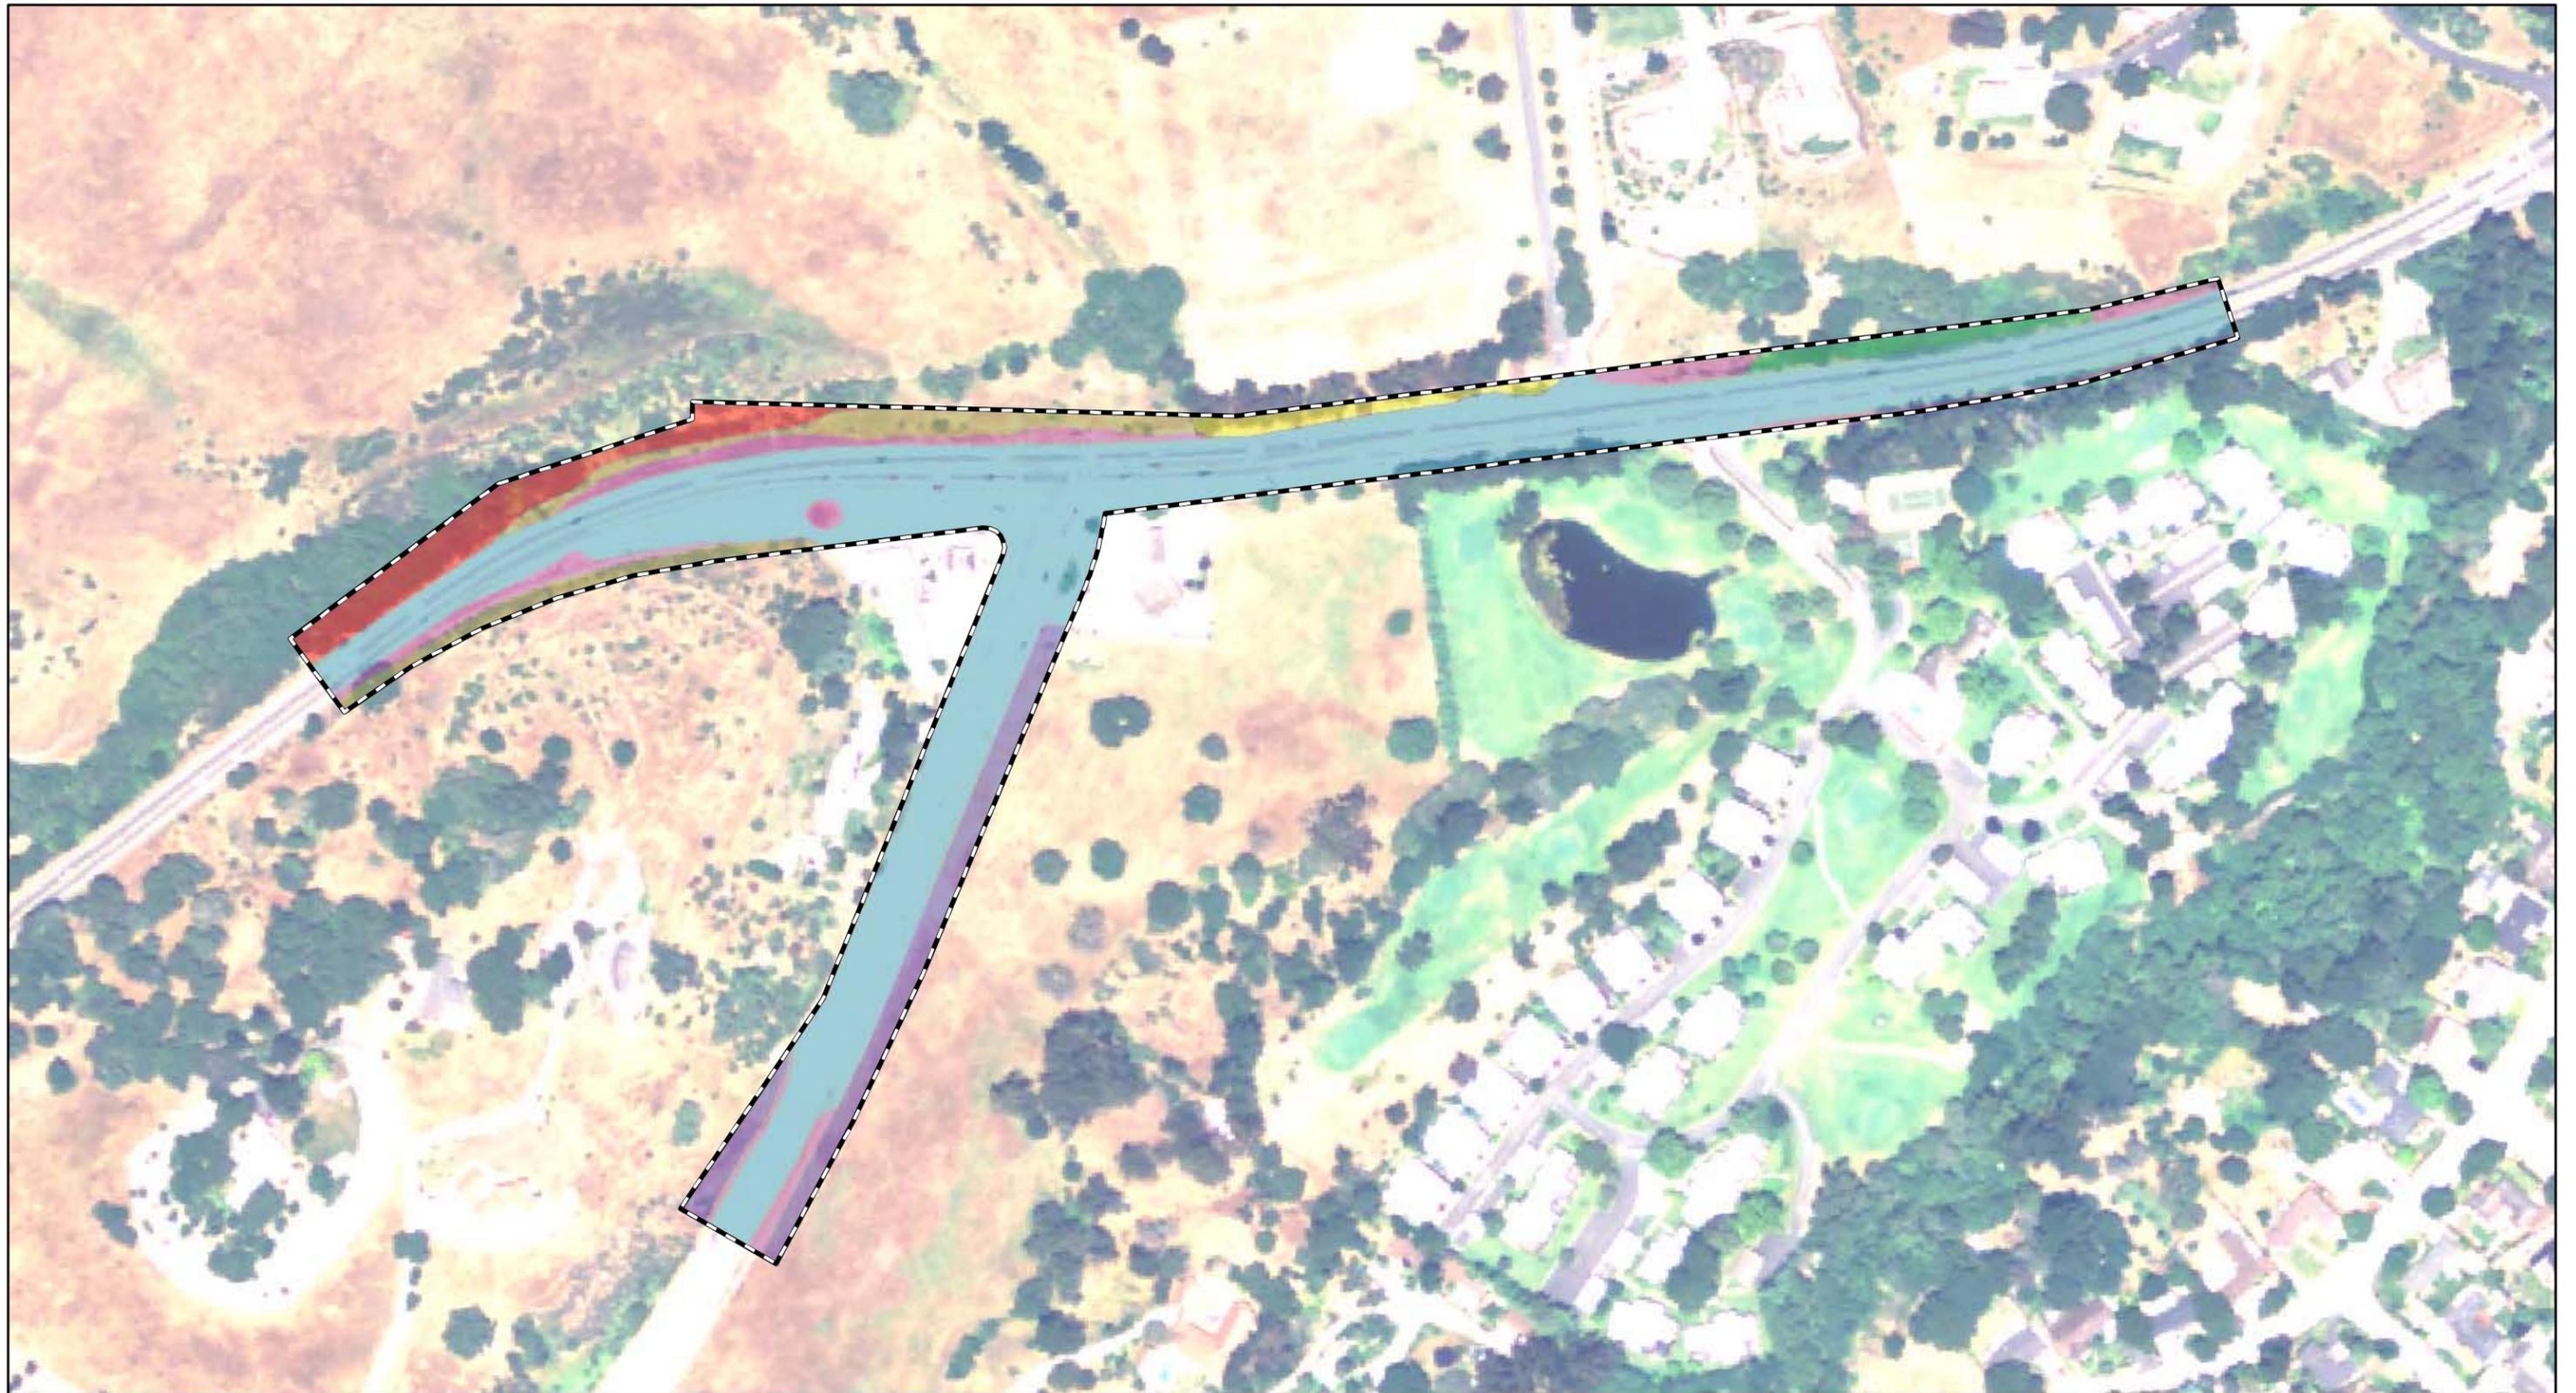
FIGURE 5

The descriptions and names of communities used are based on field surveys and descriptions found in Sawyer and Keeler-Wolf (1995). Plant communities/land uses occurring in the BSA, as described below, include coast live oak series, arroyo willow series, coyote brush series, California annual grassland series, eucalyptus series and disturbed ruderal areas. Developed areas also occur in the BSA. Plant communities/land uses in the BSA are summarized in Table 2 and are shown in Figure 5.

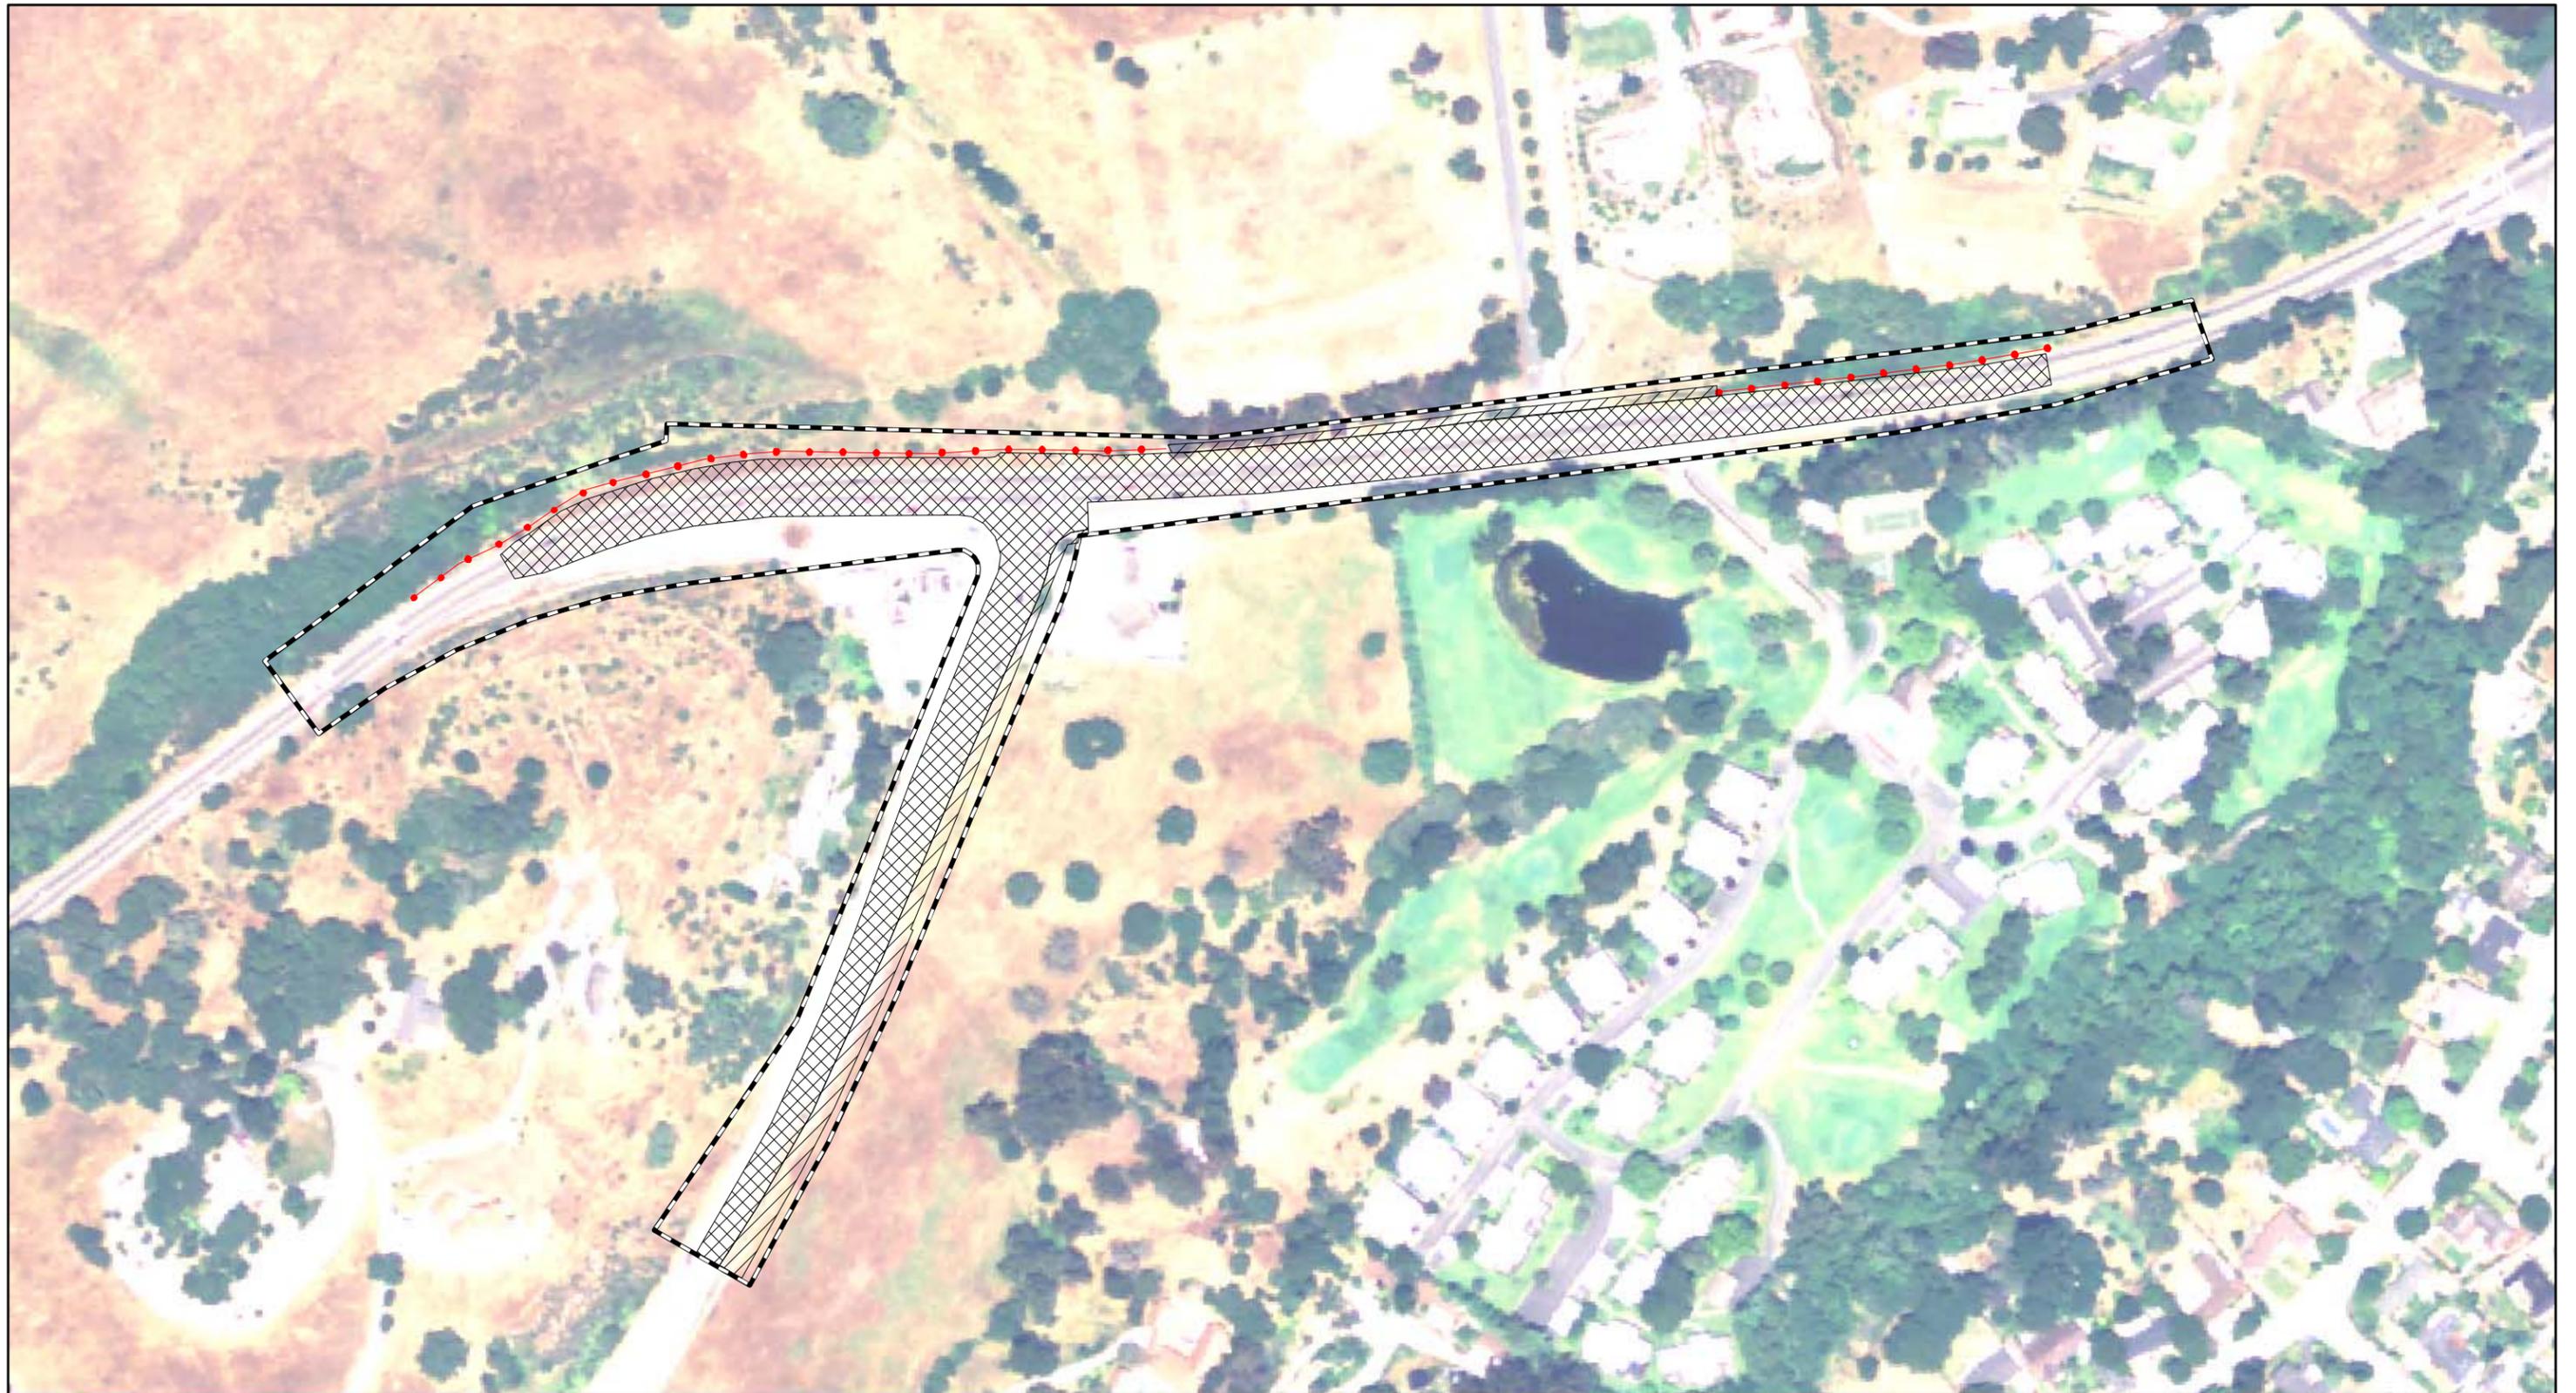
FIGURE 6

All of the work would be constructed within existing State and County rights-of-way, except for a small area of new State right-of-way that would be acquired on the north side of State Route 68 just east of the intersection to accommodate relocation of a bus stop, widening and grading. Also, a temporary construction easements would be acquired along the east side of Corral de Tierra Road to accommodate grading near the edge of the County right-of-way (refer to Figure 1-3: Build Alternative Design Plan). Temporary staging areas for construction equipment and materials would be located in those areas of the existing State and County rights-of-way that are not designated as Environmentally Sensitive Areas (ESA), as shown in Figure 6. Construction is expected to be completed in a single season.

1. ESAs, as shown in Figure 6, shall be marked using orange construction fencing or equivalent and shall be maintained in good condition until construction is complete.
2. Following completion of work, all areas denuded during project construction shall be revegetated with locally occurring native species as described in the Revegetation Guidelines in Appendix H.

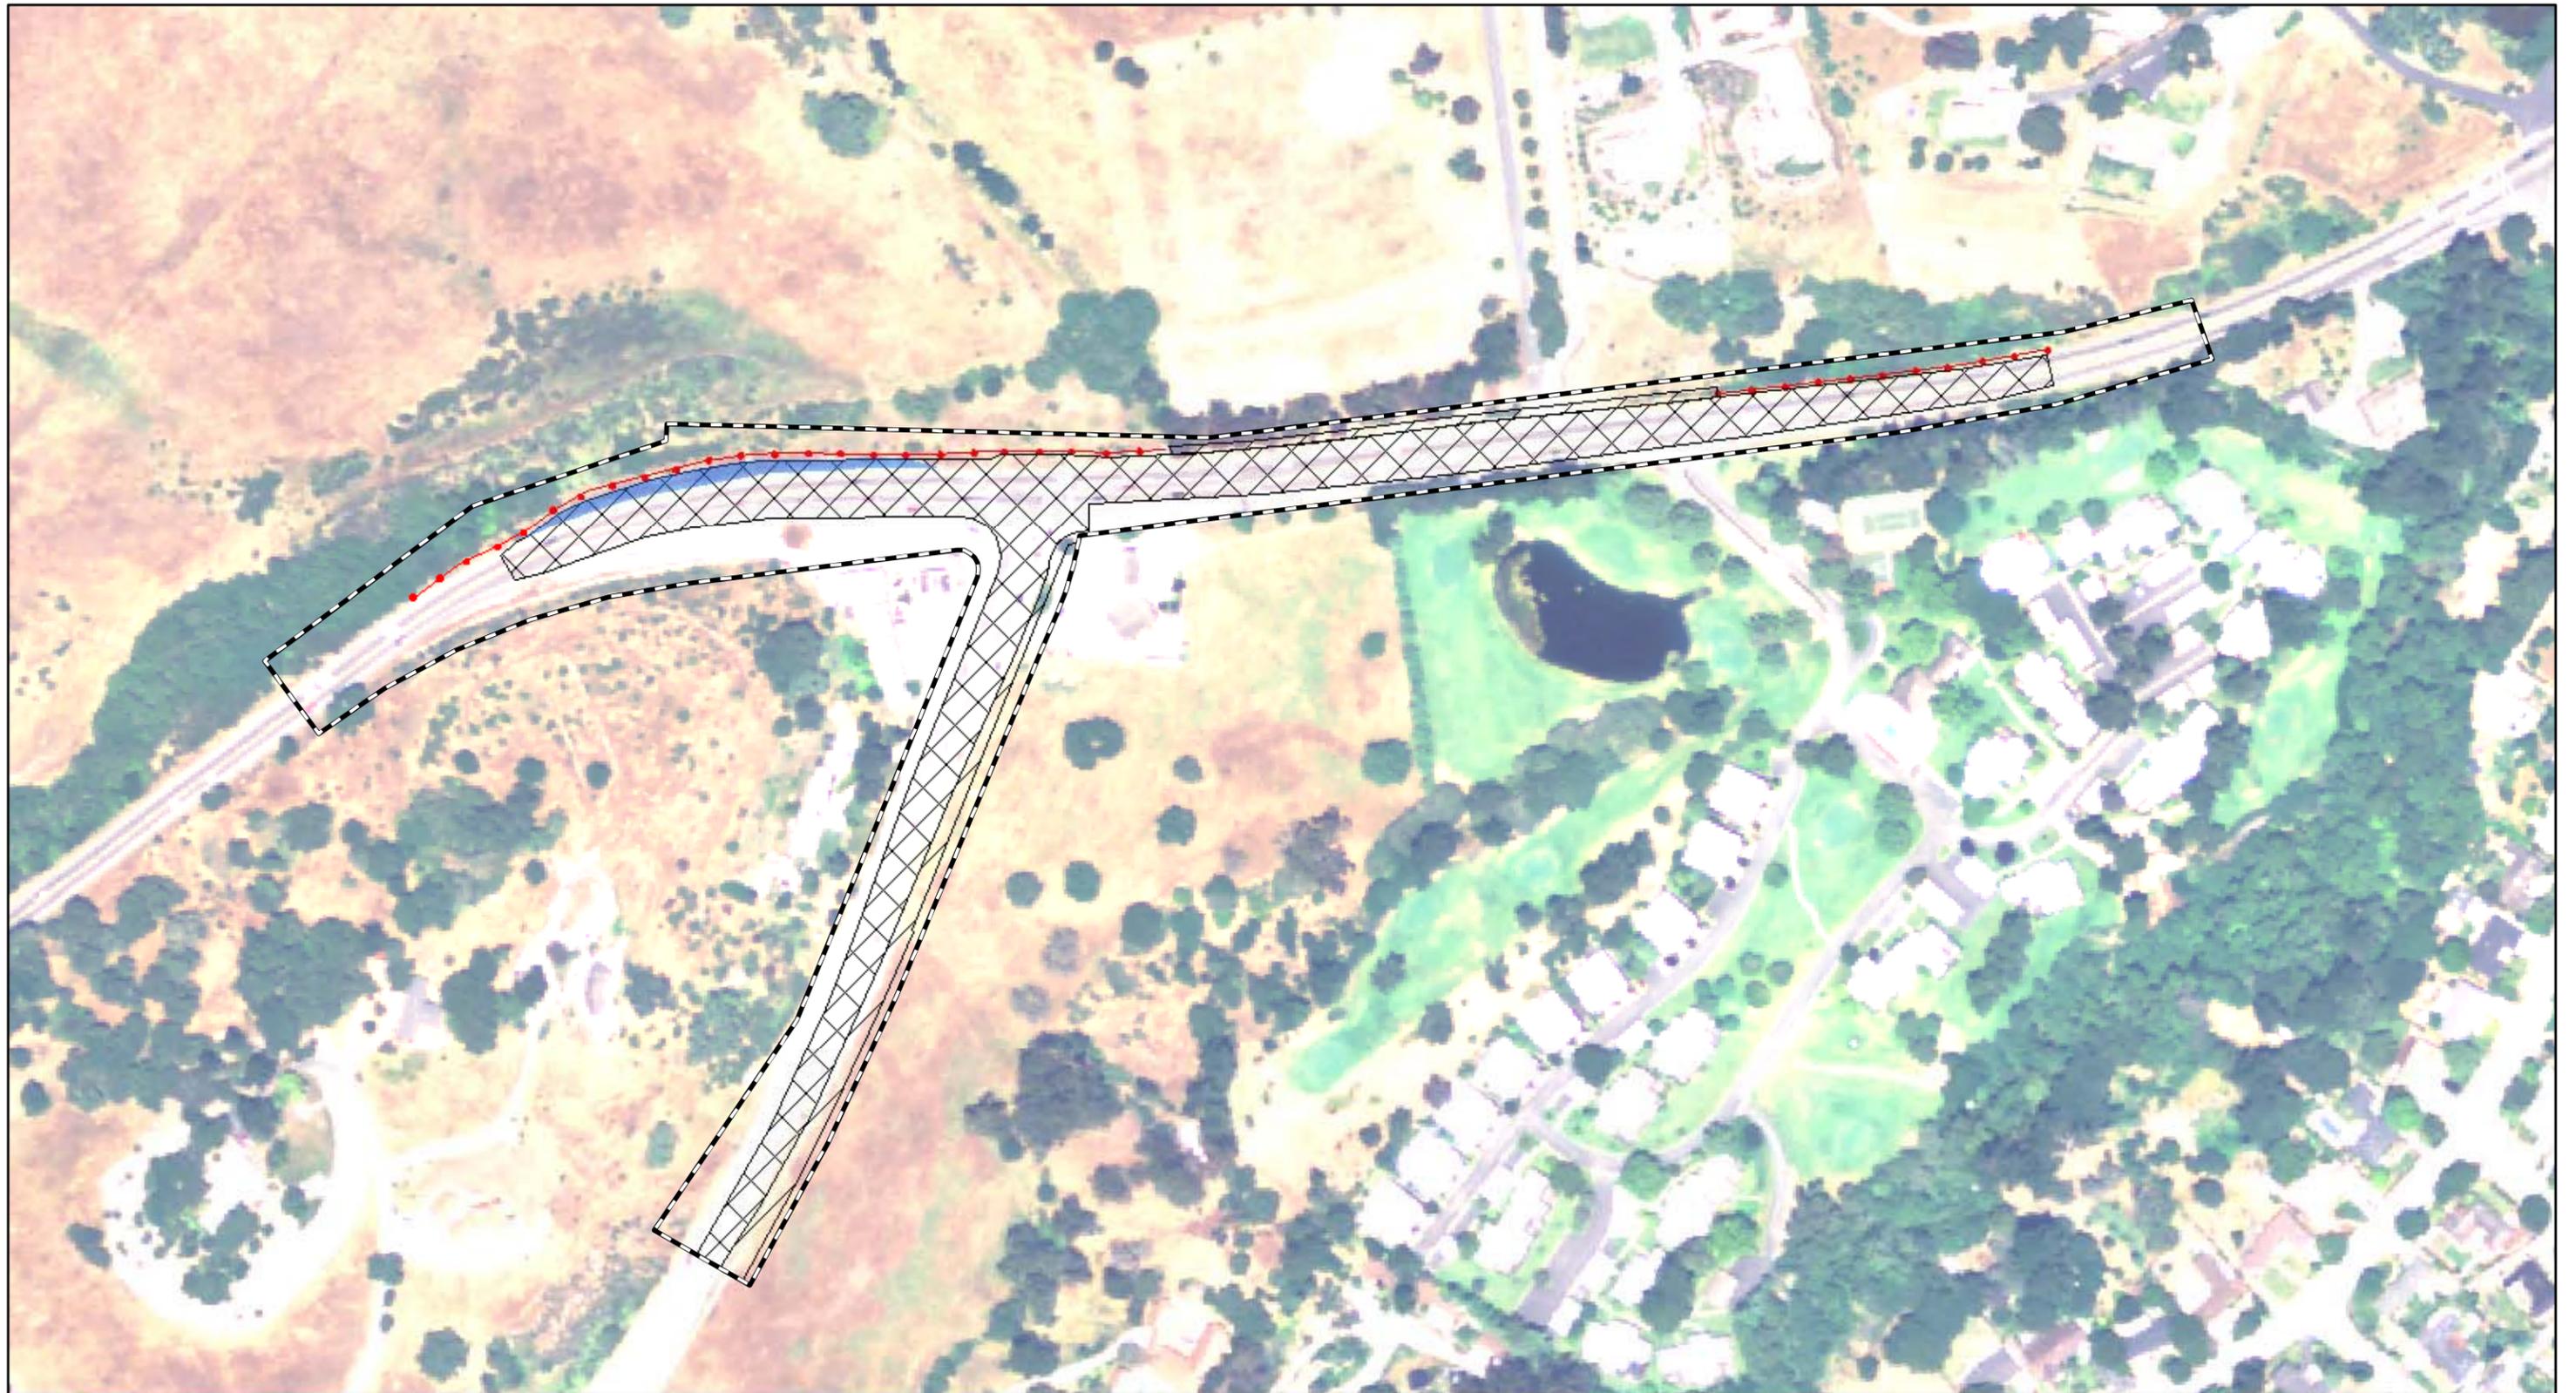
FIGURE 7

Since CTS could potentially occur in the BSA, the project could affect CTS during construction. Effects to potential CTS upland habitat will be limited to construction of the new fill slope on the north side of SR-68, west of Corral de Tierra Road. Approximately 0.16 acre of potential CTS upland habitat will be removed during construction of the new fill slope (Figure 7).
