Technical Studies

State Route 68/Corral de Tierra Road Intersection Improvement Project

Monterey County, California
05-MON-68-PM 12.8/13.2
Project ID: 05-0000-0085 (05-0H8230)

VISUAL IMPACT ASSESSMENT

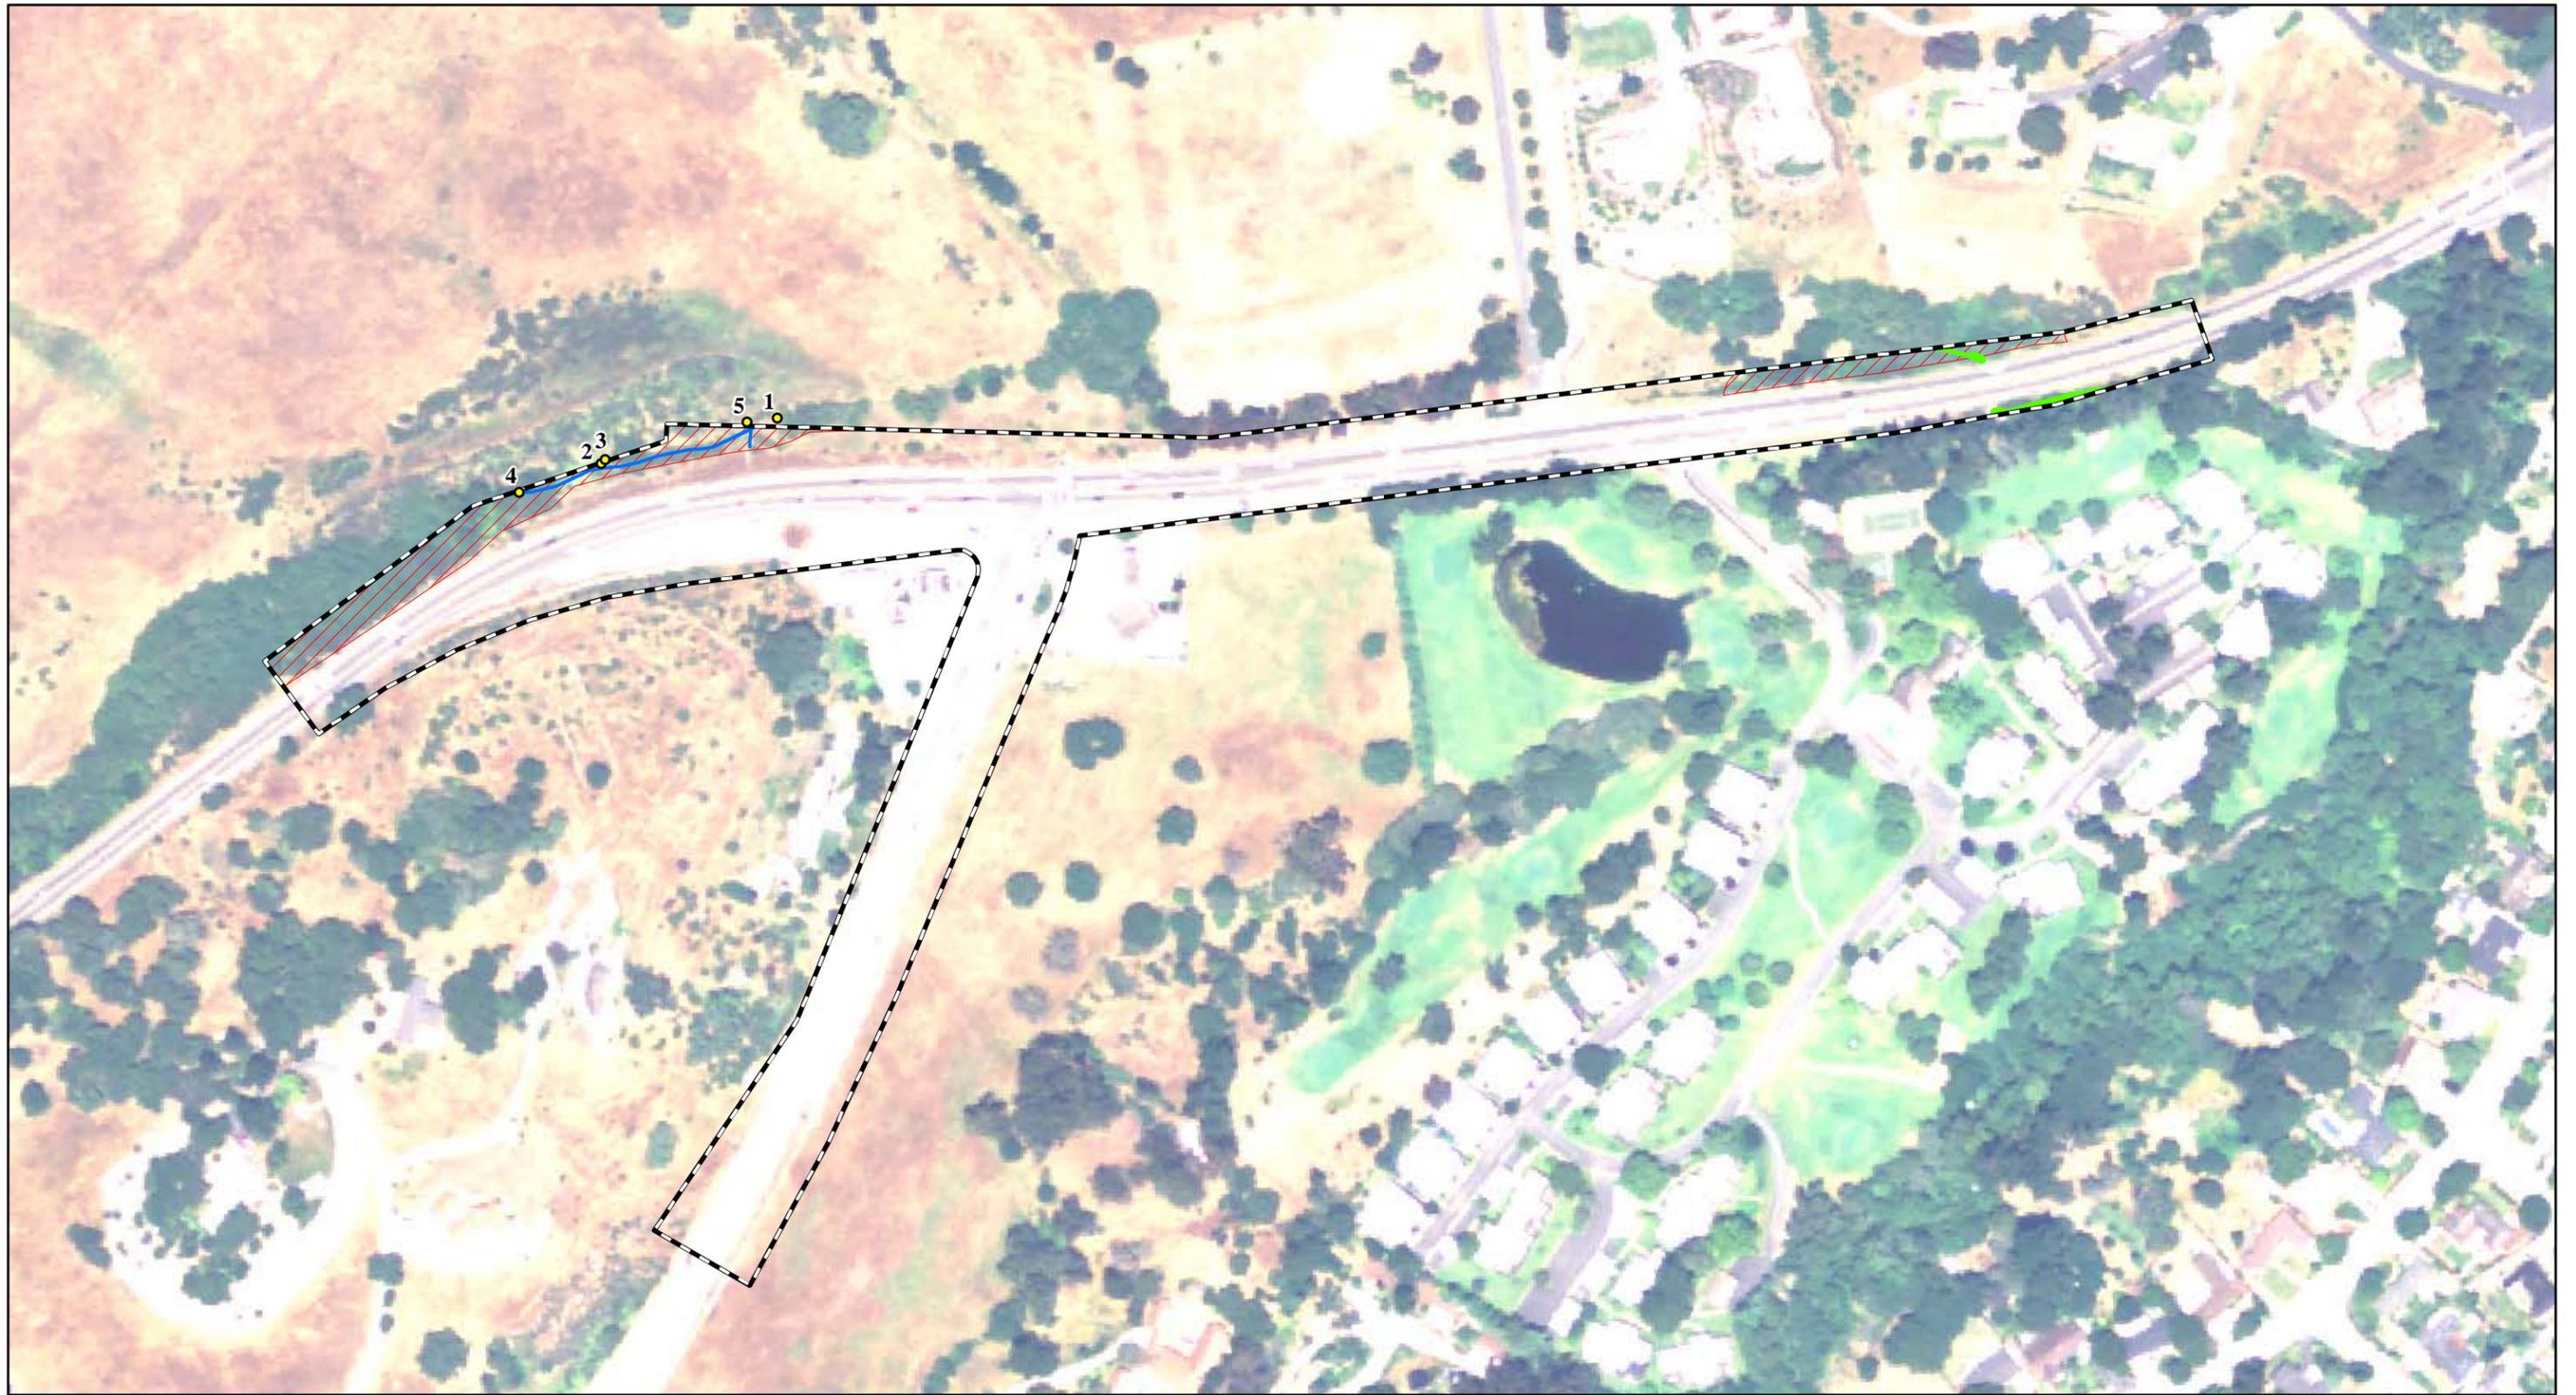
FIGURE 8

to the ephemeral tributary to El Toro Creek, as described in Table 4 and shown in Figure 8.

CDFW waters in the BSA, totaling 0.85 acre, include the ephemeral tributary and associated riparian vegetation (see Figure 8). Riparian vegetation, where present, is comprised of coast live oak woodland at the west end of the BSA and arroyo willow at the east end.

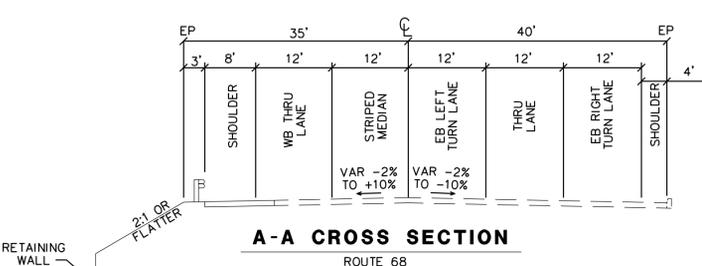
ADT (2014) = 21,600 (DESIGN VOLUME) D = 57%
 ADT (20 YEAR) = 38,500 T = 4.0%
 DHV = 2,484 V = 55 MPH
 ESAL = 5,775,045 T₂₀ = 11.0

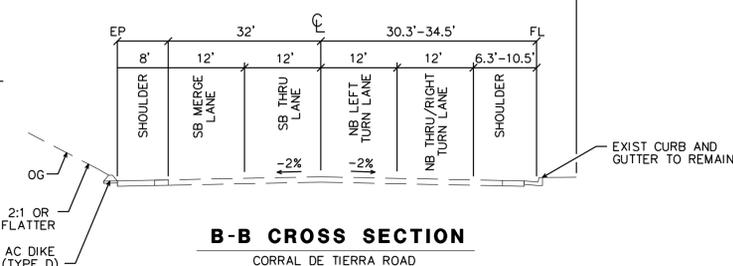
ADT (2014) = 7,100 (DESIGN VOLUME) D = 67%
 ADT (20 YEAR) = 8,900 T = 2.0%
 DHV = 619 V = 55 MPH
 ESAL = 735,017 T₂₀ = 8.5

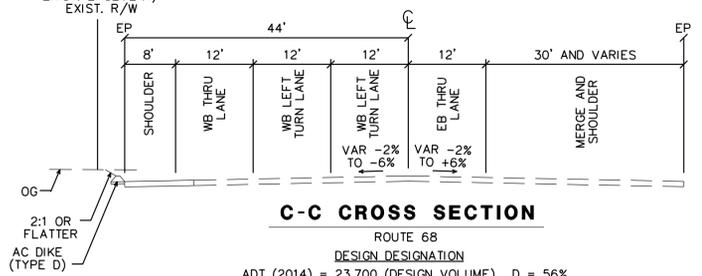
ADT (2014) = 23,700 (DESIGN VOLUME) D = 56%
 ADT (20 YEAR) = 40,500 T = 4.0%
 DHV = 2,725 V = 55 MPH
 ESAL = 6,060,788 T₂₀ = 11.0

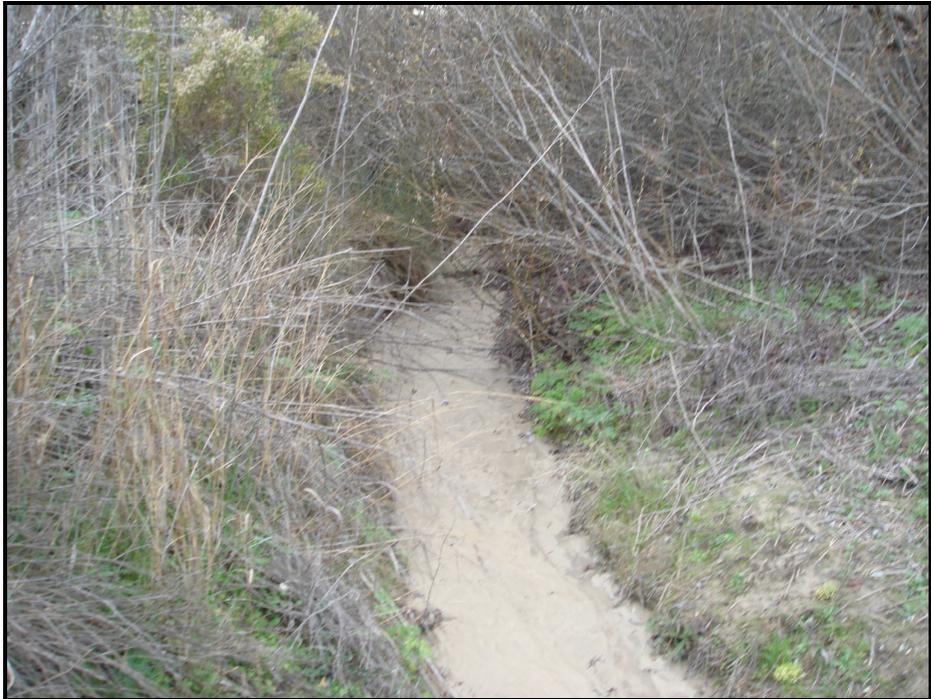
View west of ephemeral drainage below work area (February 2007).

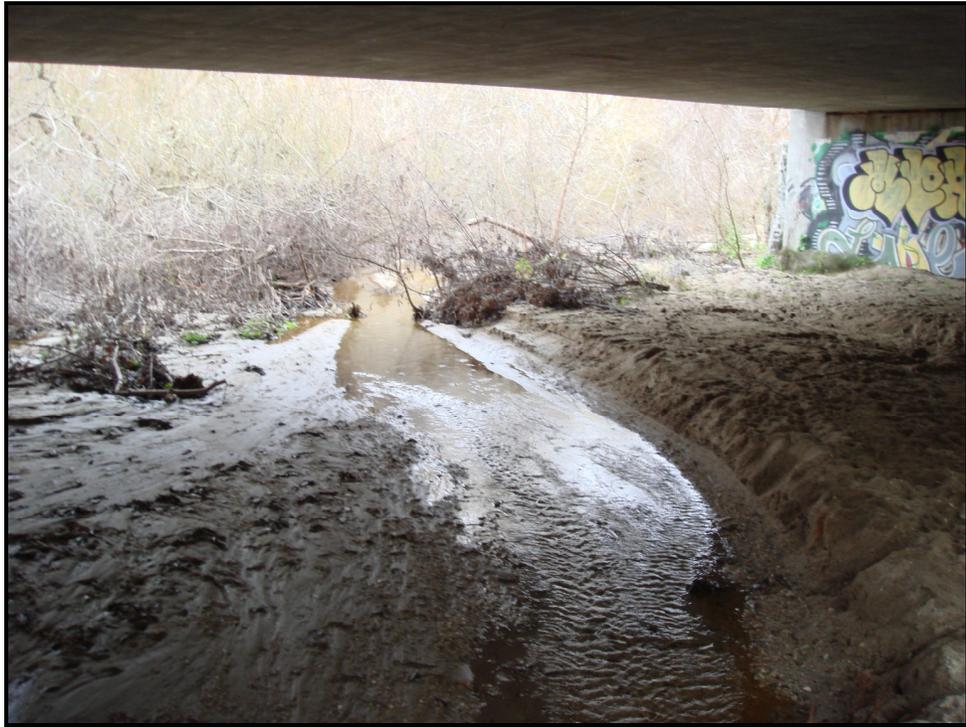
View northeast El Toro Creek at State Route 68 overcrossing (outside project area) (February 2007).

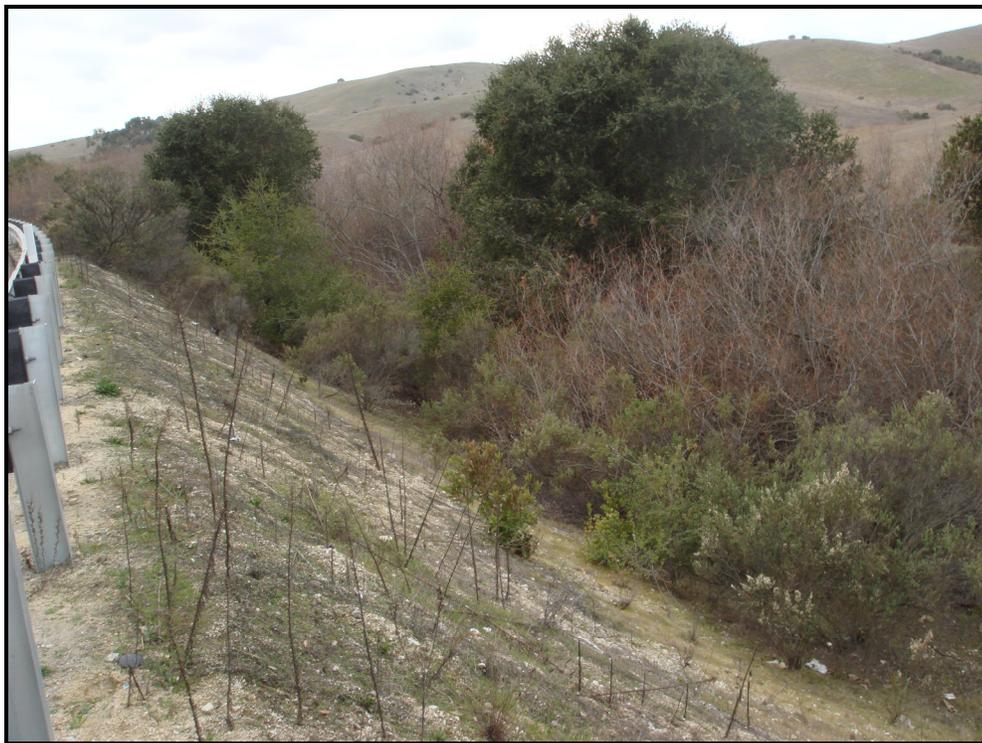
Impact area: view northwest from State Route 68 west of Corral de Tierra (February 2007).
