INFORMATION HANDOUT

FOUNDATION REPORTS FOR:
Westhaven Drive Undercrossing (Br No. 04-0056) dated April 12, 2012
Sixth Street Overcrossing (Br No. 04-0057) dated April 12, 2012
Trinidad Road Undercrossing (Br No. 04-0058) dated July 9, 2012

TRINIDAD ROAD FAULT STUDY DATED JULY 6, 2012

A Coastal Development Permit for seismic retrofit of the Westhaven Drive Undercrossing and the Sixth Street Overcrossing. The bridges have been selected for retrofit because of the type of bridge construction and the proximity to two active faults. The construction work will consist of retrofitting the bridges with shear walls, catcher blocks, and timber blocking. Concrete slope paving and sections of existing sidewalk will be removed and replaced. Concrete barrier rails will be constructed. Minor concrete will be placed under the metal beam guardrail for vegetation control. Temporary K-rail, crash cushions and drums will be used during construction. Utilities will be relocated at Westhaven Drive undercrossing prior to construction. Minor drainage work will be completed.

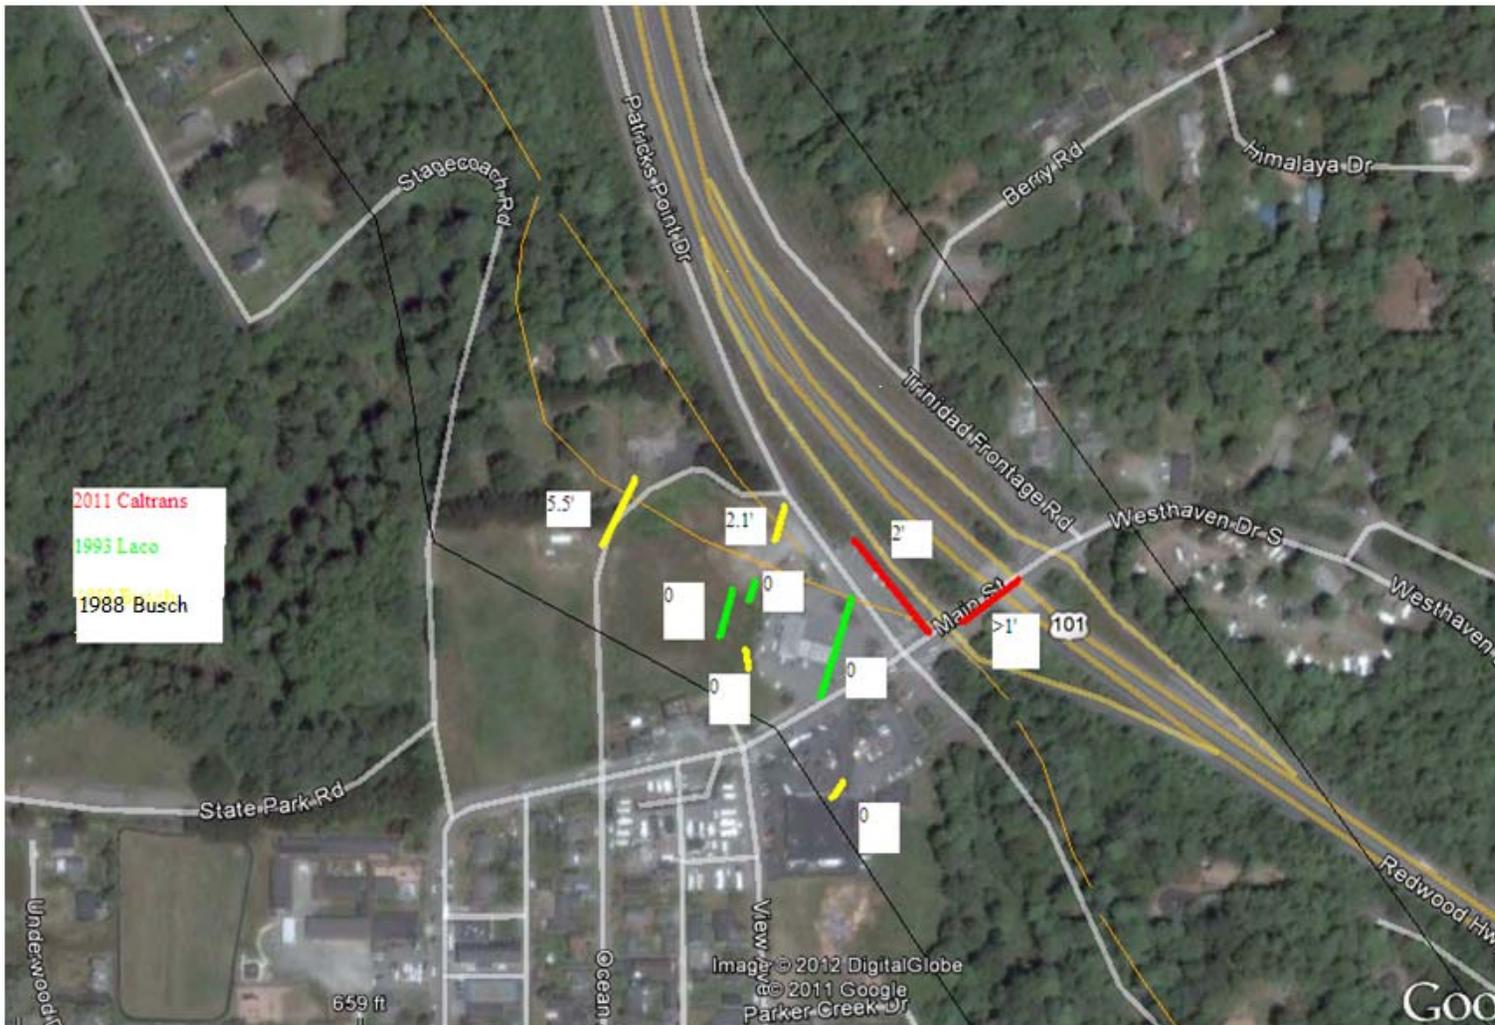
Figure 3. Trench locations, including those from previous investigations. Numbers are dip-slip displacement observed in trench.

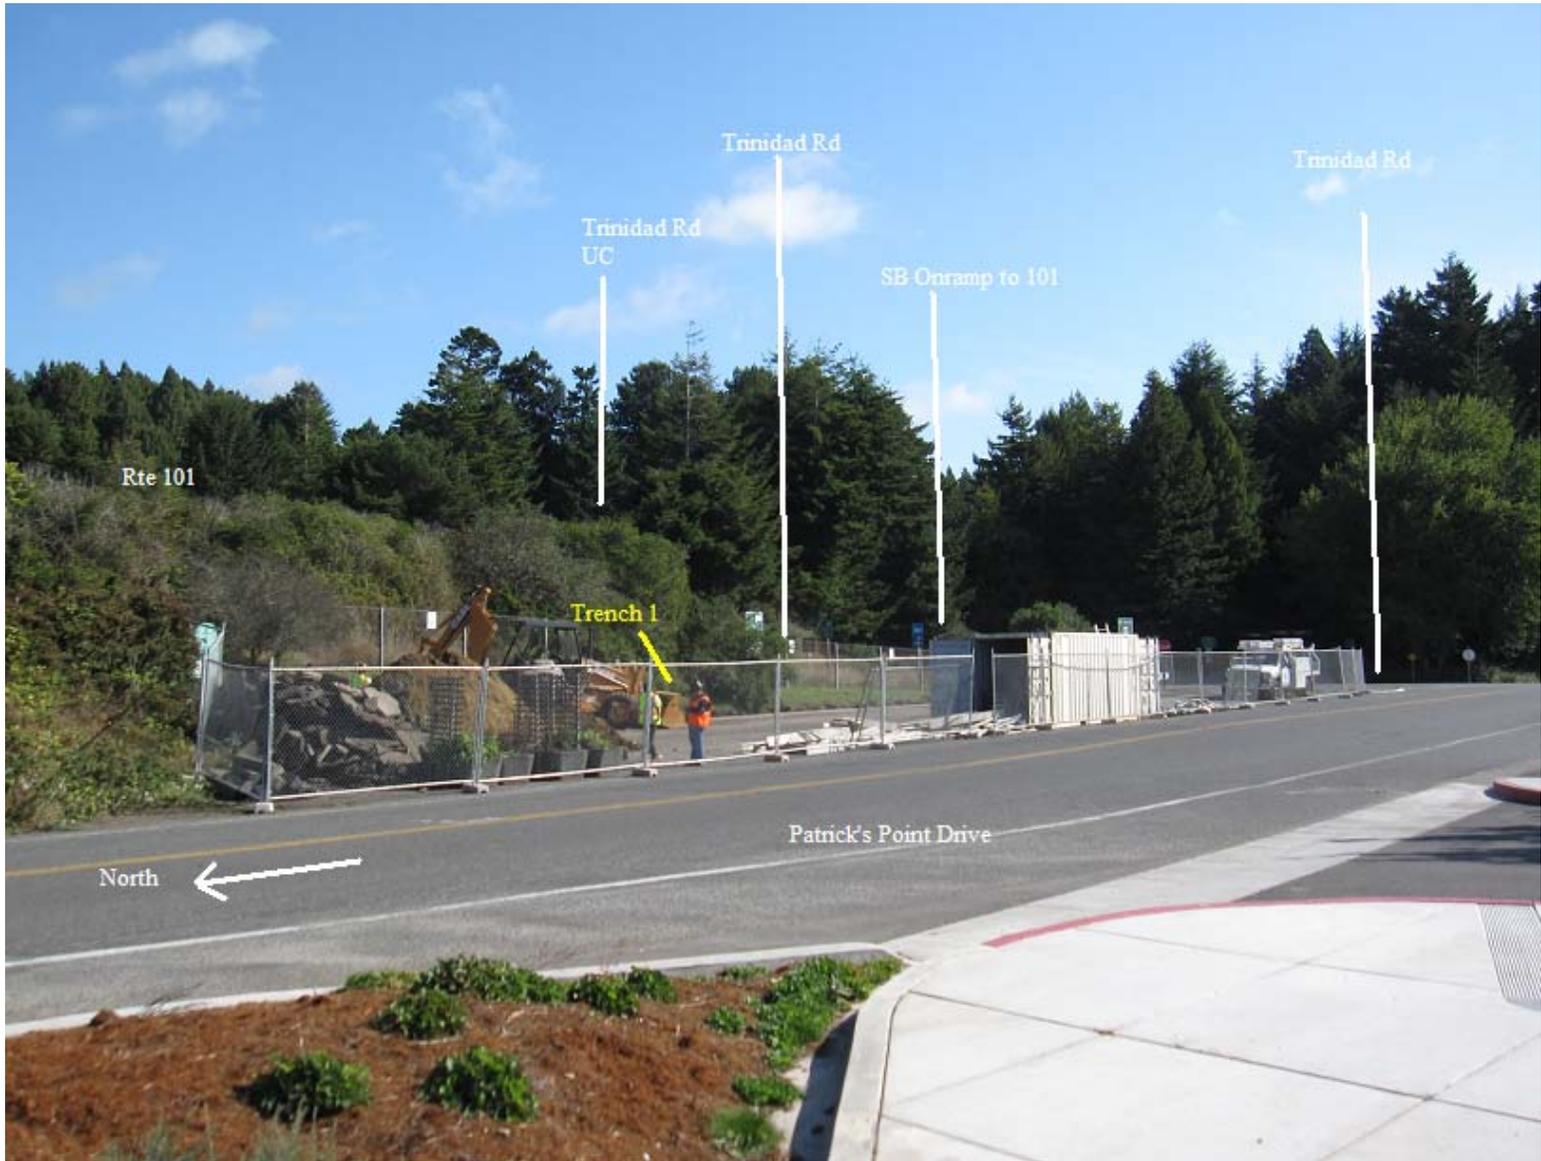
Figure 4. Caltrans Trench 1 location, looking southeasterly.

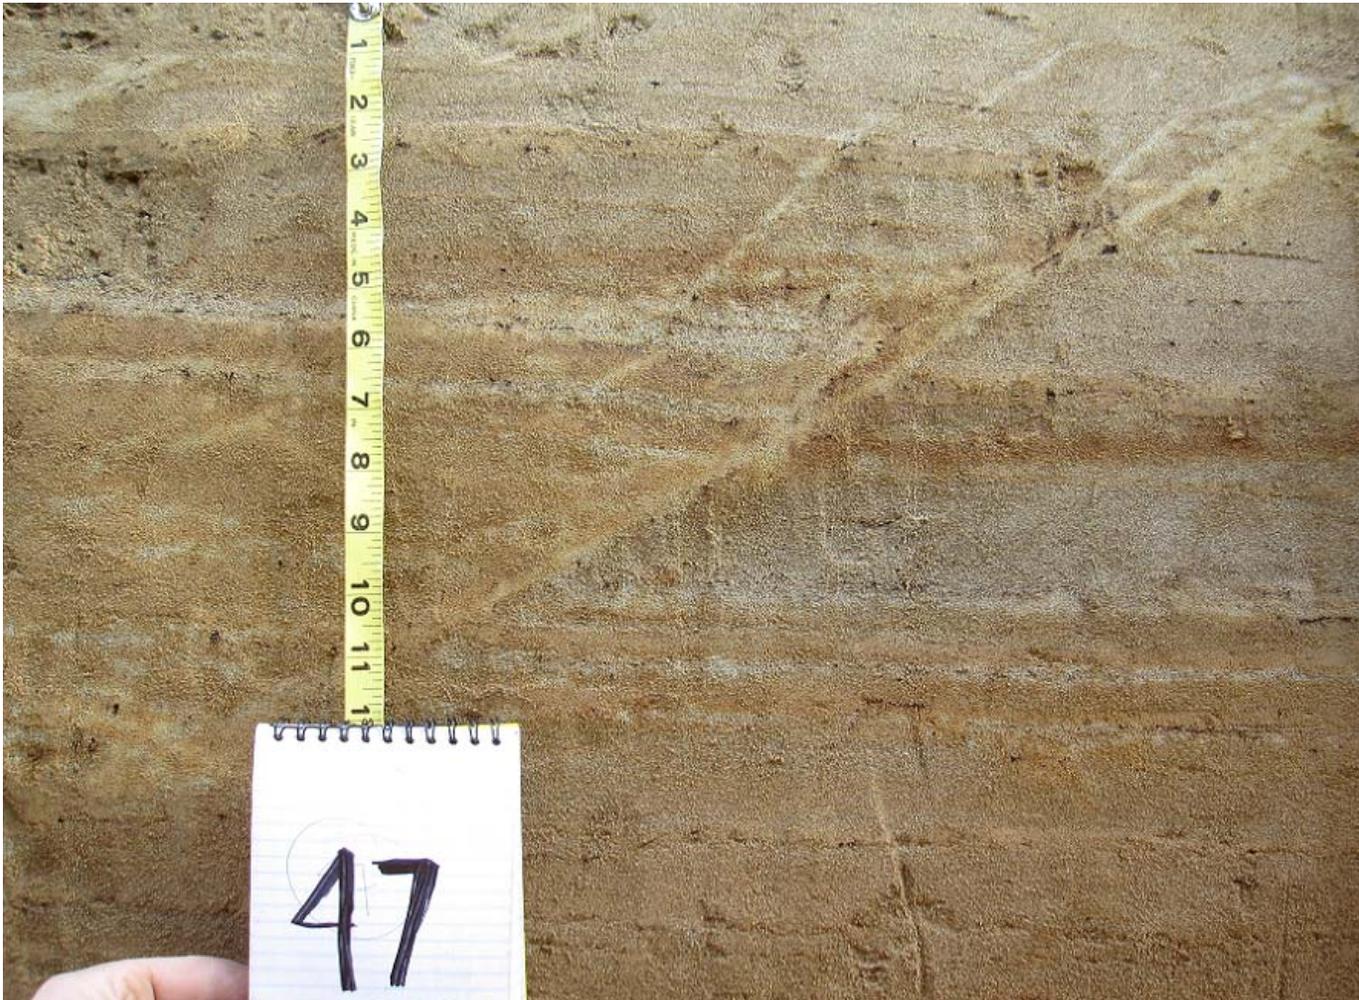
Figure 5. Example of small thrust faults encountered in Caltrans Trench 1. East trench wall, scale is inches.

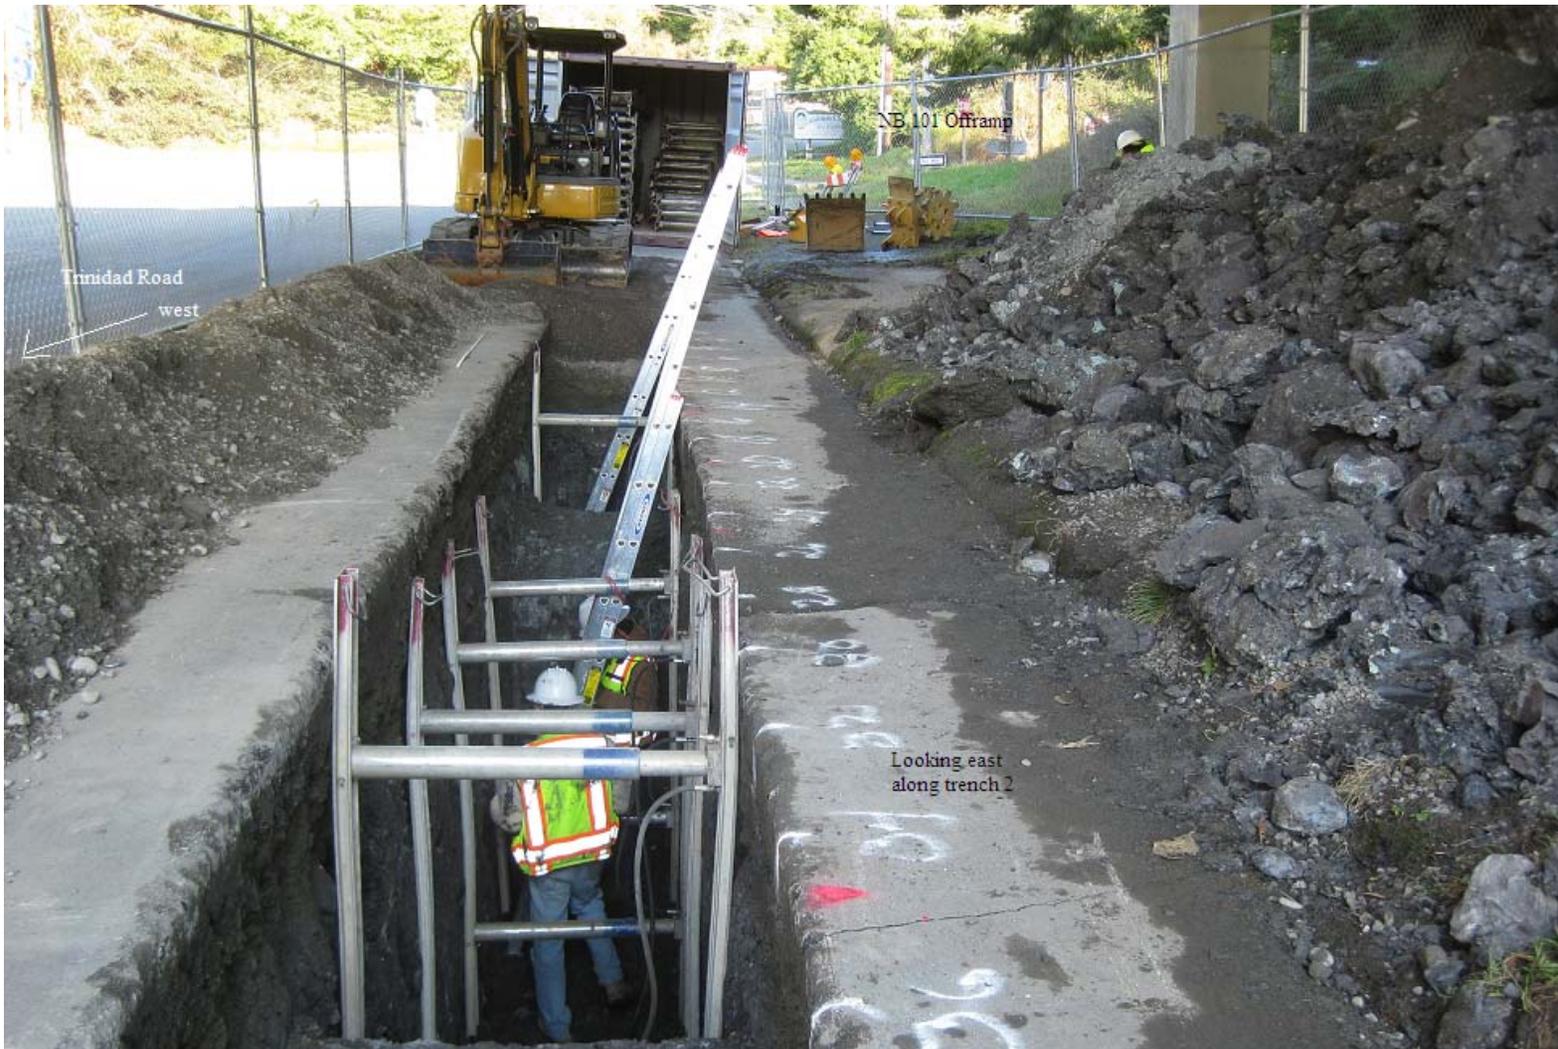
Figure 6. Caltrans Trench 2 looking easterly.

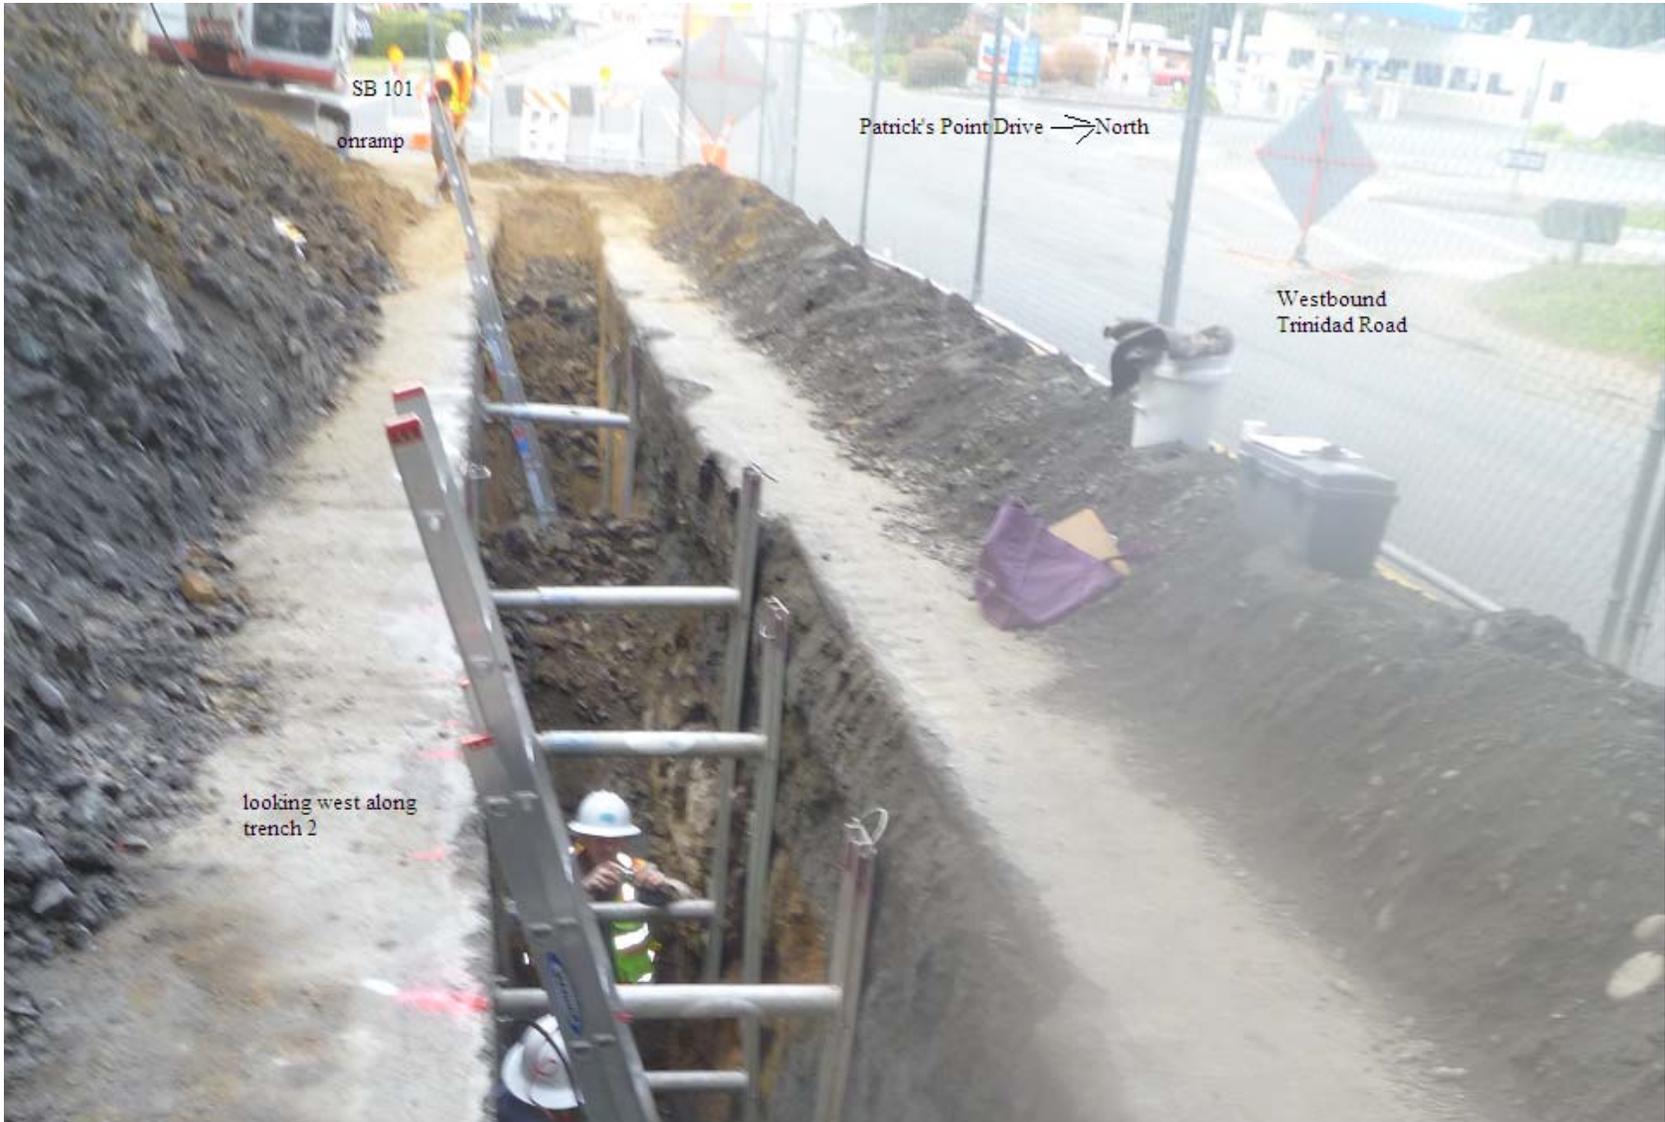
Figure 7. Caltrans Trench 2 looking westerly.

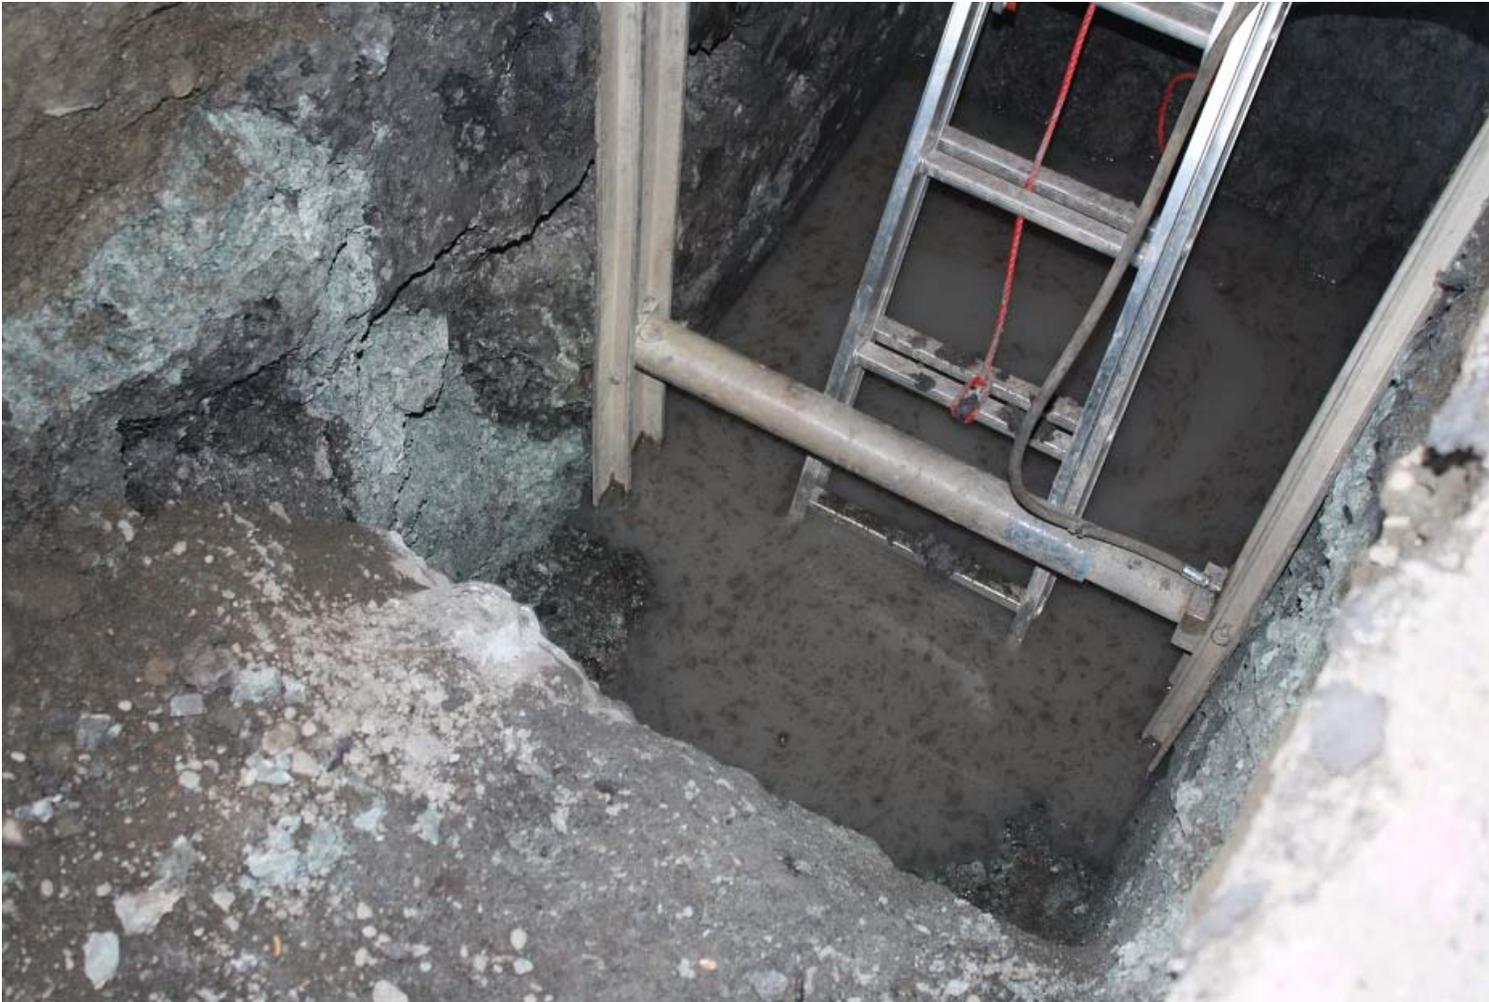
Figure 8. Steeply dipping gouge zone in Franciscan melange at east end of Caltrans Trench 2. North trench wall.
