INFORMATION HANDOUT

**For Contract No. 06-0H6304
At 06-Tul-198-R12.0**

Revised Final Foundation Report

Asbestos and Lead containing Paint Survey report

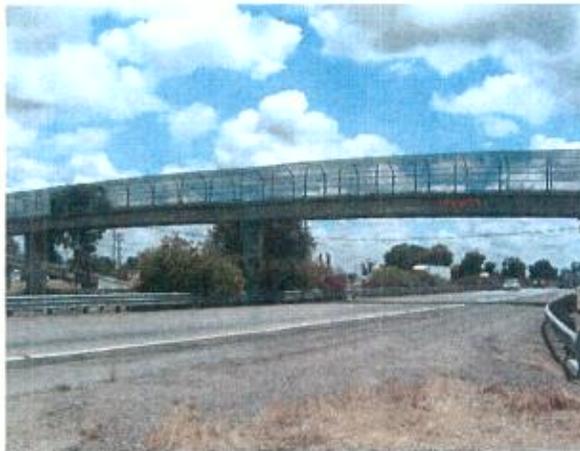
Photo 1 – Avenue 80 POC (Bridge 46-0180)

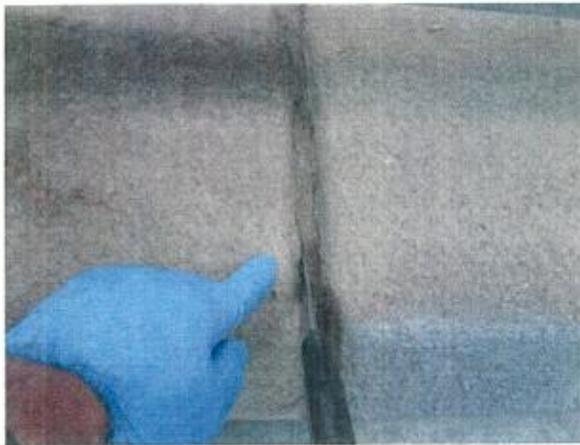
Photo 2 – Bridge 46-0180 expansion joint fill material

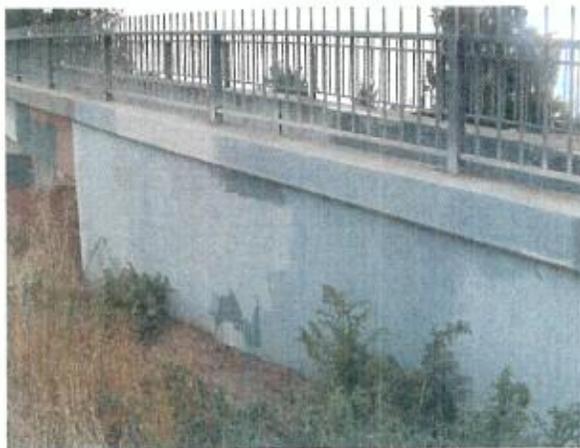
Photo 3 – Bridge 46-0180 graffiti abatement paint

Intact LCP was identified on both bridges during our survey. Additional analysis of identified lead-containing graffiti abatement paint used on Bridge 46-0180 would be required to evaluate waste classification as a California hazardous waste or Federal (RCRA) waste based on lead content.

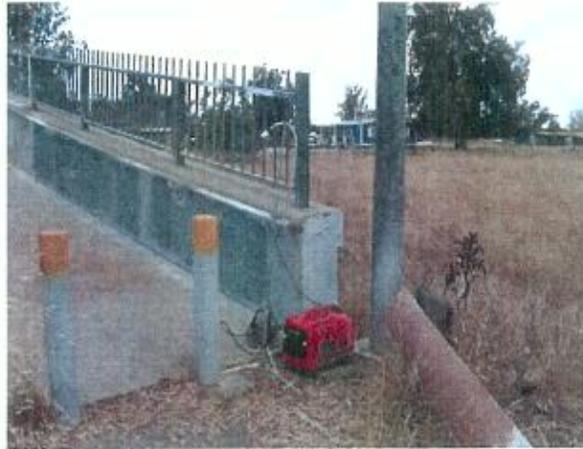
Photo 4 – Bridge 46-0180 typical air monitoring station

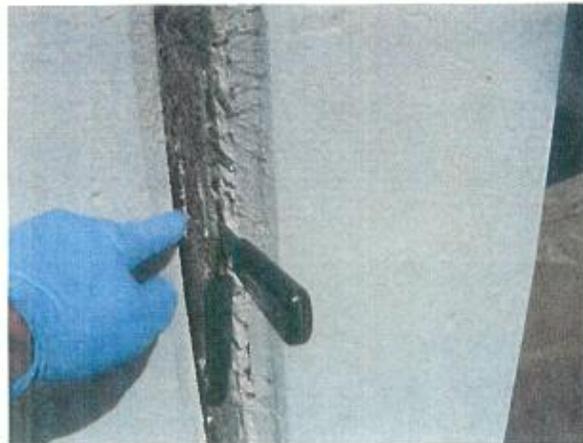
Photo 6 – Bridge 46-0218 expansion joint fill material and graffiti abatement paint

Intact gray graffiti abatement paint used on Bridge 46-0218 would not be classified as a California hazardous waste based on lead content if stripped, blasted, or otherwise separated from the substrate.

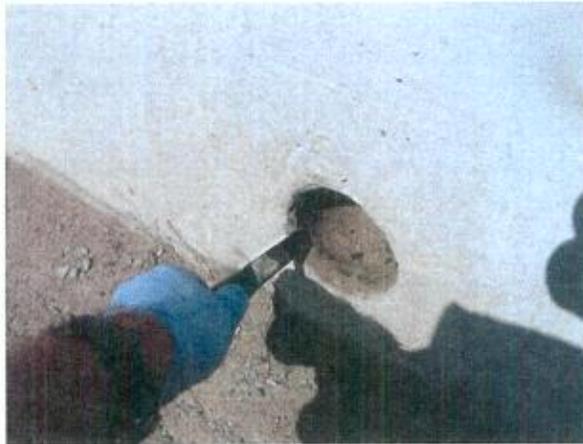
Photo 7 – Bridge 46-0218 black drain pipe

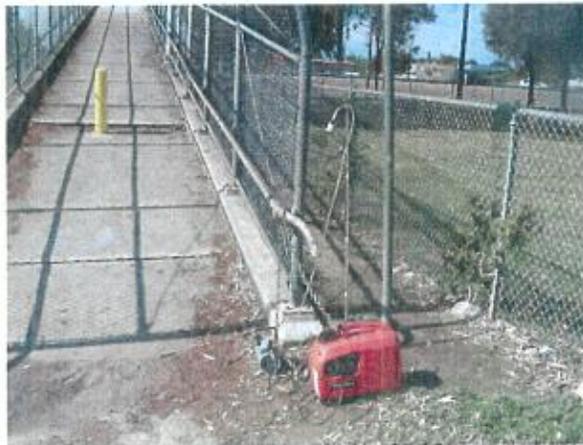
Photo 8 – Bridge 46-0218 typical air monitoring station

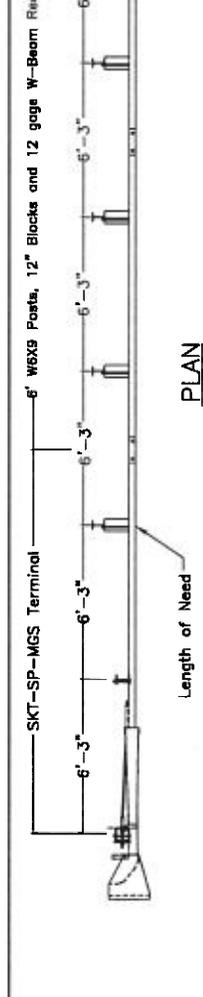
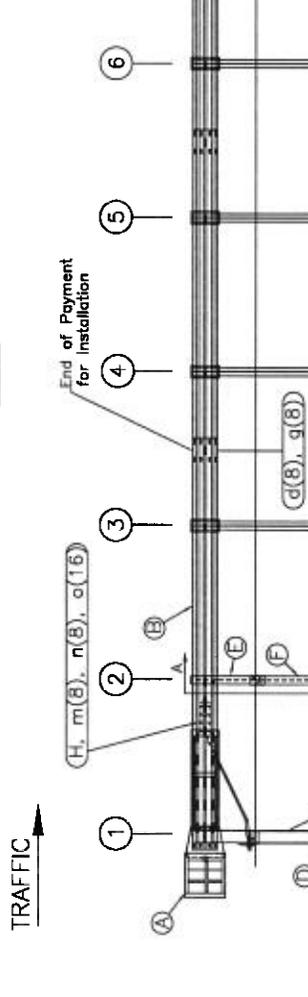
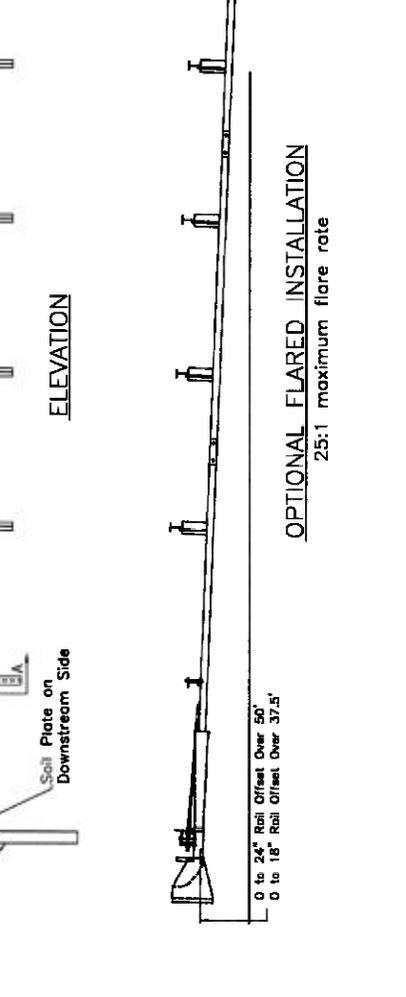
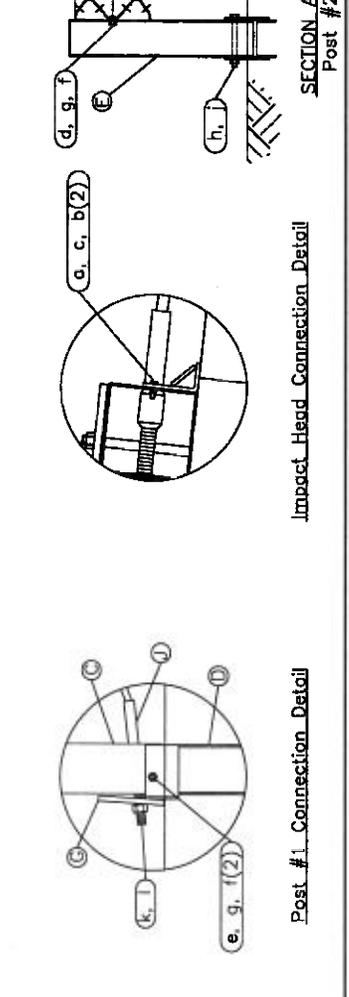
**SKT-SP-MGS Terminal
 Midwest Guardrail System
 31" Top of Rail**

- A site evaluation should be considered if there is less than 25' between the outlet side of the terminal and any adjacent driving lane.
- The breakaway cable assembly must be taut. A locking device (vice grips or channel lock pliers) should be used to prevent the cable from twisting when tightening nuts.

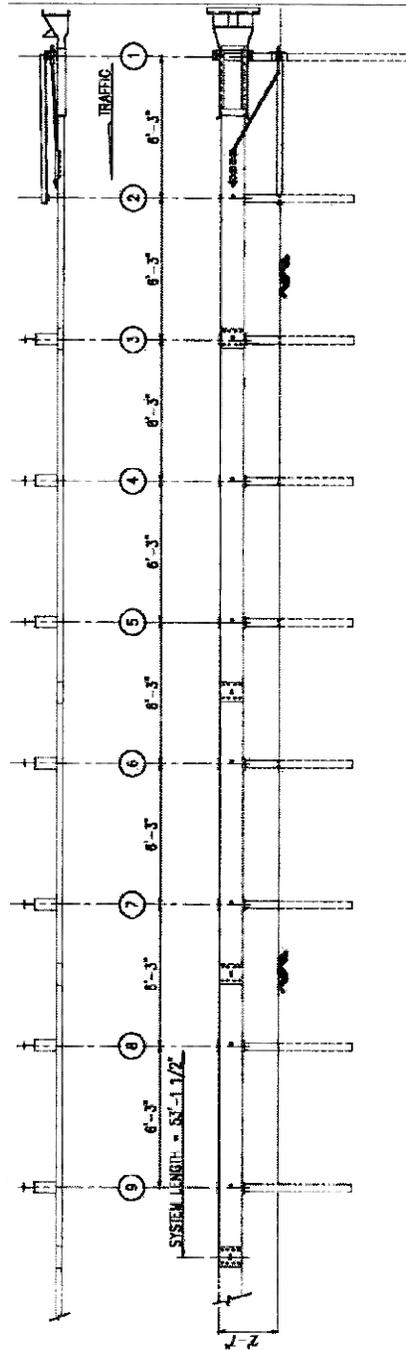
Figure 4 (TL-3)

**ET-31™ Guardrail End Treatment
NCHRP Report 350 Test Level 3
System Length 53'-1 1/2" (16.19 m)**

[This drawing represents one version of the 53'-1 1/2" (16.19 m) system]
