Geotechnical Report
Plan Review/Recommendations for Slope Protection at
Sand Canyon Overcrossing on Route 14

File: 07-LA-14 PM 33.4
EA: 07-272-258801
E-FIS: 0700020195
Slope Protection/Sand
Canyon OC

Subject: Plan Review/Recommendations for Slope Protection at Sand Canyon Overcrossing on SR14

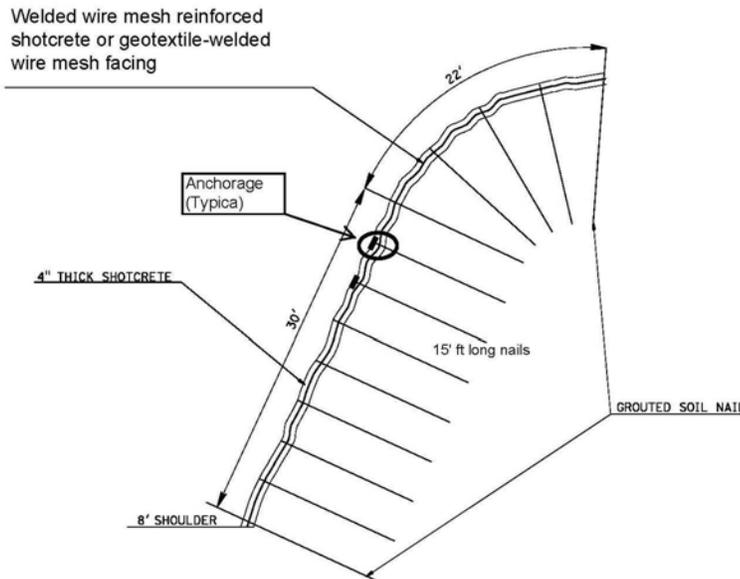
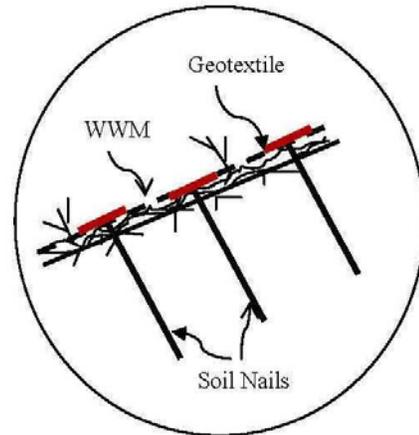
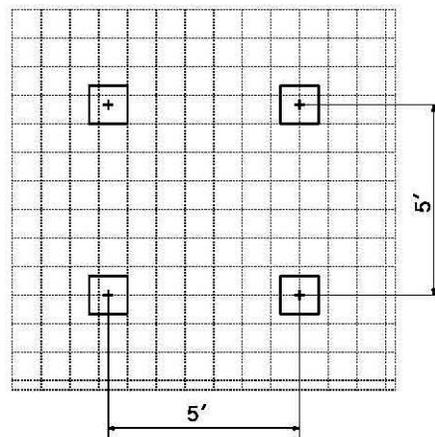
FIGURE 2. RECOMMENDED STABILIZATION MEASURES (SCHEMATIC)

(b) Geotextile-Welded Wire Mesh (WWM) Facing

(a) Typical Section

1. We recommend that the subject slopes be protected by installing a surficial slope stabilization measures consisting either a wire-reinforced shotcrete or a geotextile-wire mesh facing anchored with grouted soil nails, as shown schematically in the attached Figure 2.

- iii. Install Soil Nails: Drill holes and install 15 feet long threaded grouted nails (#6 or 7 Grade 60) in a grid pattern (5 ft by 5 ft) as shown schematically in the attached Figure 2. The soil nails should be double corrosion protected.
- iv. Install Facing: Install welded wire mesh (6"x 6" W2xW2) reinforced shotcrete facing (≥ 4 inch thick) or geotextile-welded wire mesh facing. Either Type A or Type geotextile fabric as defined in Section 88-1.04 of the Caltrans' Standard Specifications may be used.
- v. Anchor Facing: Install and tension 10" by 10" square, $\frac{3}{4}$ " thick bearing plates over the soil nail heads. The tension force should be on the order of 1.5 to 2.0 kips. If shotcrete facing is used, tensioning should be performed once the shotcrete has developed adequate strength.

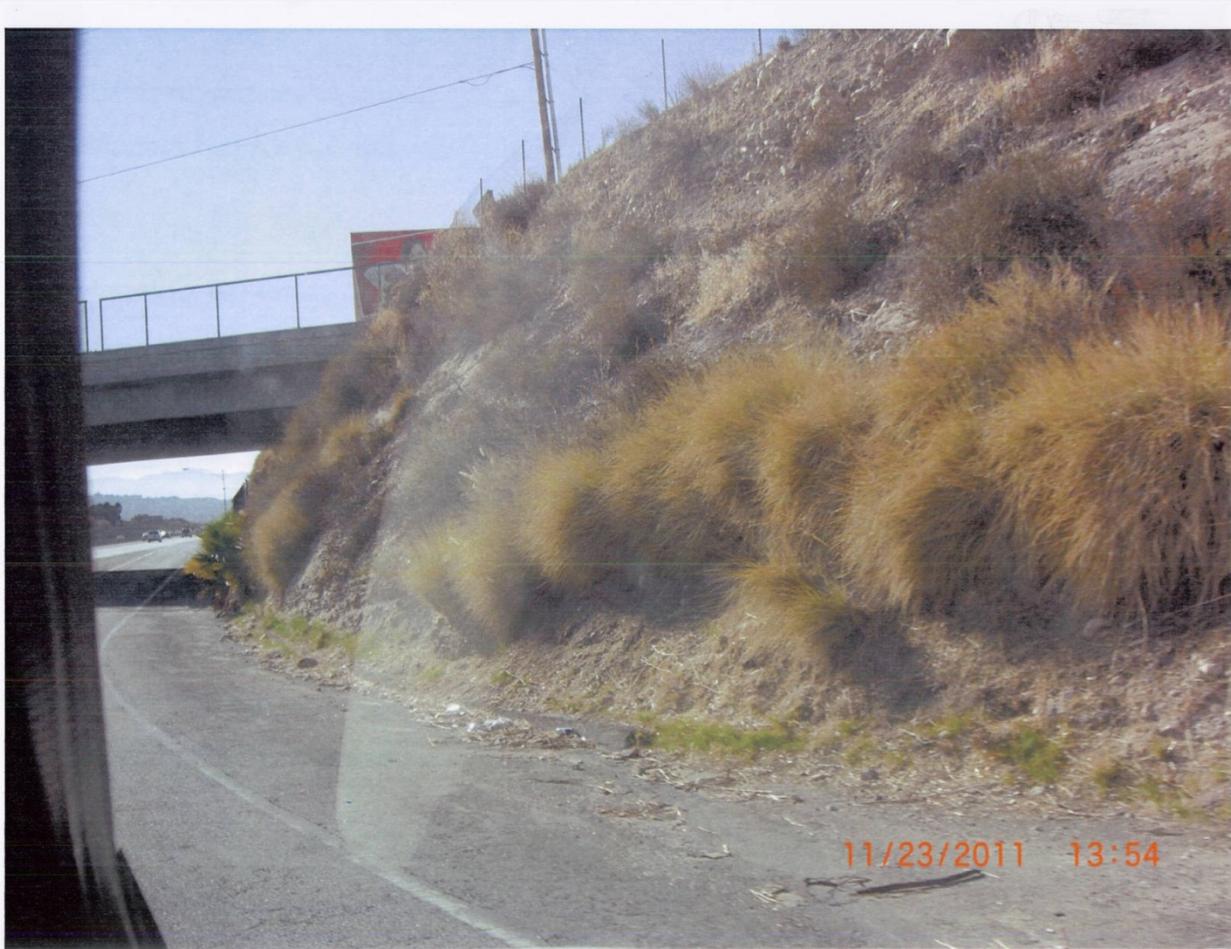
PLATE 1. PHOTO OF EXISTING SLOPE EAST OF SAND CANYON NORTH ABUTMENT

The existing slopes within the State right-of-way (R/W) on both sides of the north abutment of the Sand Canyon OC have experienced instability in the forms of surficial sloughing and erosion as can be seen from the attached Photographs 1 and 2.

Based on our review of the available information, the existing slopes on both sides of the north abutment of the Sand Canyon OC are cut slopes associated with the construction of SR 14. The height of the subject slopes ranges approximately from 30 to 35 feet. These slopes are very steep with slope ratios 1:2 (H:V) or steeper within the lower portions.

Based on the attached as-built LOTB's as well as visual observation of the exposed materials on the attached photographs, the surface soils consist of 5 to 7 feet of loose to medium dense silty sand (SM), which is underlain by semi-consolidated conglomerate that are partially cemented by clayey sand. The above soil layers are underlain by claystone and sandstone bedrock.

- The existing slope surfaces are very steep. Such steep slopes are susceptible to surficial sloughing due to gravitational forces.
- The upper 5 to 7 feet of the slope materials are relatively loose and cohesionless in nature. Such materials are susceptible to erosion due to rainfall, surface run off and wind.
- The subject slopes are highly susceptible to surficial sloughing and erosion due to the combination of the steep gradient, and the presence of loose and cohesionless soils at the surface.
- Surficial sloughing and erosion problems are visible from site photos provided. The eroded materials can be seen accumulated along the on ramp shoulder.
- These slopes appear to be stable against overall or global sliding failures.

3. We also recommend constructing a lined surficial interceptor drain or channel along the top of the slope to intercept and prevent runoff from above from entering into or flowing over the slope. The intercept drain should have sufficient size and gradient necessary to convey collected water in a non-erosive manner. Collected water collected should be discharge to a stable and non-erodible area.
