INFORMATION HANDOUT

For Contract No. 07-300704

Aerially Deposited Lead Site Report

**PAVEMENT REHABILITATION PROJECT- ADA
CURB RAMP RECONSTRUCTION,
CONSTRUCTION OF CONCRETE SAFETY
BARRIER, CONSTRUCTION OF MVPS AND
REPLACEMENT OF BRIDGE APPROACH AND
DEPARTURE PAVEMENT SLABS FROM ROUTE
5/710 SEPARATION TO MAIN STREET
UNDERCROSSING**

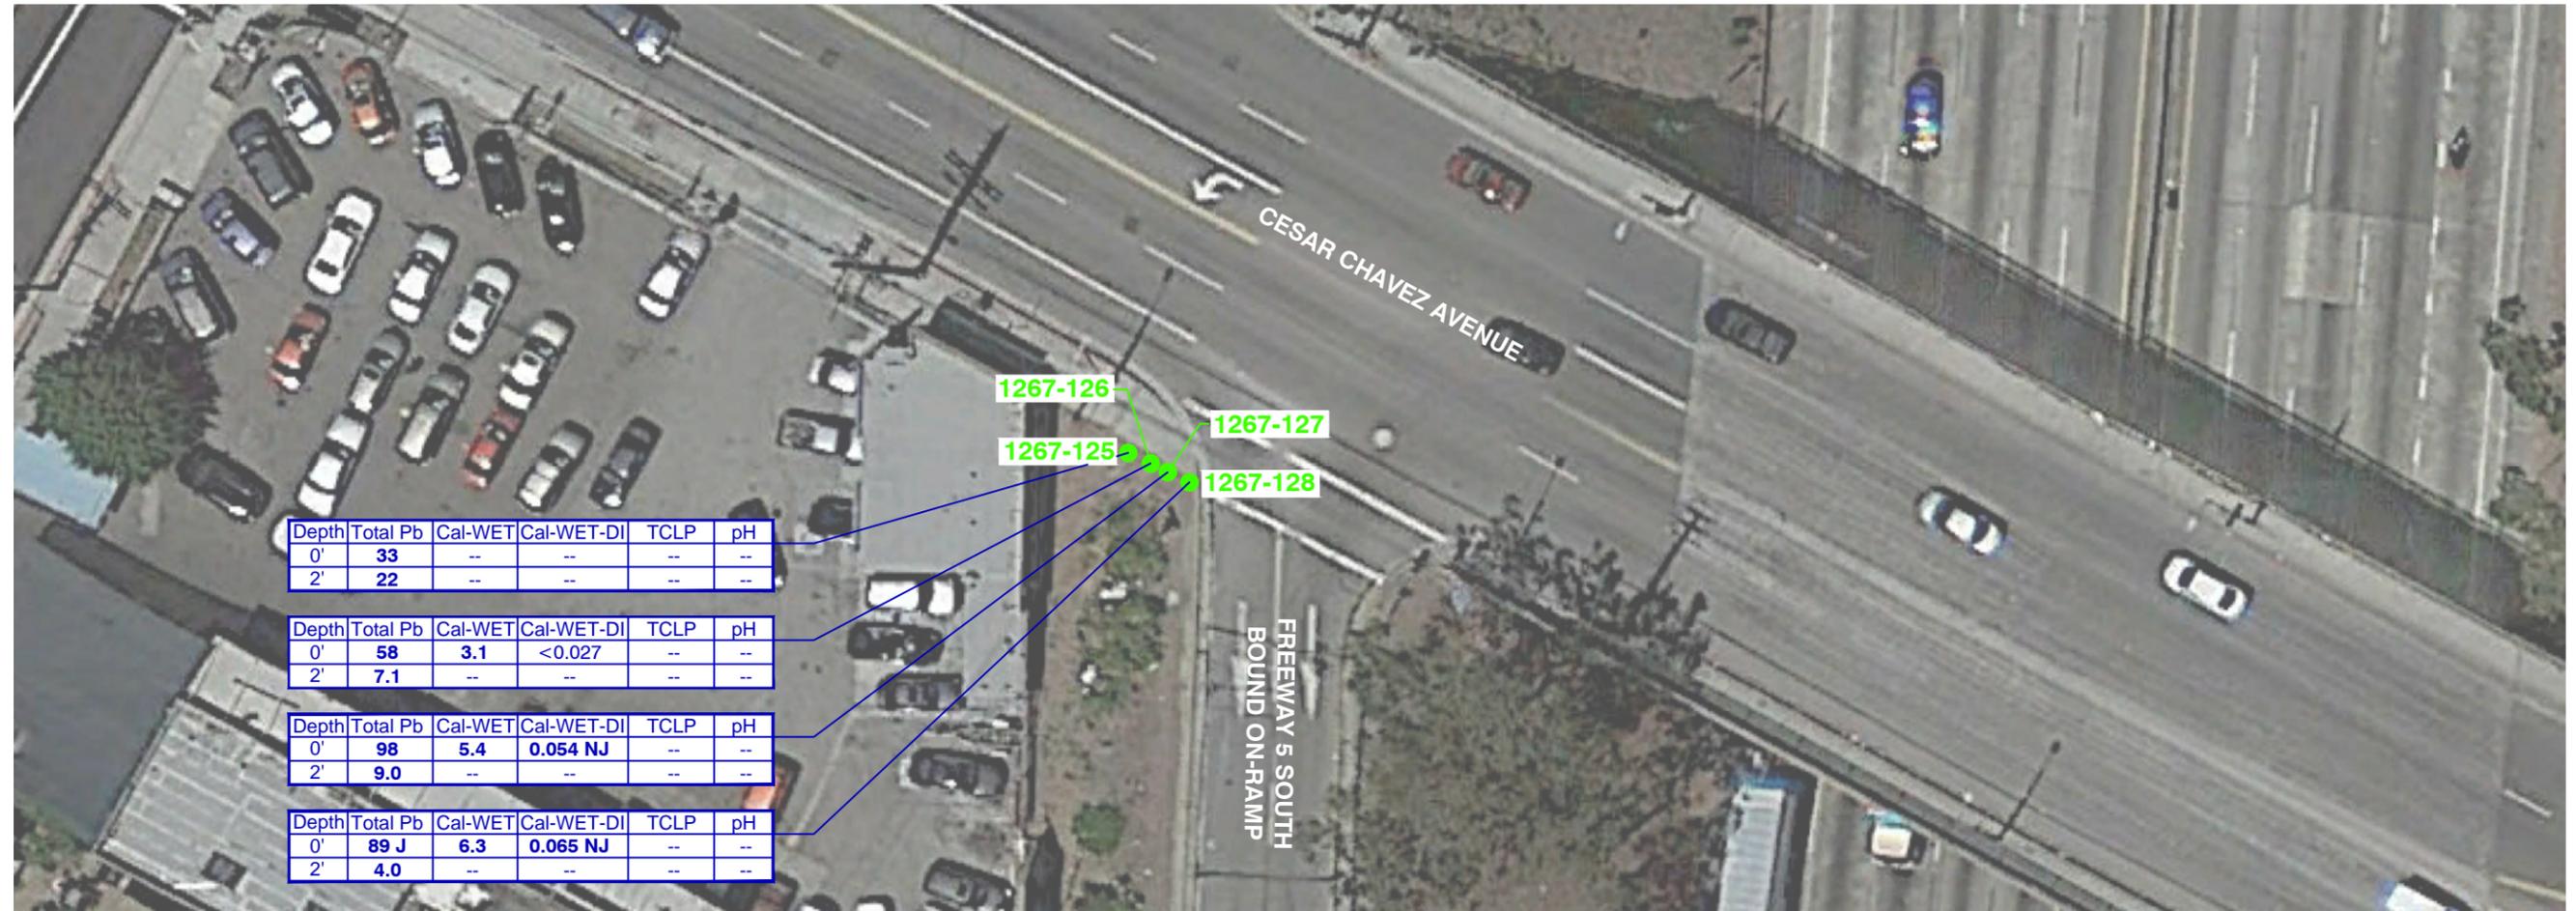
Depth	Total Pb	Cal-WET	Cal-WET-DI	TCLP	pH
0'	33	--	--	--	--
2'	22	--	--	--	--

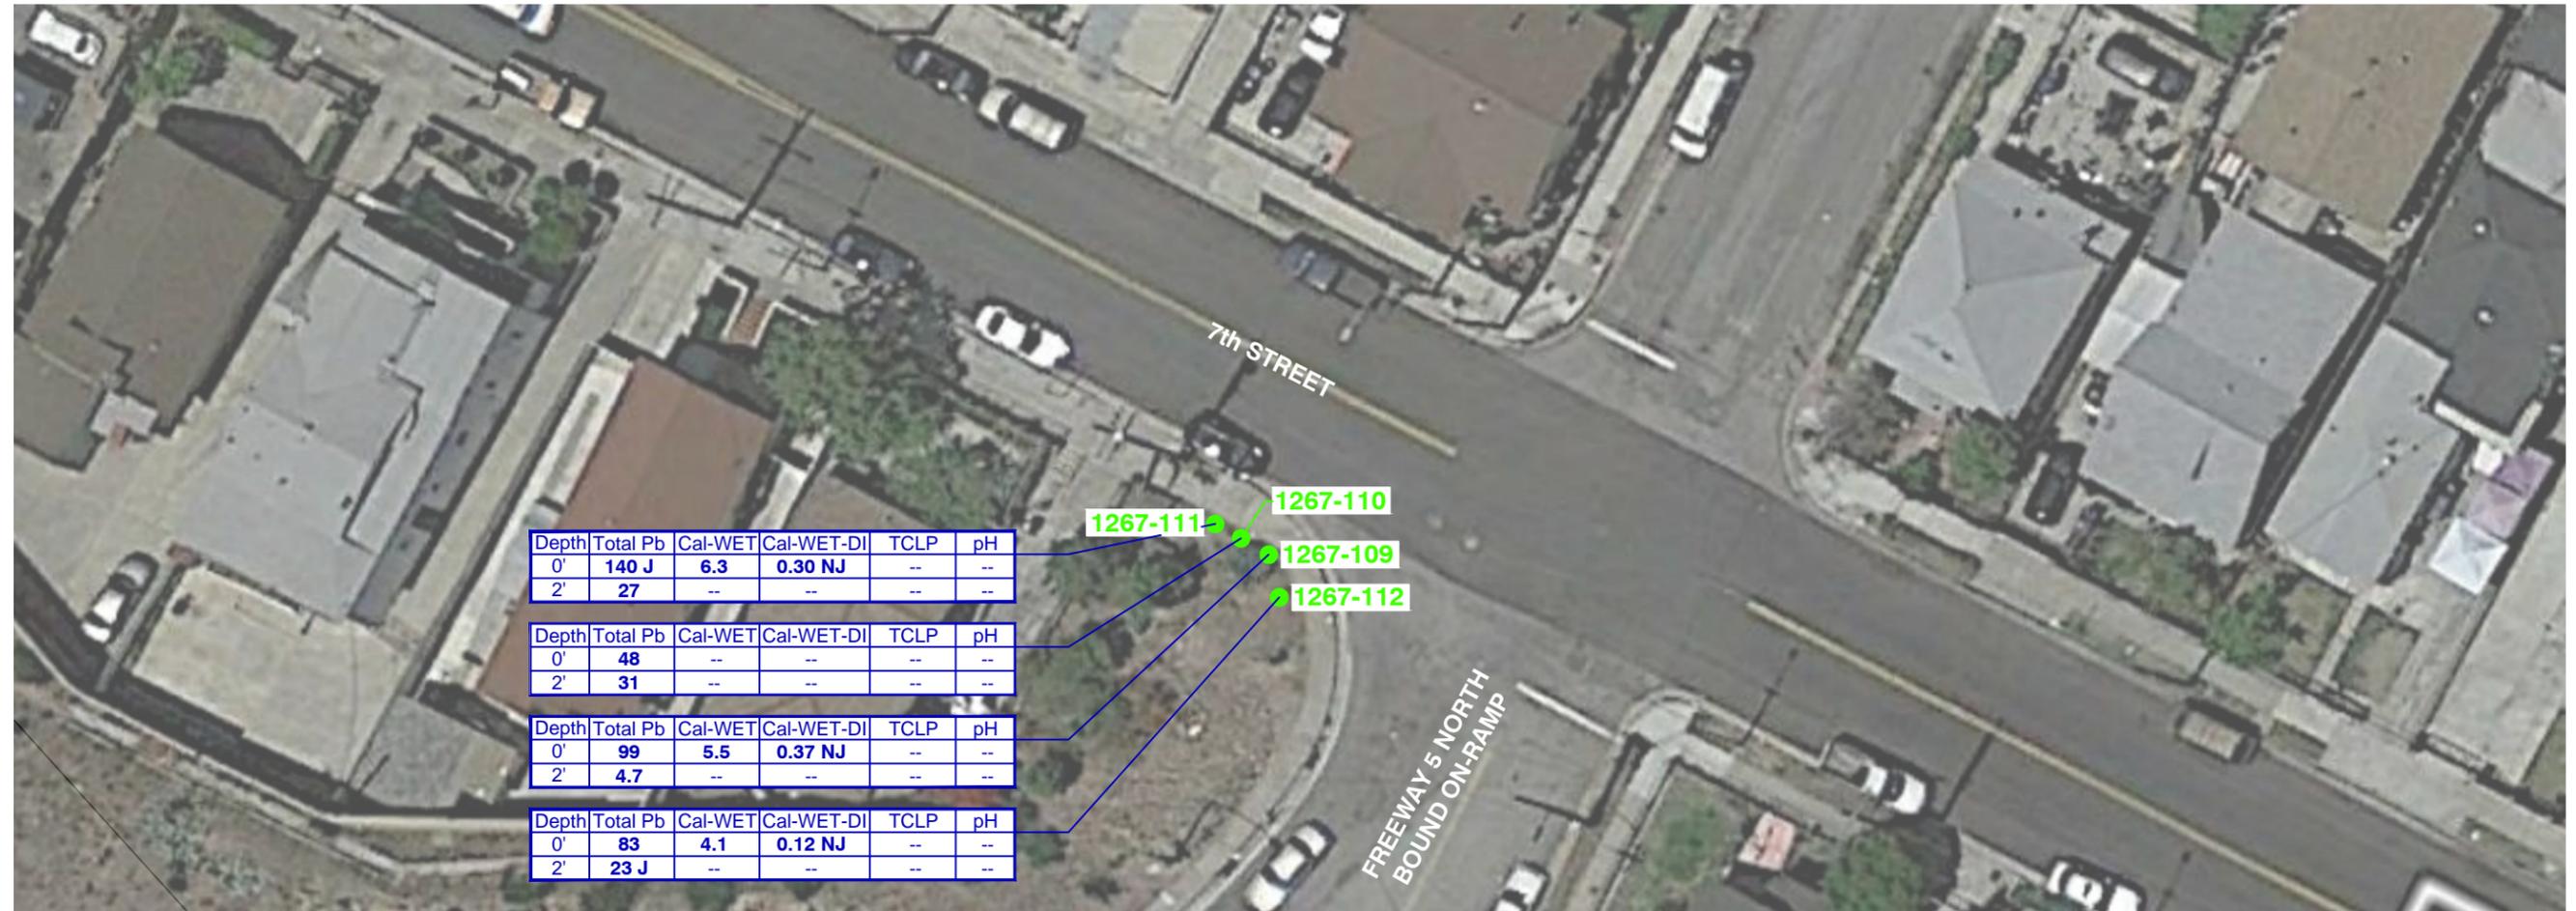
25964-F BUSINESS CENTER DRIVE REDLANDS, CALIFORNIA 92374 PHONE: (909) 335-6116 FAX: (909) 335-6120	FOR: CALTRANS, DISTRICT 7 Contract: 07A3321 Task Order No. 17 LA-5 PM 13.8/19.2 PN: 0713000492-1; EA: 07-300701		CURB RAMP LOCATION 7 SAMPLE LOCATION MAP SOUTH BOUND ON-RAMP FROM CESAR CHAVEZ AVENUE (LEFT)		FIGURE: 5
	JOB NUMBER: 185831017	DRAWN BY: STA	CHECKED BY: MA-S	APPROVED BY: KM	DATE: 01/10/15

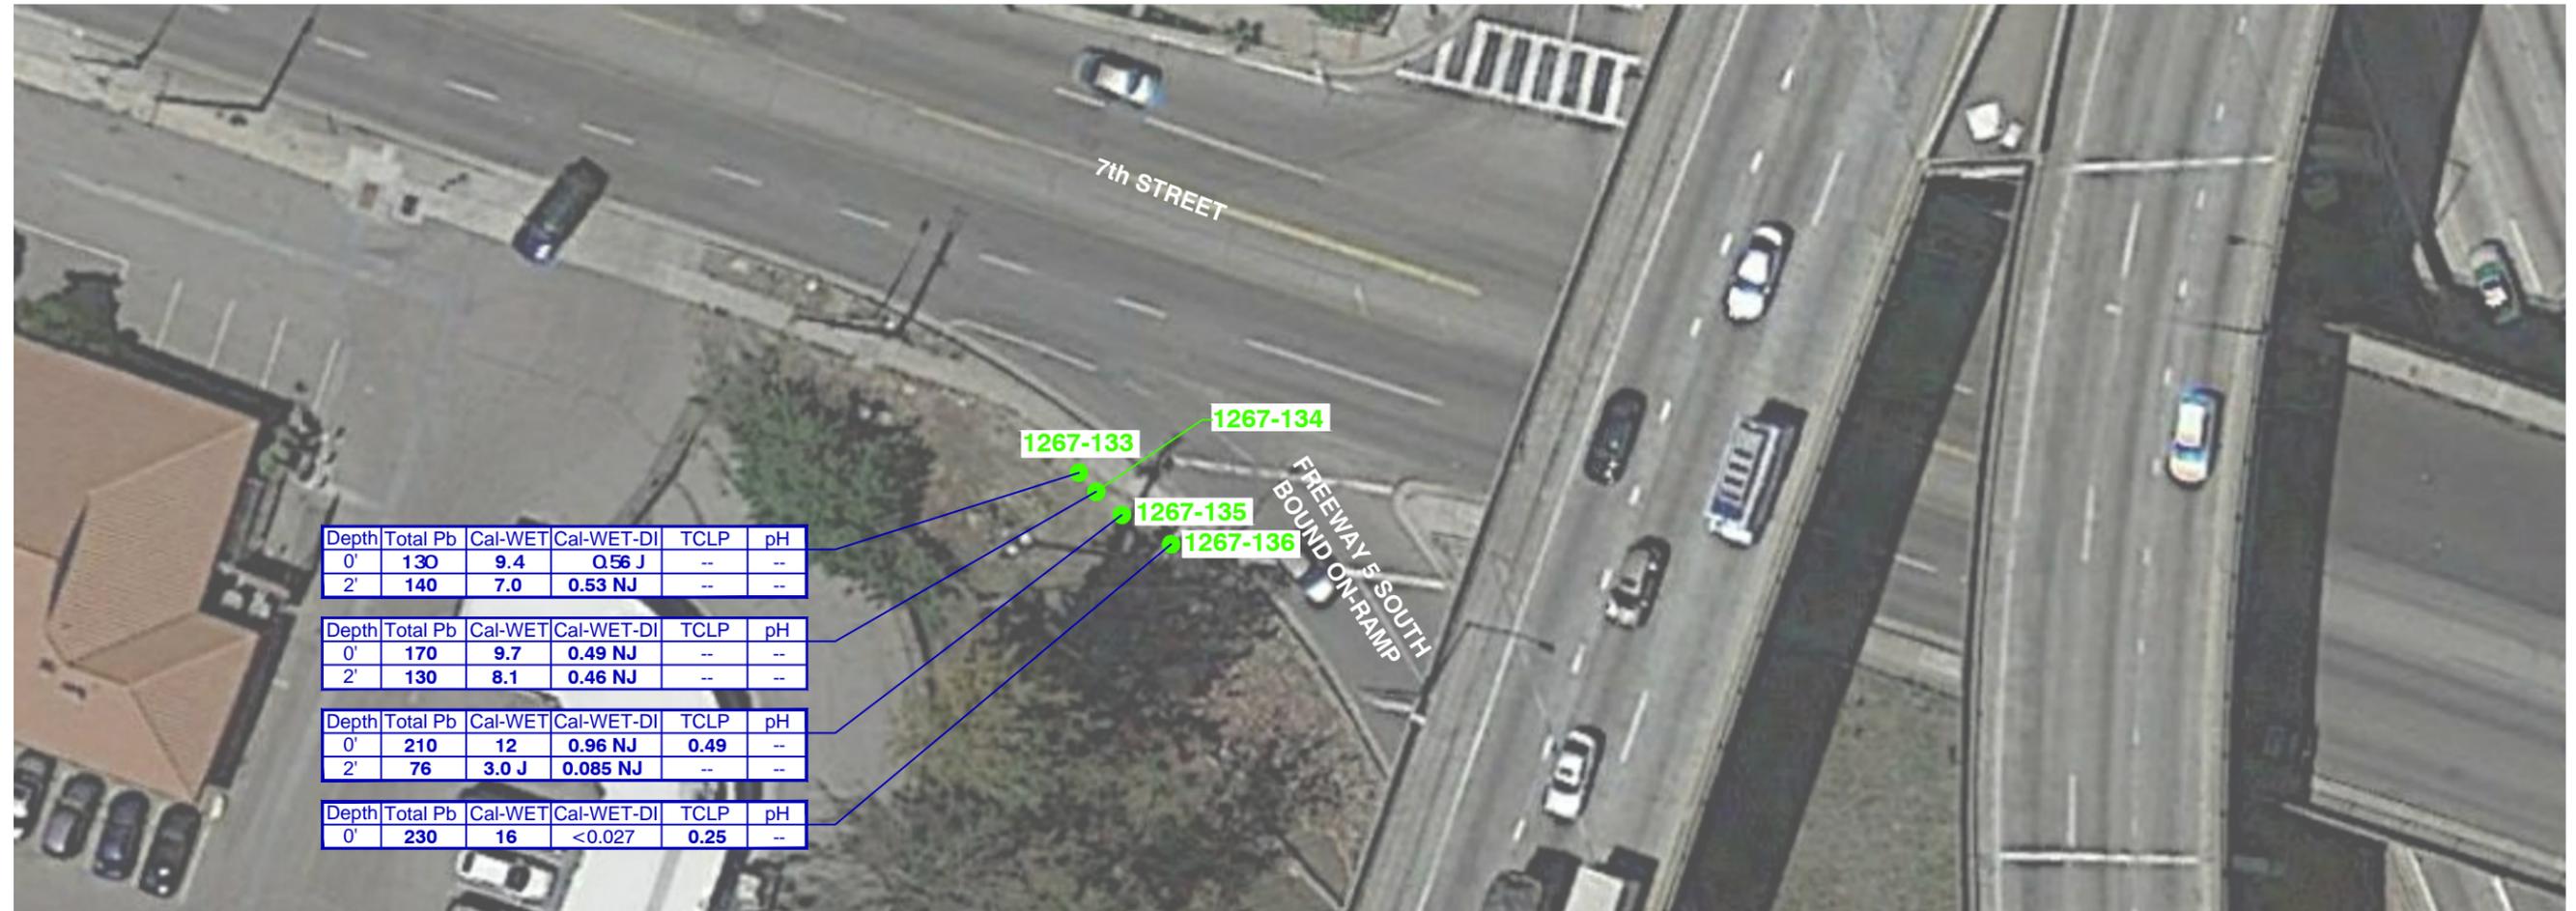
Depth	Total Pb	Cal-WET	Cal-WET-DI	TCLP	pH
0'	130	9.4	0.56 J	--	--
2'	140	7.0	0.53 NJ	--	--

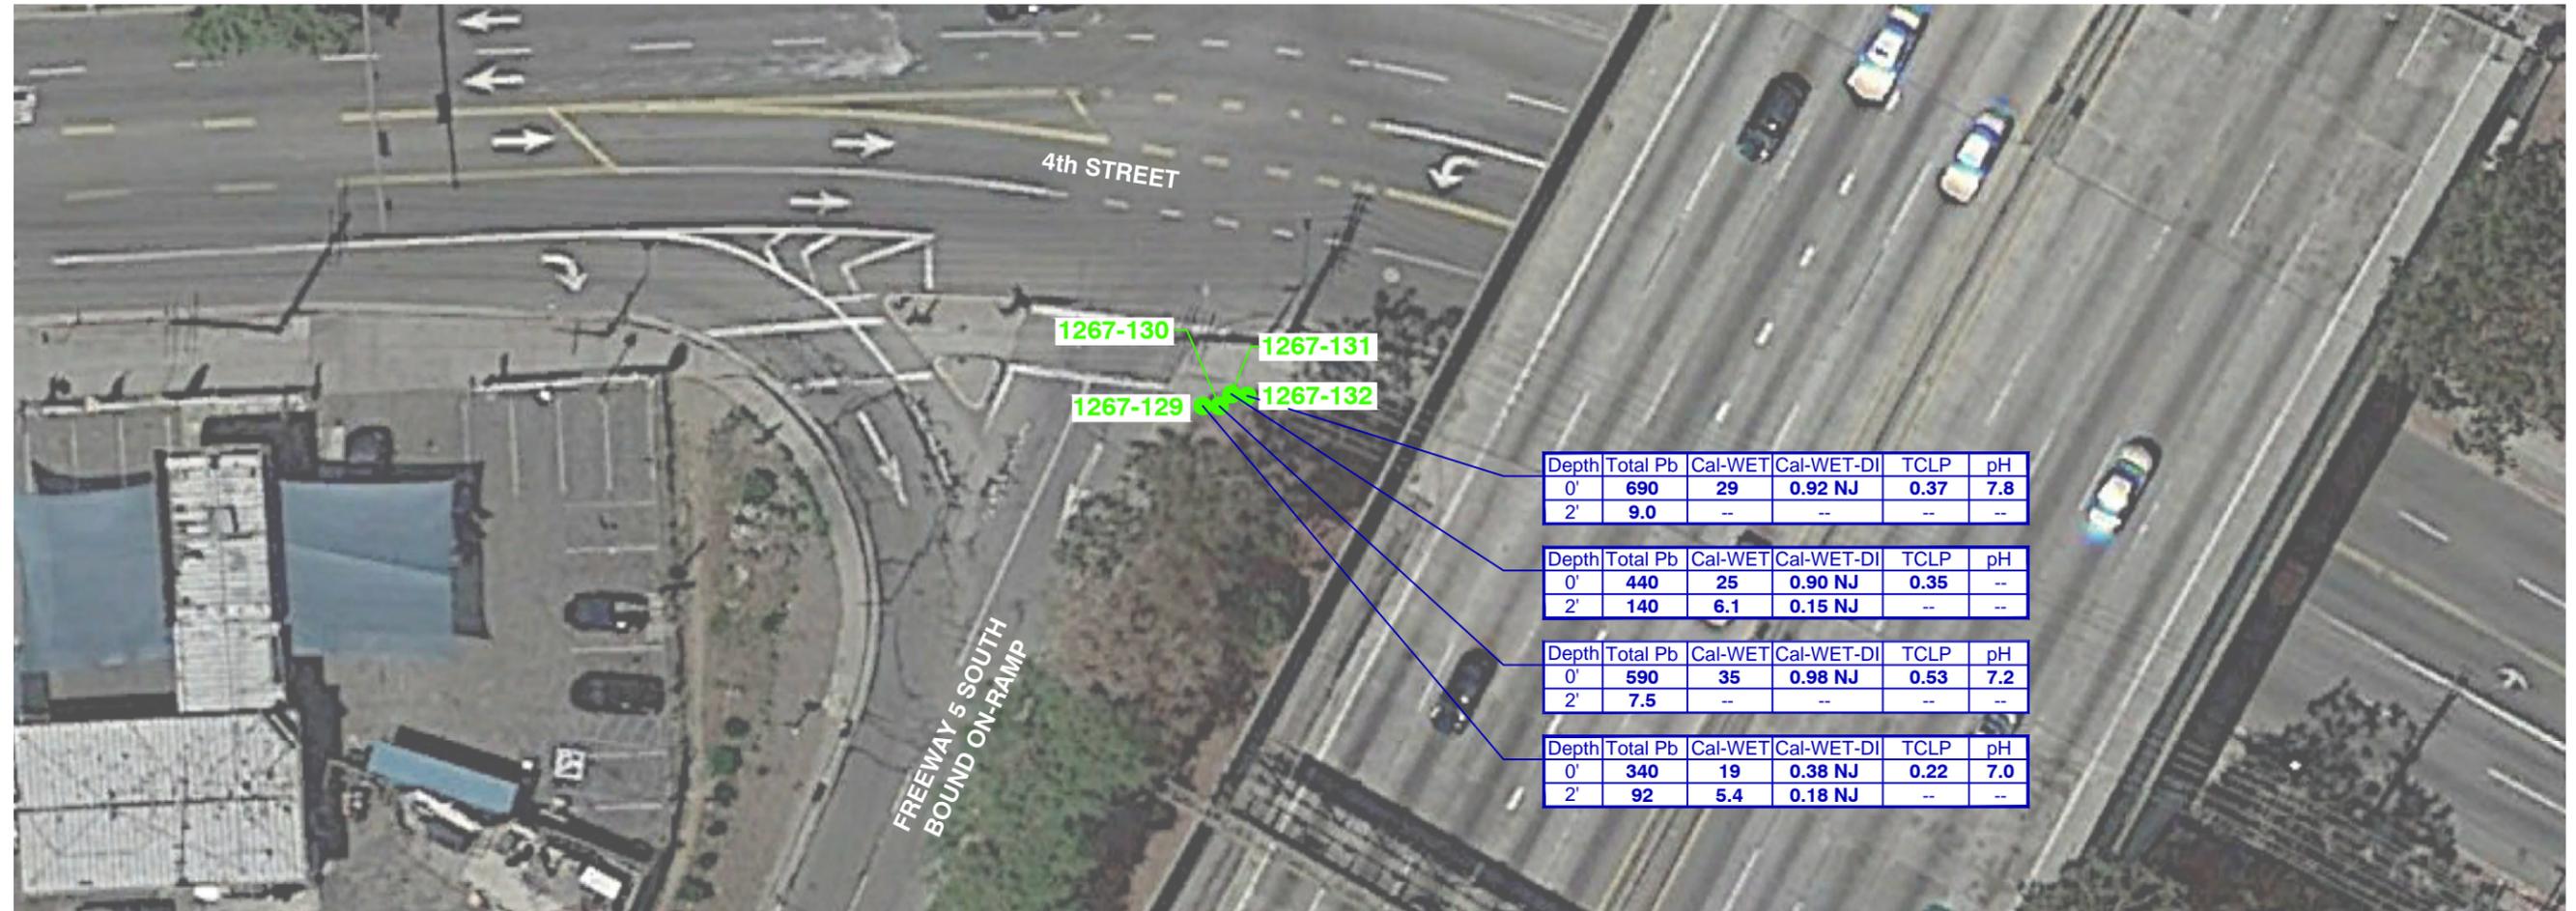
Depth	Total Pb	Cal-WET	Cal-WET-DI	TCLP	pH
0'	690	29	0.92 NJ	0.37	7.8
2'	9.0	--	--	--	--

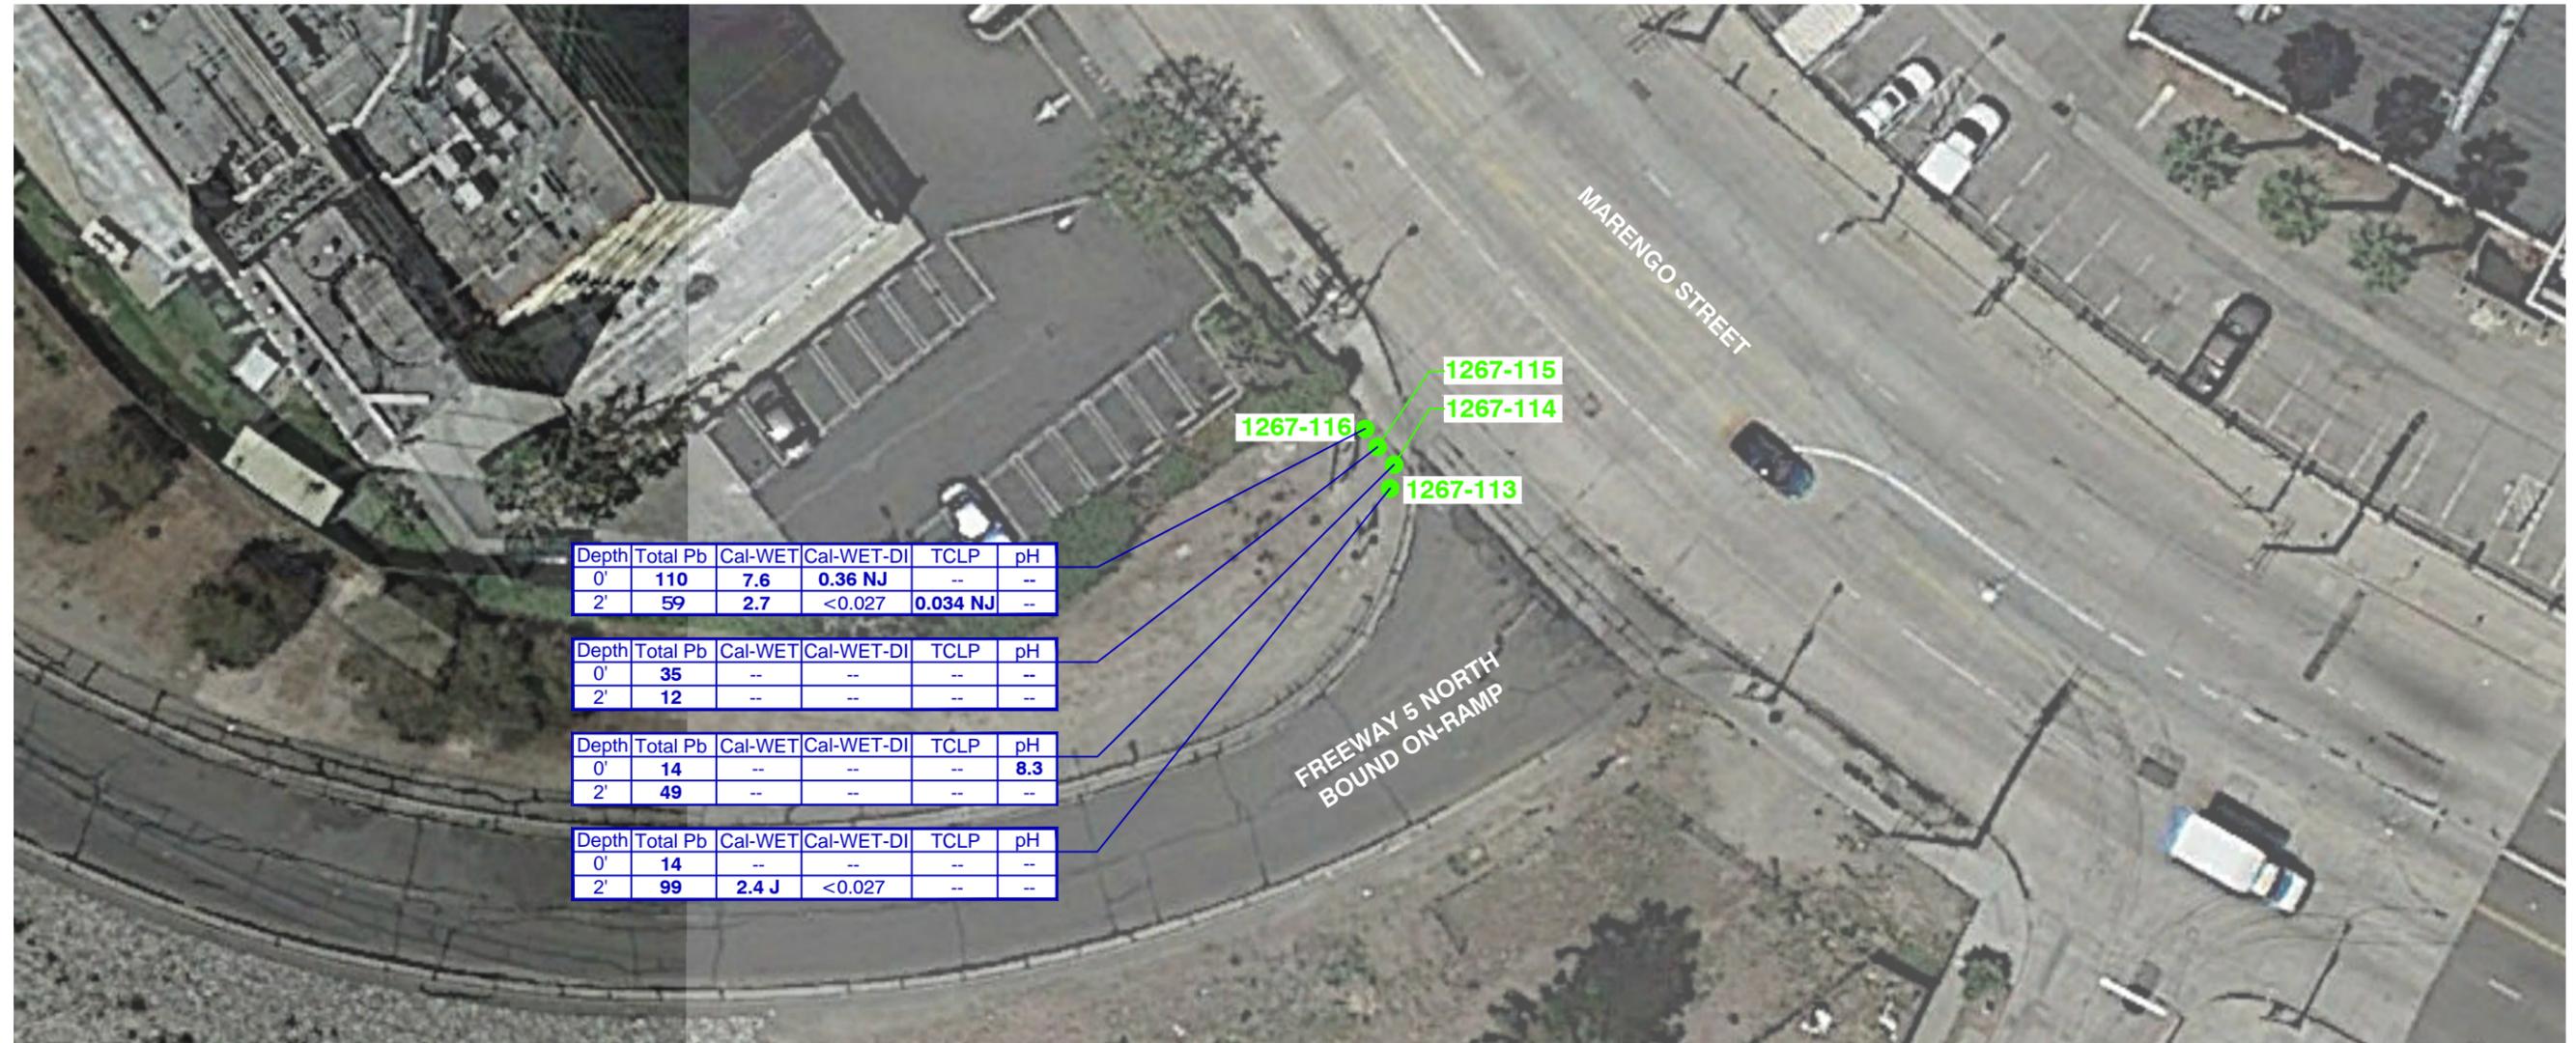
Depth	Total Pb	Cal-WET	Cal-WET-DI	TCLP	pH
0'	110	7.6	0.36 NJ	--	--
2'	59	2.7	<0.027	0.034 NJ	--

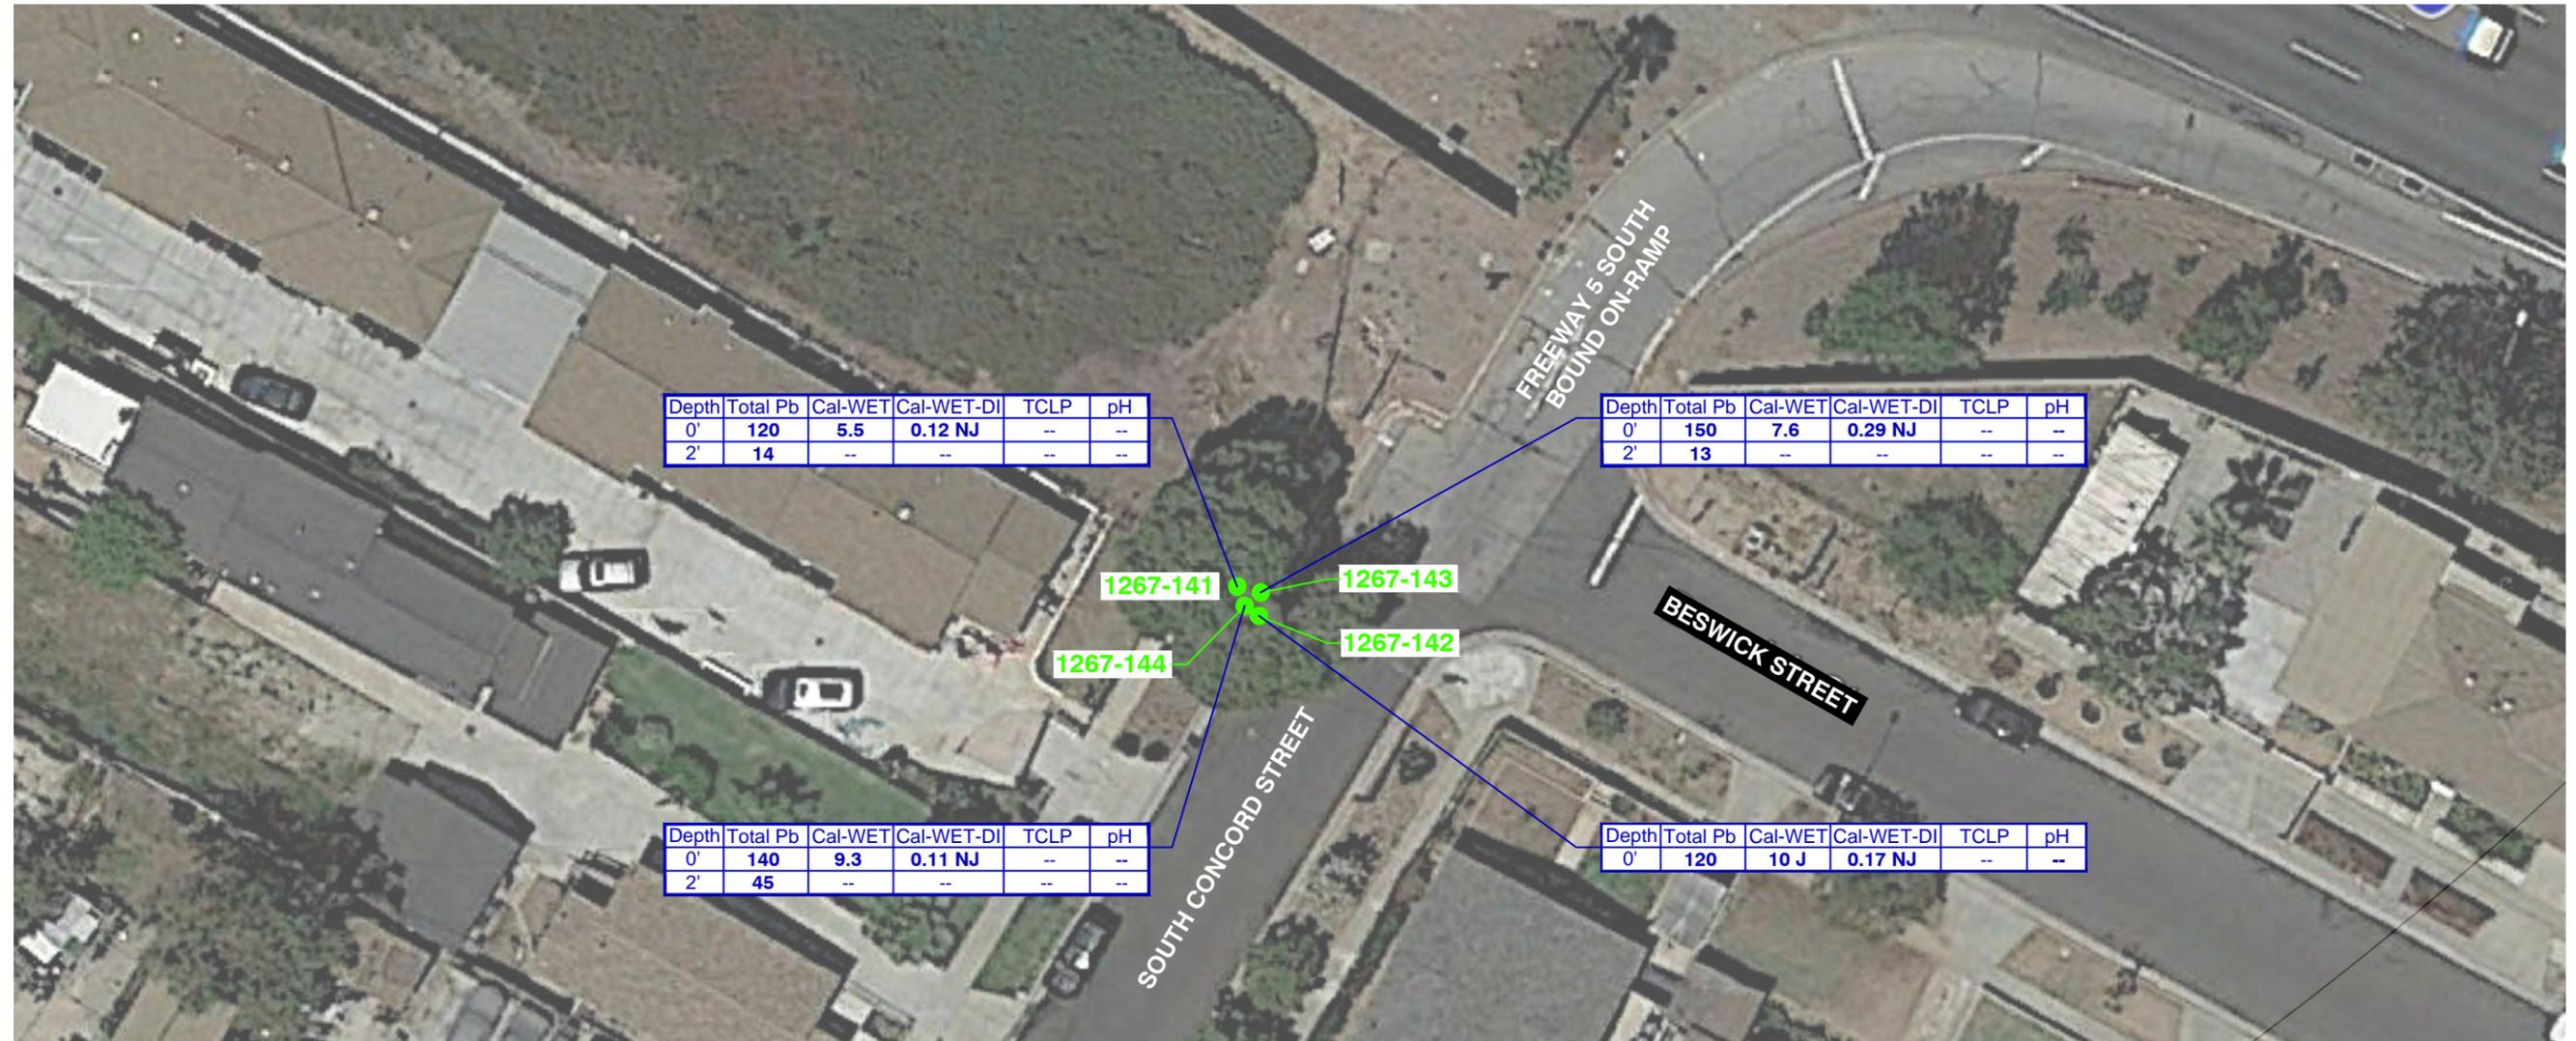
Depth	Total Pb	Cal-WET	Cal-WET-DI	TCLP	pH
0'	120	5.5	0.12 NJ	--	--
2'	14	--	--	--	--

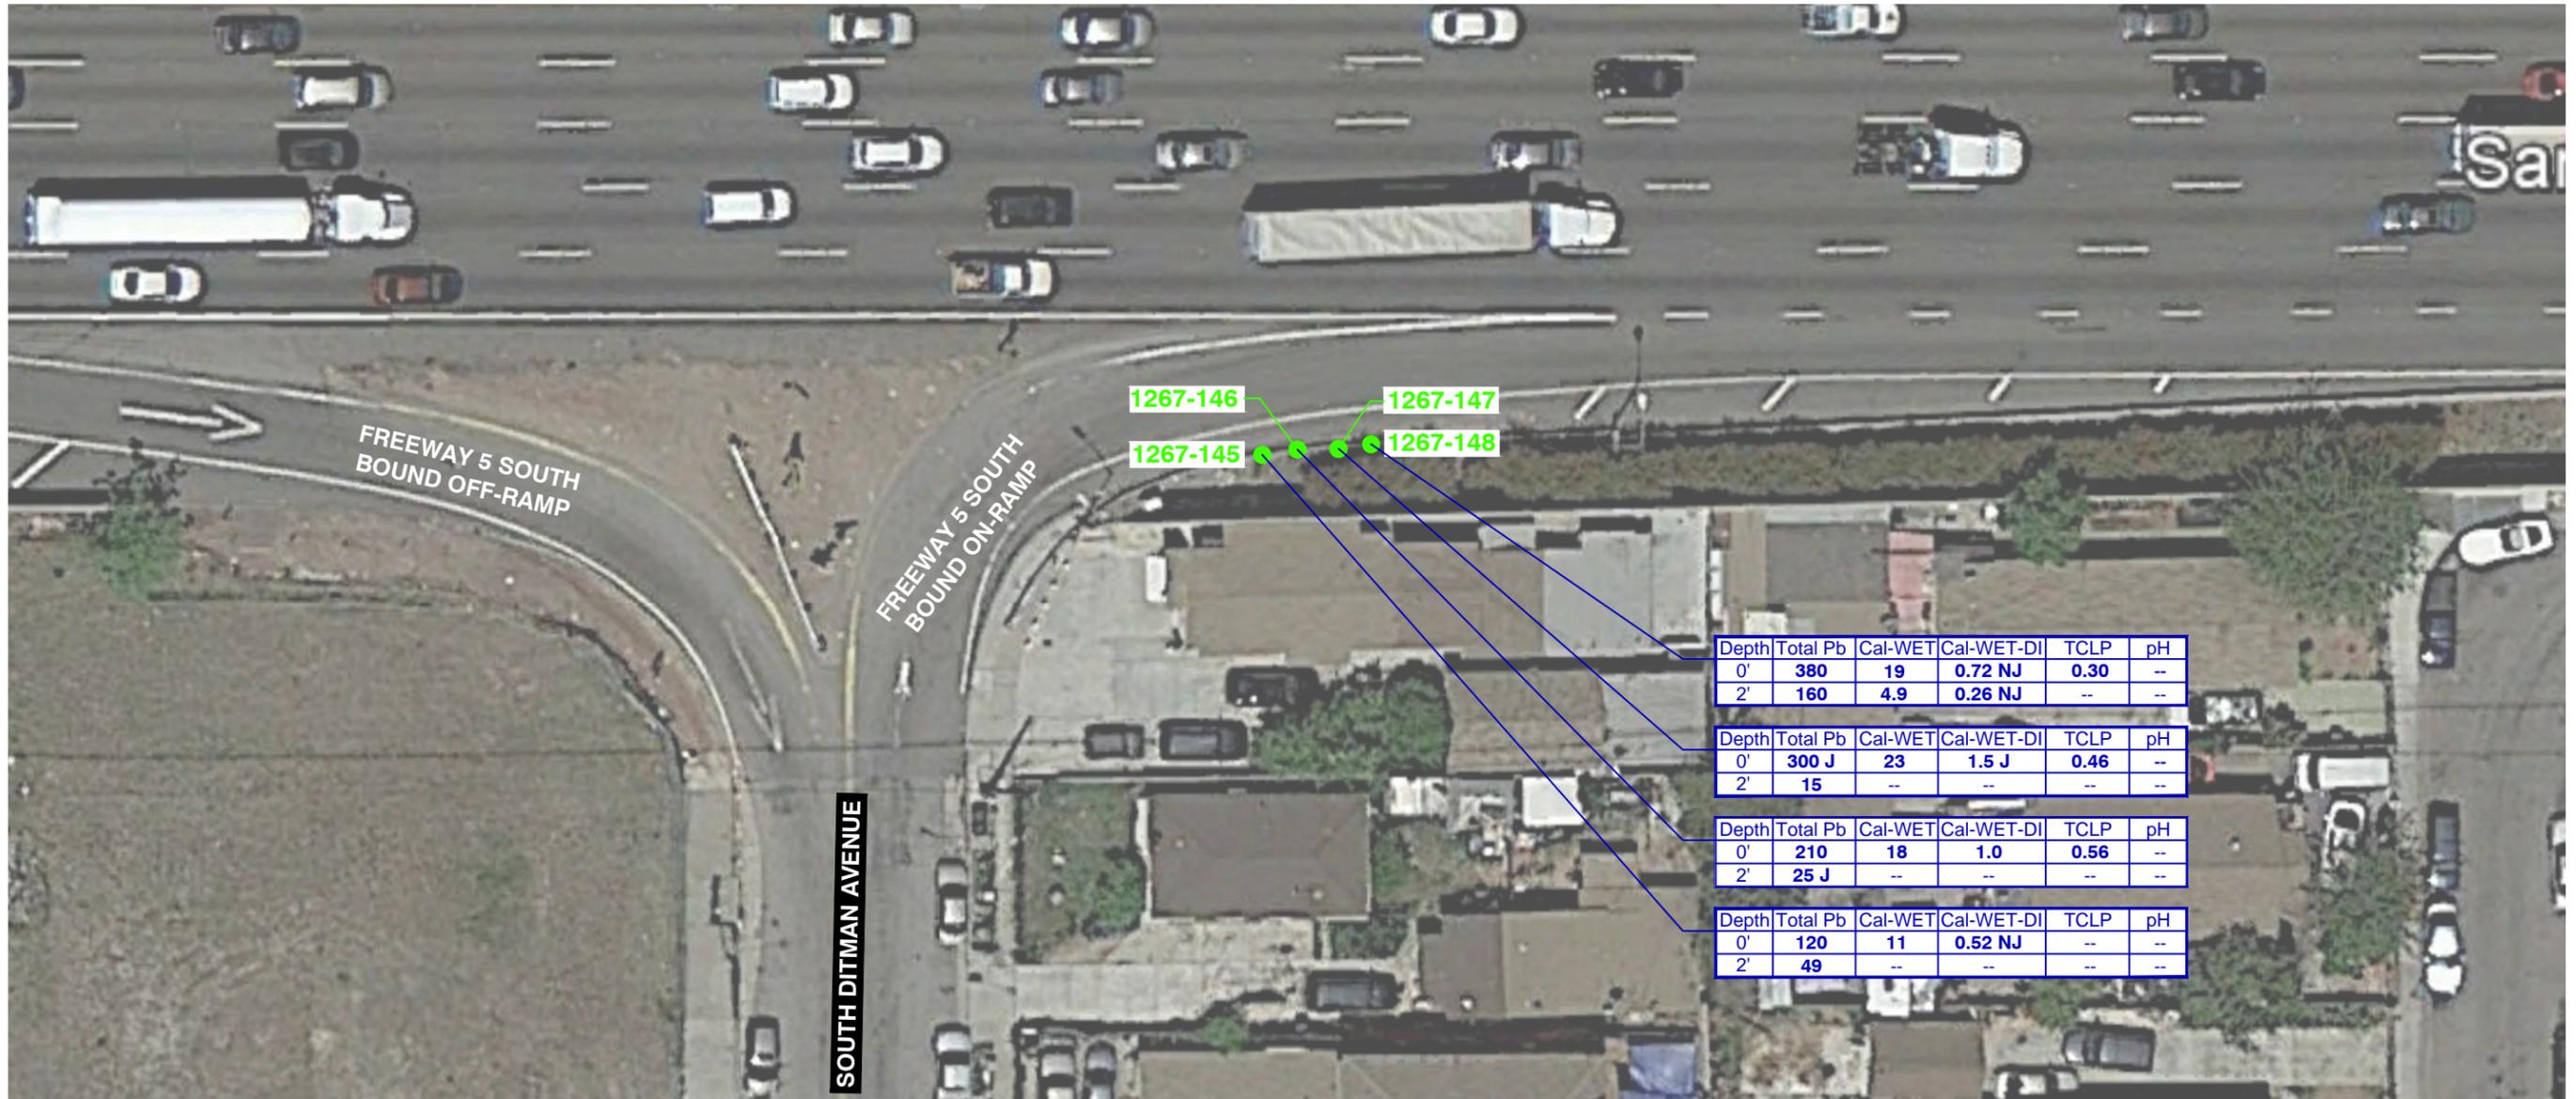
Depth	Total Pb	Cal-WET	Cal-WET-DI	TCLP	pH
0'	380	19	0.72 NJ	0.30	--
2'	160	4.9	0.26 NJ	--	--

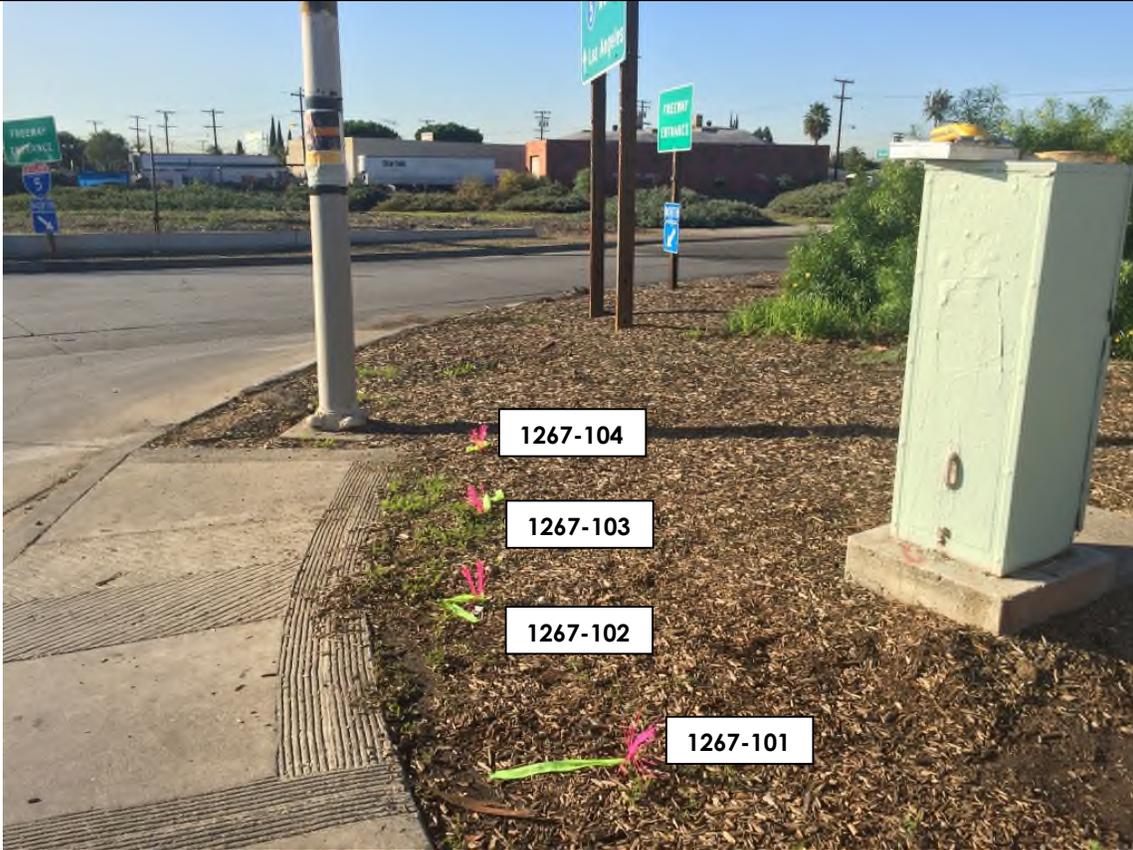
Photograph No. 1

Location 1 – On-Ramp from Downey Road: View of location of borings 1267-101 through 1267-104 – Facing Southwest.

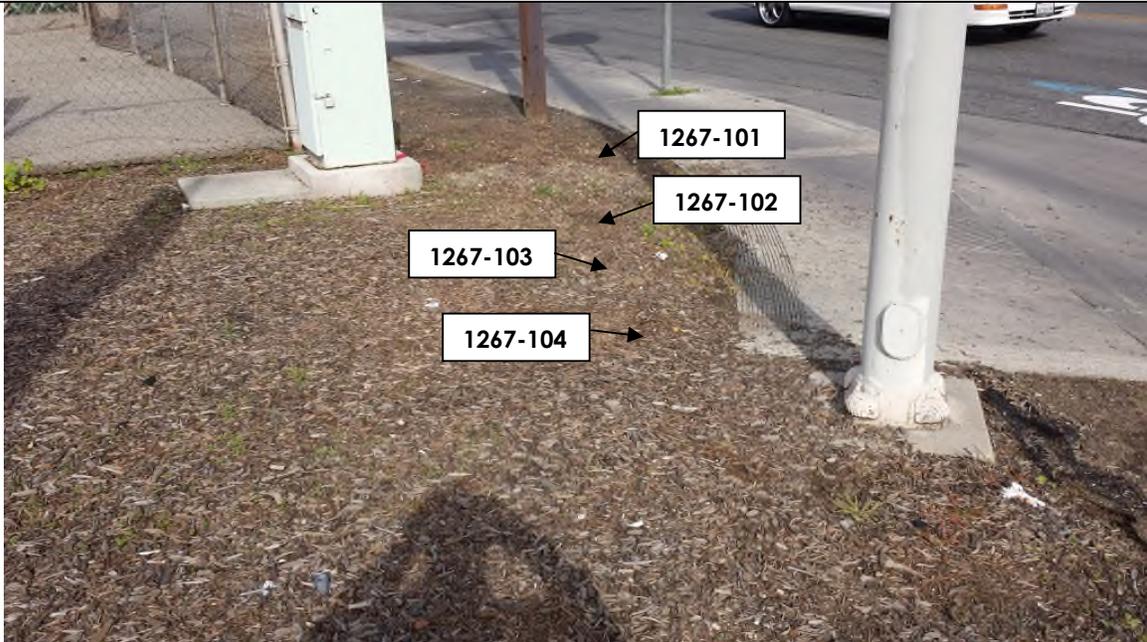
Photograph No. 2

Location 1 – On-Ramp from Downey Road: View of location of borings 1267-101 through 1267-104 after soil sampling – Facing Southwest.

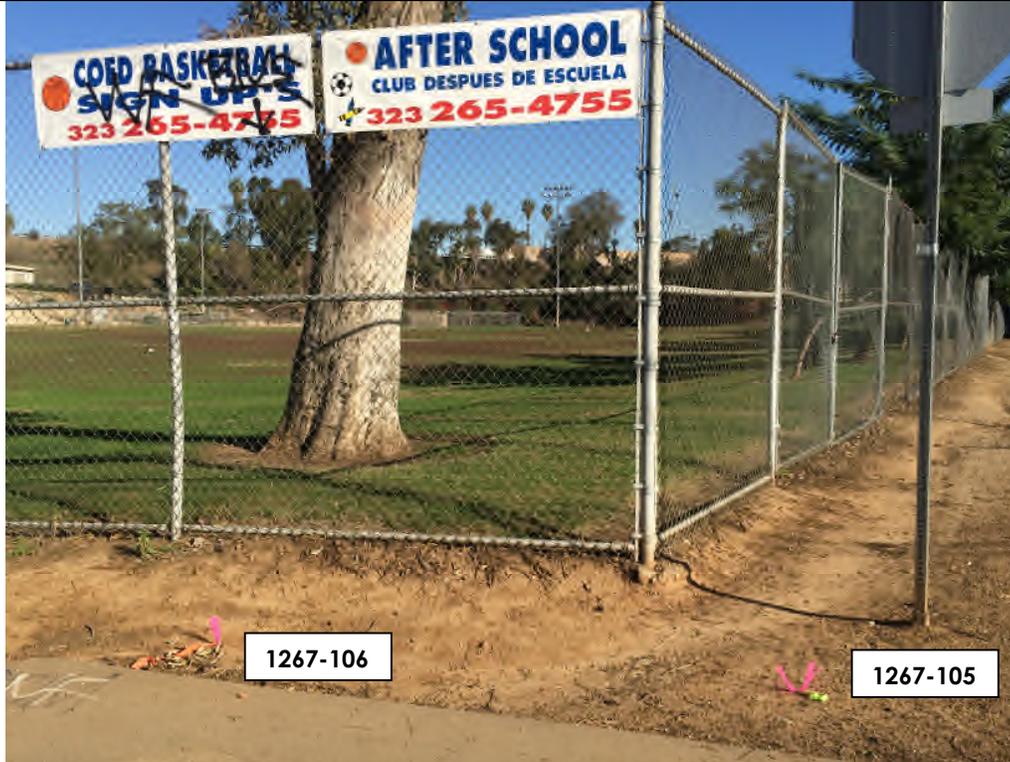
Photograph No. 3

Location 3 – Off-Ramp to Grande Vista Avenue (Left): View of location of borings 1267-105 and 1267-106 – Facing Northwest.

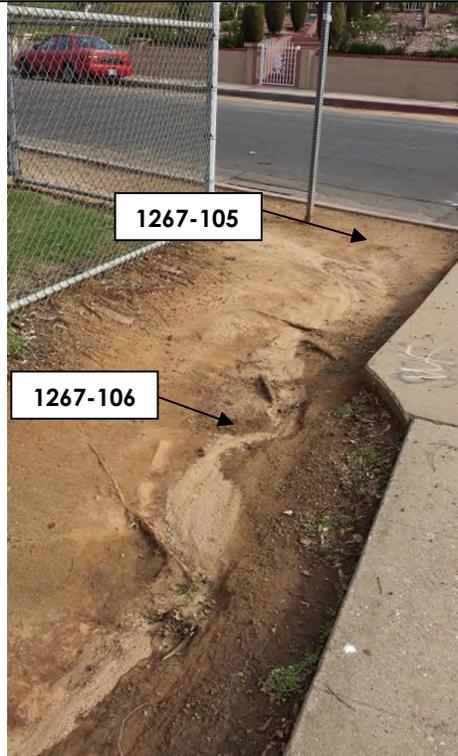
Photograph No. 4

Location 3 – Off-Ramp to Grande Vista Avenue (Left): View of location of borings 1267-105 and 1267-106 after soil sampling – Facing east.

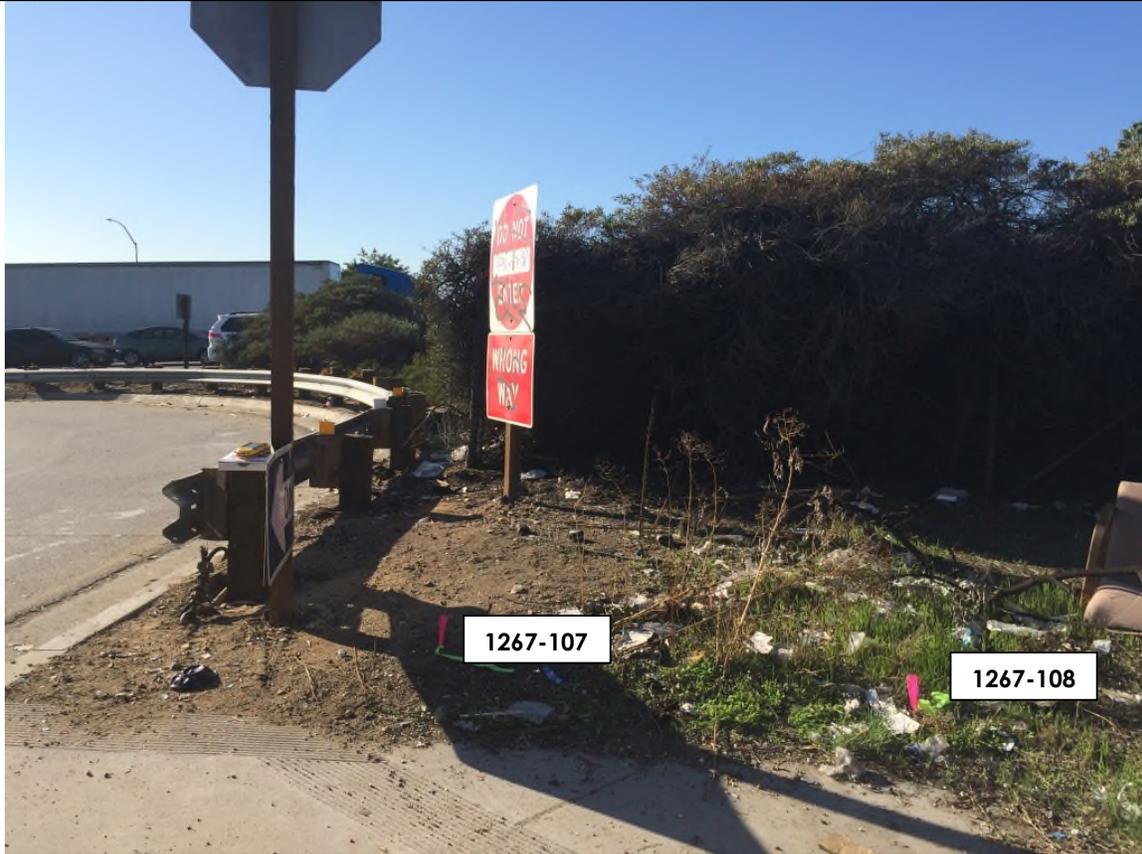
Photograph No. 5

Location 5 – Off-Ramp to Grande Vista Avenue (Left): View of location of borings 1267-107 and 1267-108 – Facing South.

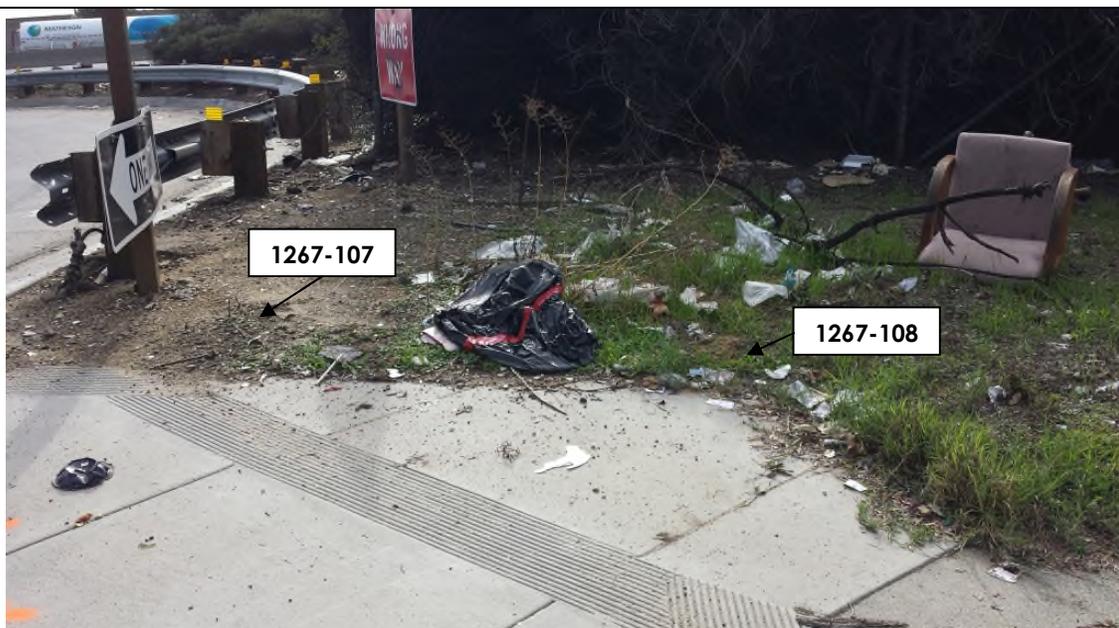
Photograph No. 6

Location 5 – Off-Ramp to Grande Vista Avenue (Left): View of location of borings 1267-107 and 1267-108 after soil sampling – Facing South.
