INFORMATION HANDOUT

For Contract No. 07-300704

Aerially Deposited Lead Site Report

**PAVEMENT REHABILITATION PROJECT- ADA
CURB RAMP RECONSTRUCTION,
CONSTRUCTION OF CONCRETE SAFETY
BARRIER, CONSTRUCTION OF MVPS AND
REPLACEMENT OF BRIDGE APPROACH AND
DEPARTURE PAVEMENT SLABS FROM ROUTE
5/710 SEPARATION TO MAIN STREET
UNDERCROSSING**

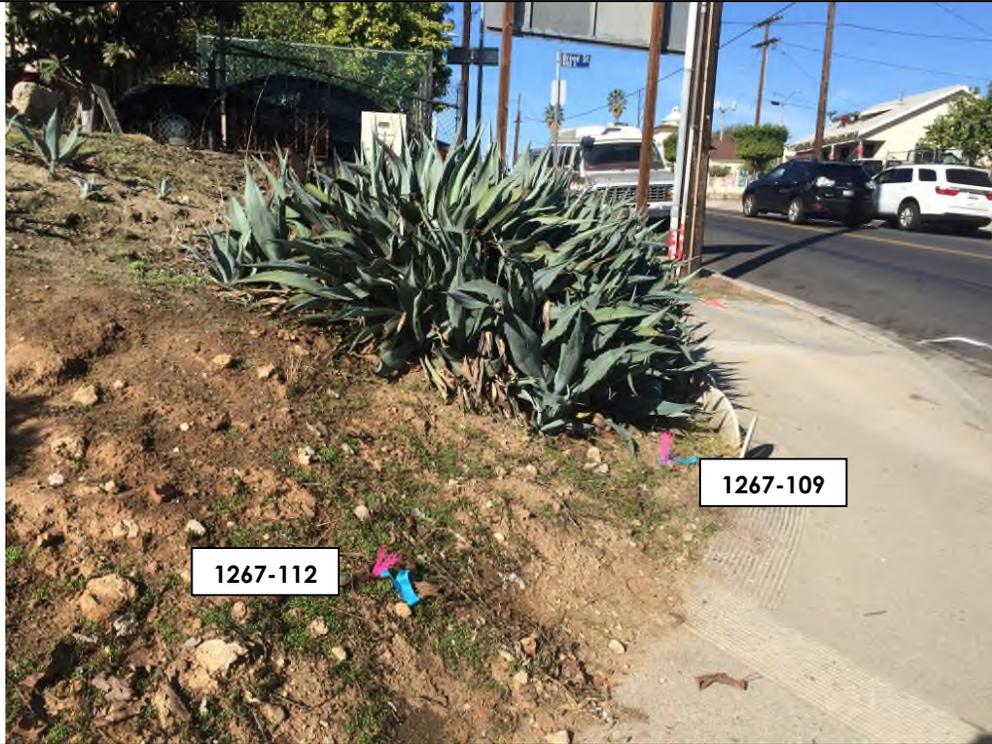
Photograph No. 7

Location 11 – On-Ramp from 7th /Breed Street (Right): View of location of borings 1267-109 and 1267-112 – Facing North.

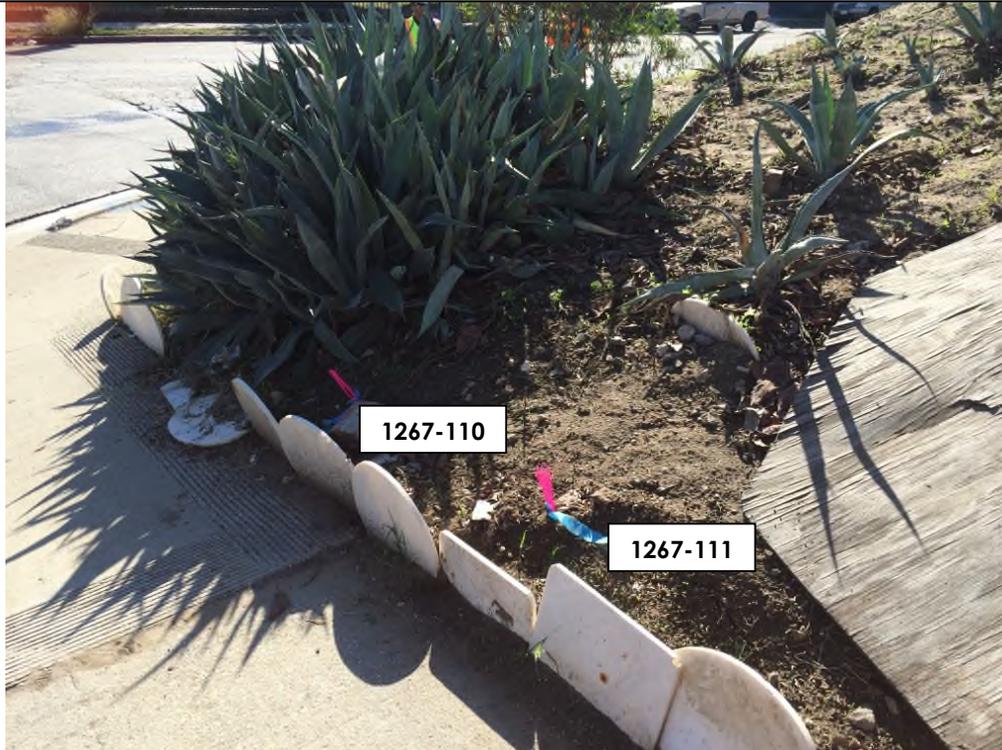
Photograph No. 8

Location 11 – On-Ramp from 7th /Breed Street (Right): View of location of borings 1267-110 and 1267-111 – Facing South

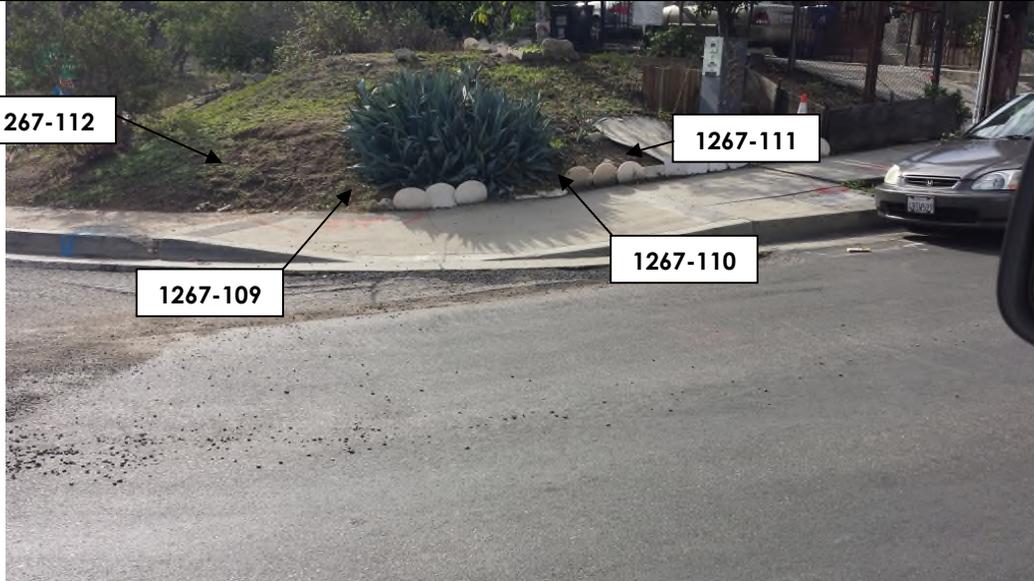
Photograph No. 9

Location 11 – On-Ramp from 7th /Breed Street (Right): View of location of borings 1267-109 through 1267-112 after soil sampling – Facing west.

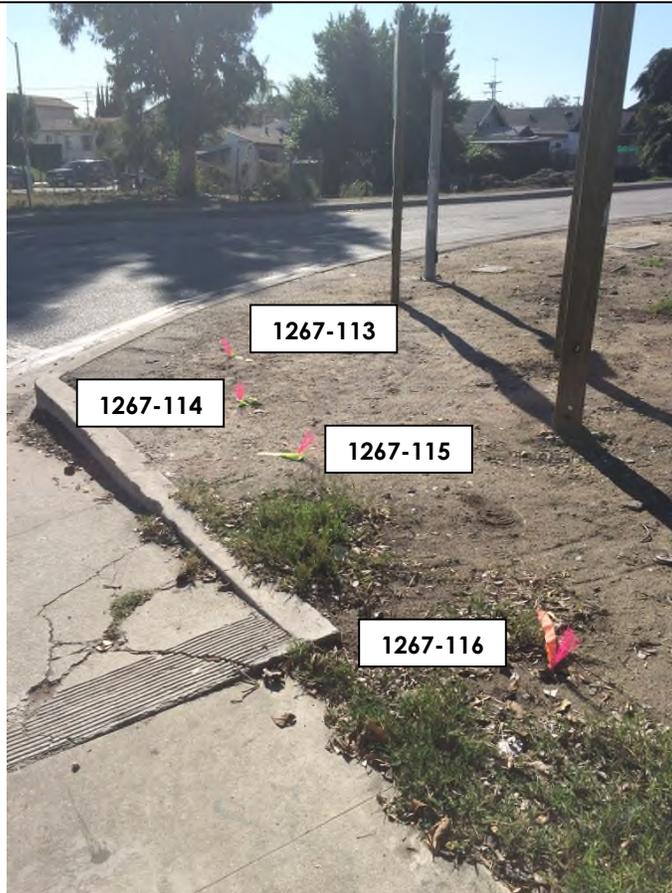
Photograph No. 10

Location 20 – On-Ramp from Marengo Street (Right): View of location of borings 1267-113 through 1267-116 – Facing Southeast.

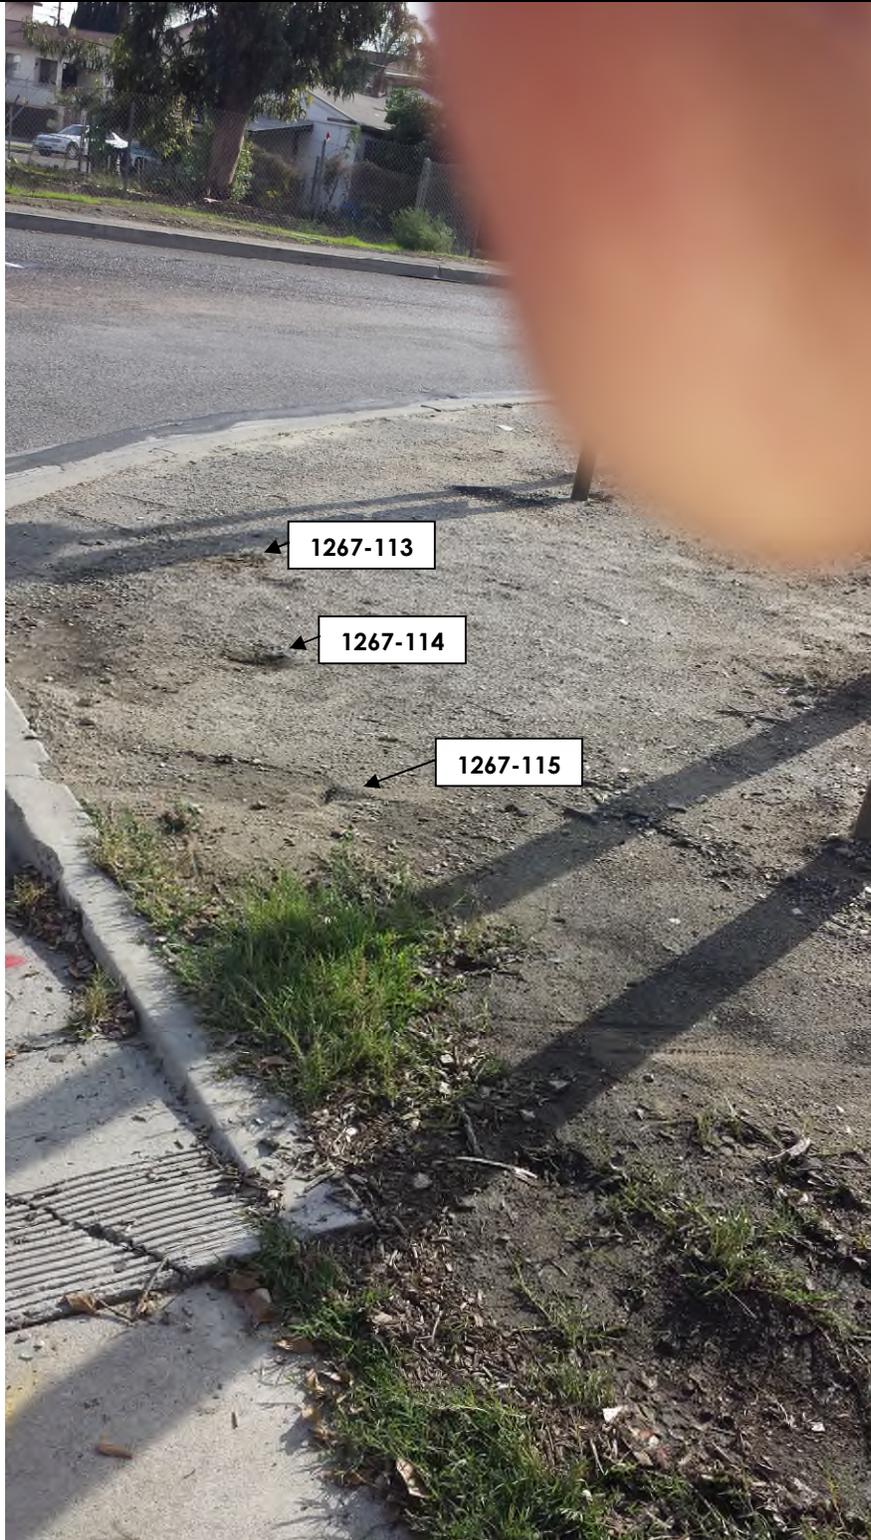
Photograph No. 11

Location 20 – On-Ramp from Marengo Street (Right): View of location of borings 1267-113 through 1267-115 after soil sampling – Facing Southeast.

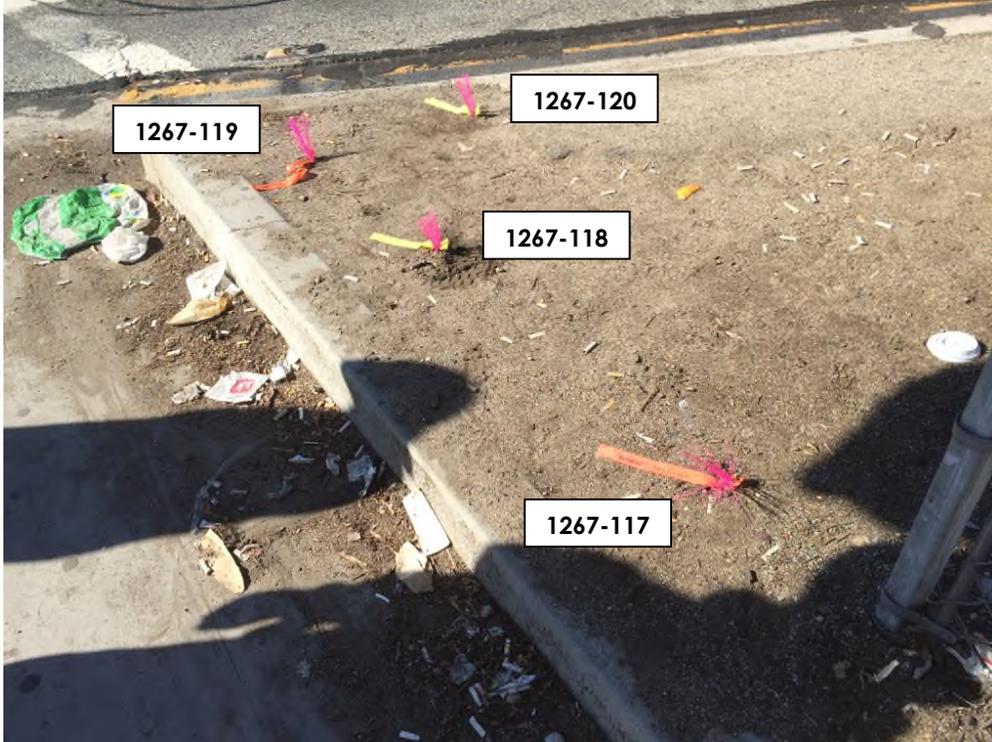
Photograph No. 12

Location 2 – Off-Ramp to Mission Road (Left): View of location of boring 1267-117 through 1267-120 – Facing West.

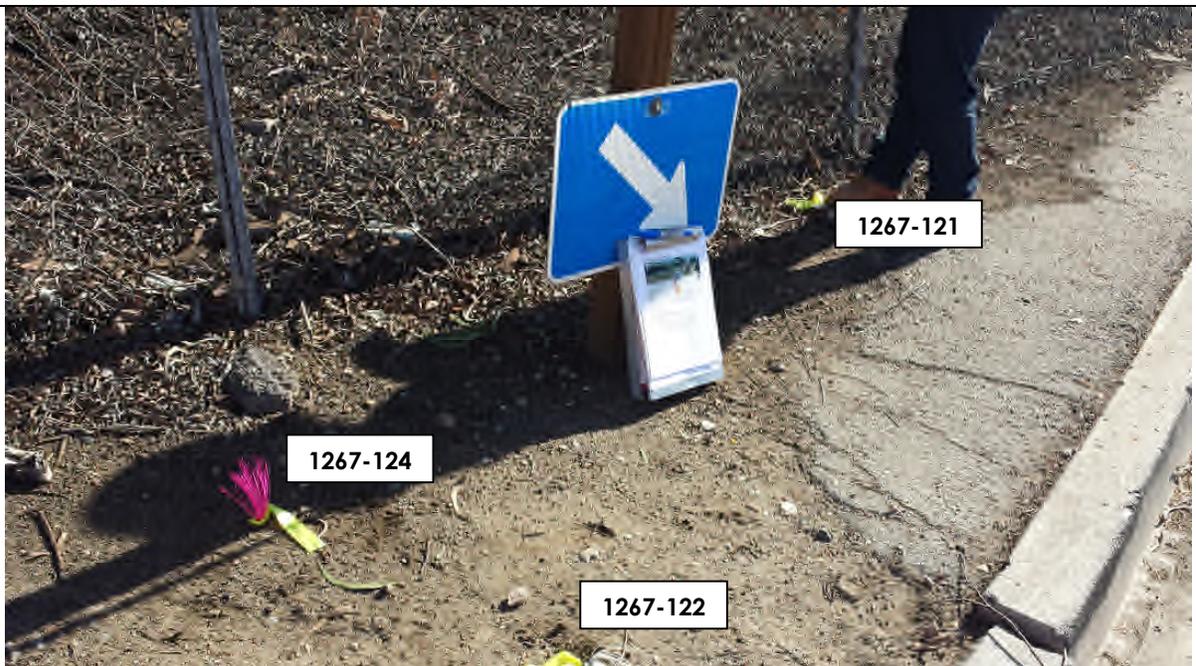
Photograph No. 13

Location 4 – On-Ramp to Mission Road (Left): View of location of borings 1267-121, 1267-124 and 1267-122 – Facing southeast.

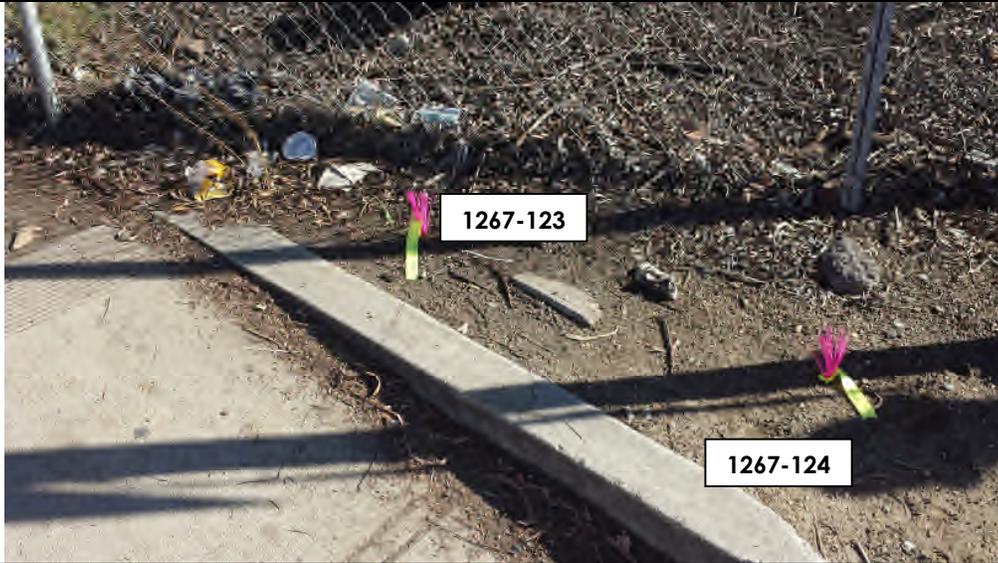
Photograph No. 14

Location 4 – On-Ramp from Mission Road (Left): View of location of borings 1267-123 and 1267-124 – from Above, facing Southeast.

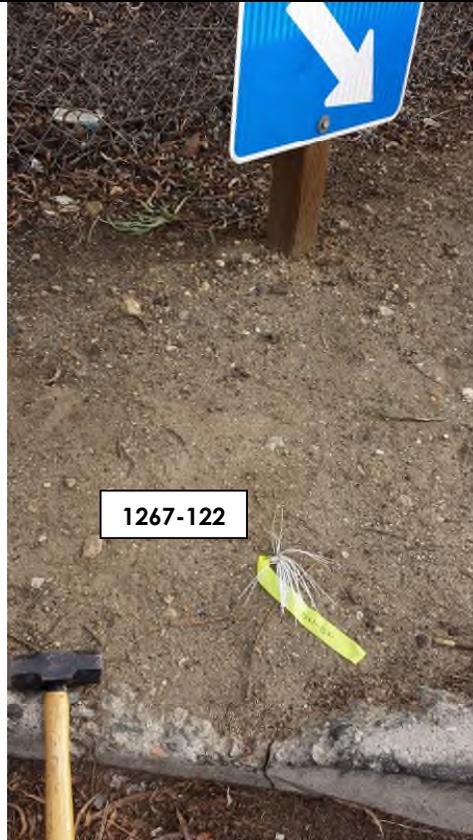
Photograph No. 15

Location 4 – On-Ramp from Mission Road (Left): View of location of boring 1267-122 – from Above, facing east.

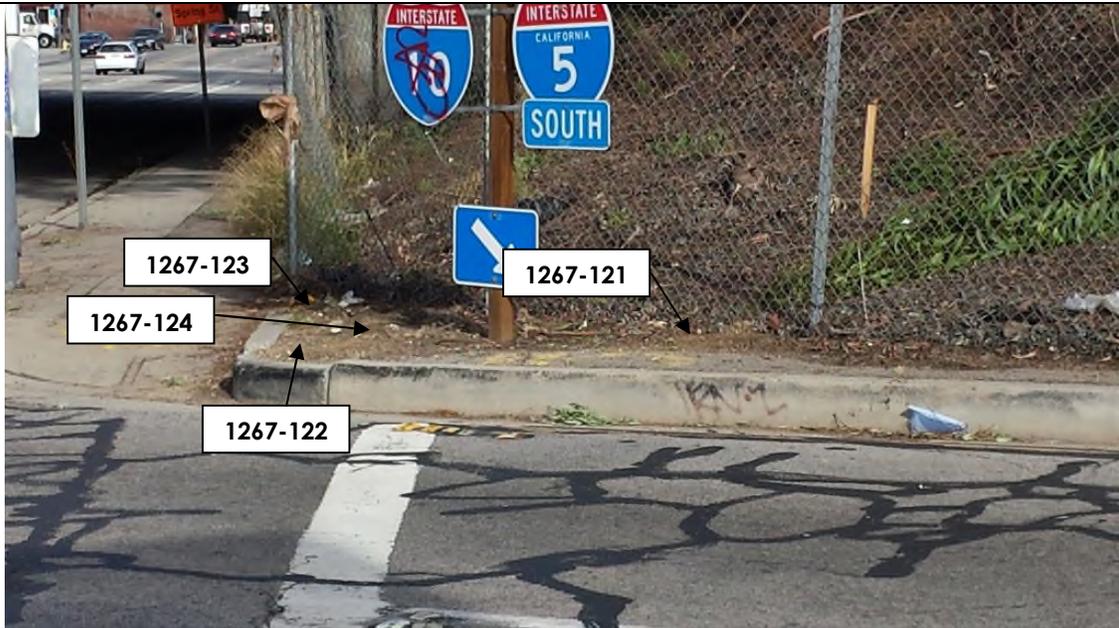
Photograph No. 16

Location 4 – On-Ramp from Mission Road (Left): View of location of borings 1267-121 through 1267-124 after soil sampling – Facing east.

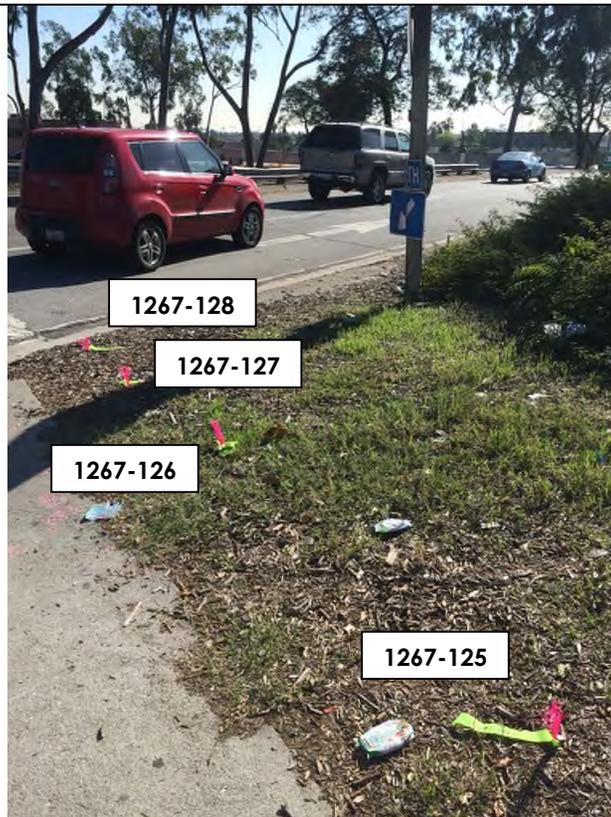
Photograph No. 17

Location 7 – On-Ramp from Cesar Chavez Avenue (Right): View of location of borings 1267-125 through 1267-128 – Facing Southeast.

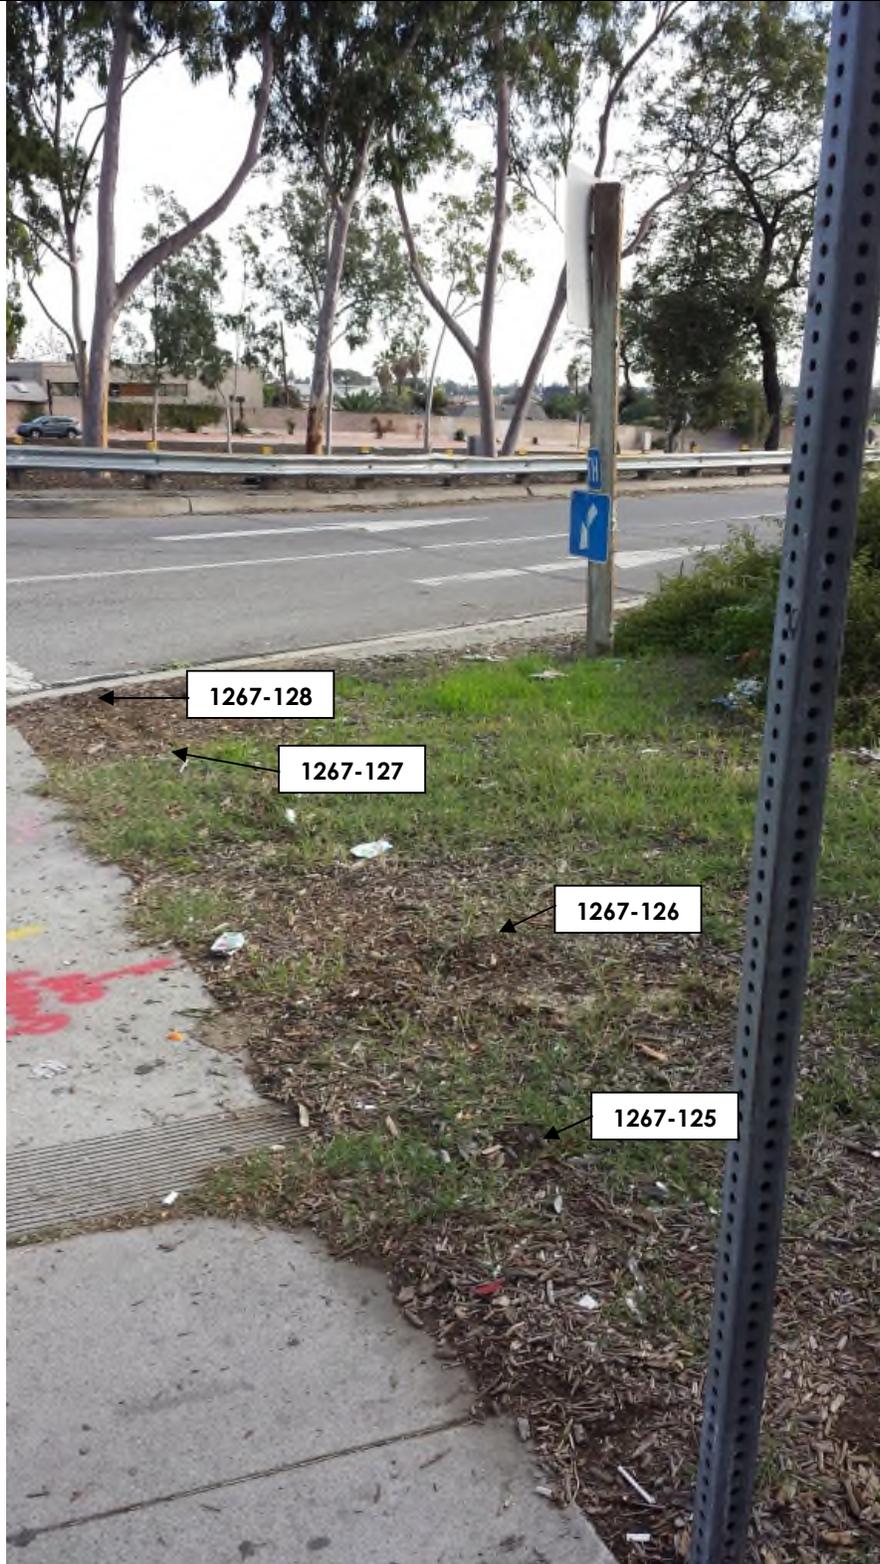
Photograph No. 18

Location 7 – On-Ramp from Cesar Chavez Avenue (Right): View of location of borings 1267-125 through 1267-128 – Facing Southeast.

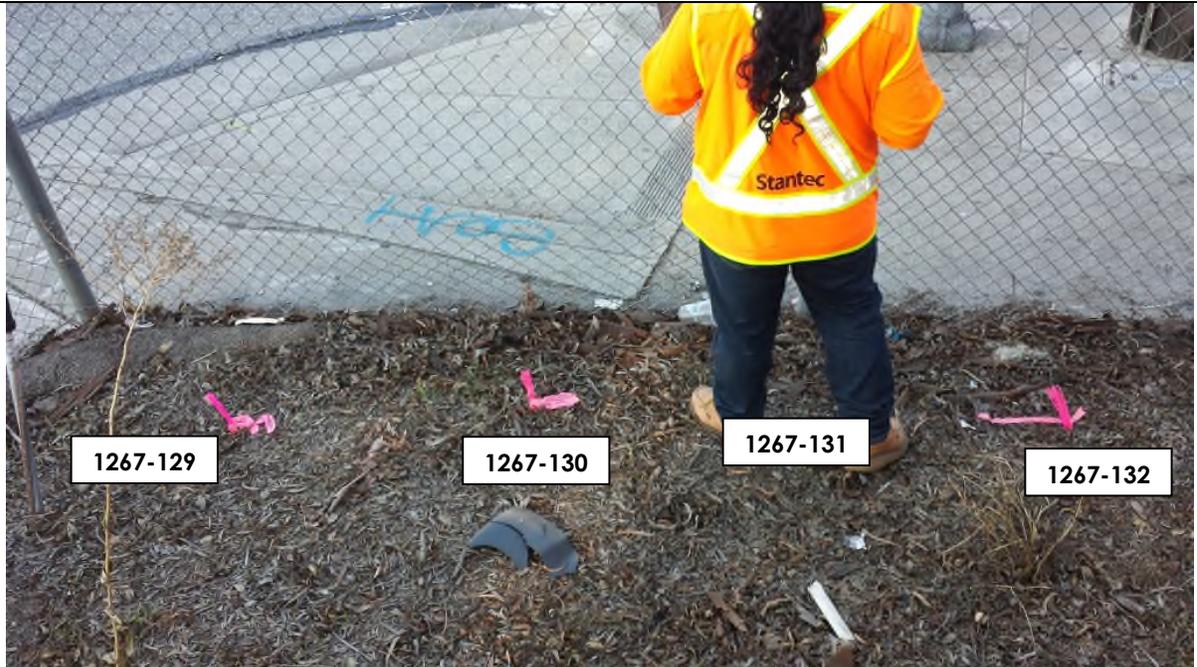
Photograph No. 19

Location 13 – On-Ramp from 4th Street (Left): View of location of borings 1267-129 through 1267-132 – Facing North.

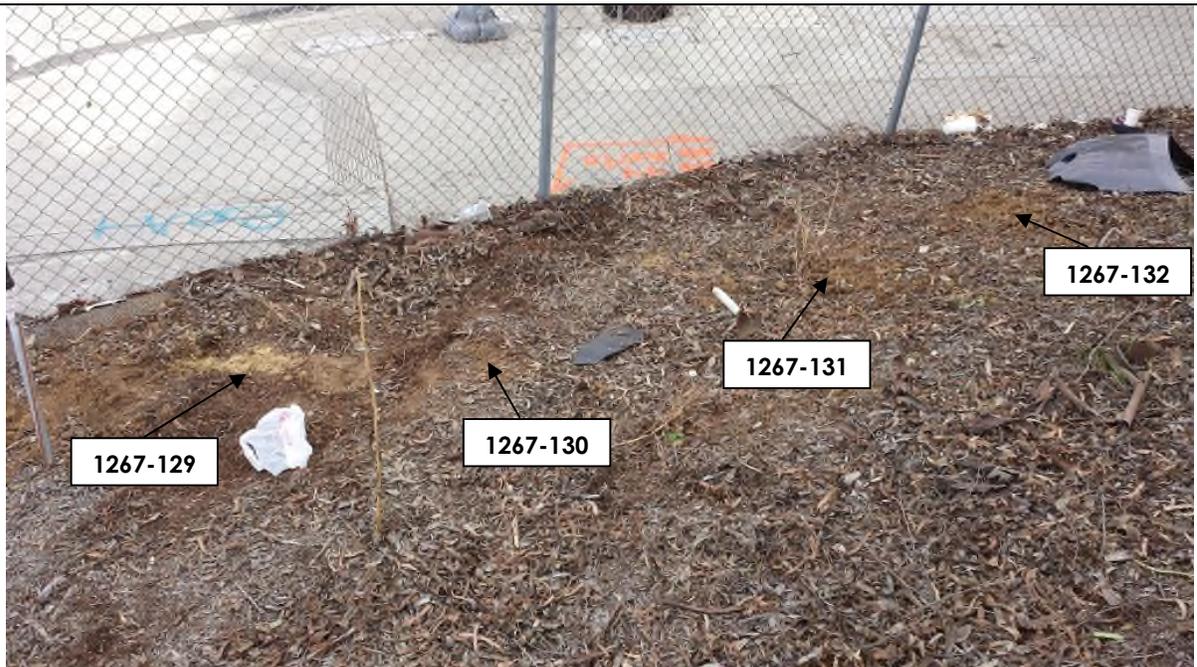
Photograph No. 20

Location 13 – On-Ramp from 4th Street (Left): View of location of borings 1267-129 through 1267-132 after soil sampling – Facing Northeast.

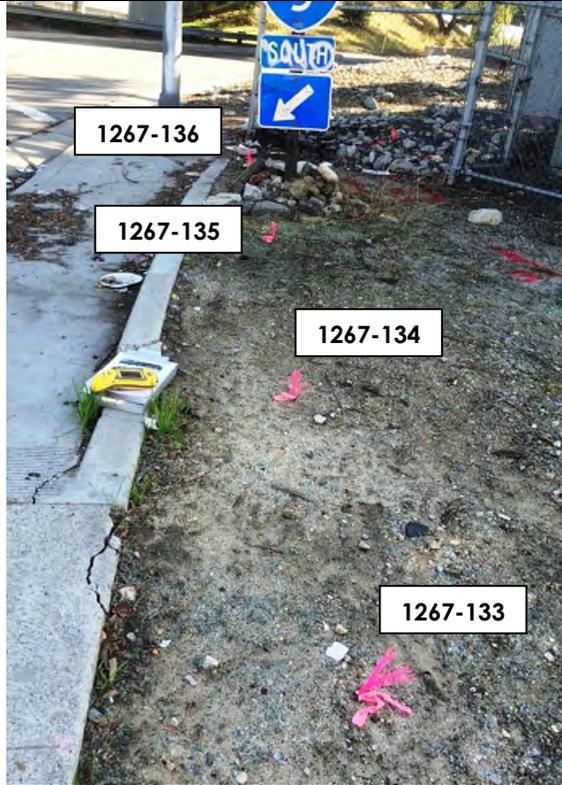
Photograph No. 21

Location 14 – On-Ramp from 7th Street (Right): View of location of borings 1267-133 through 1267-136 – Facing Southeast.

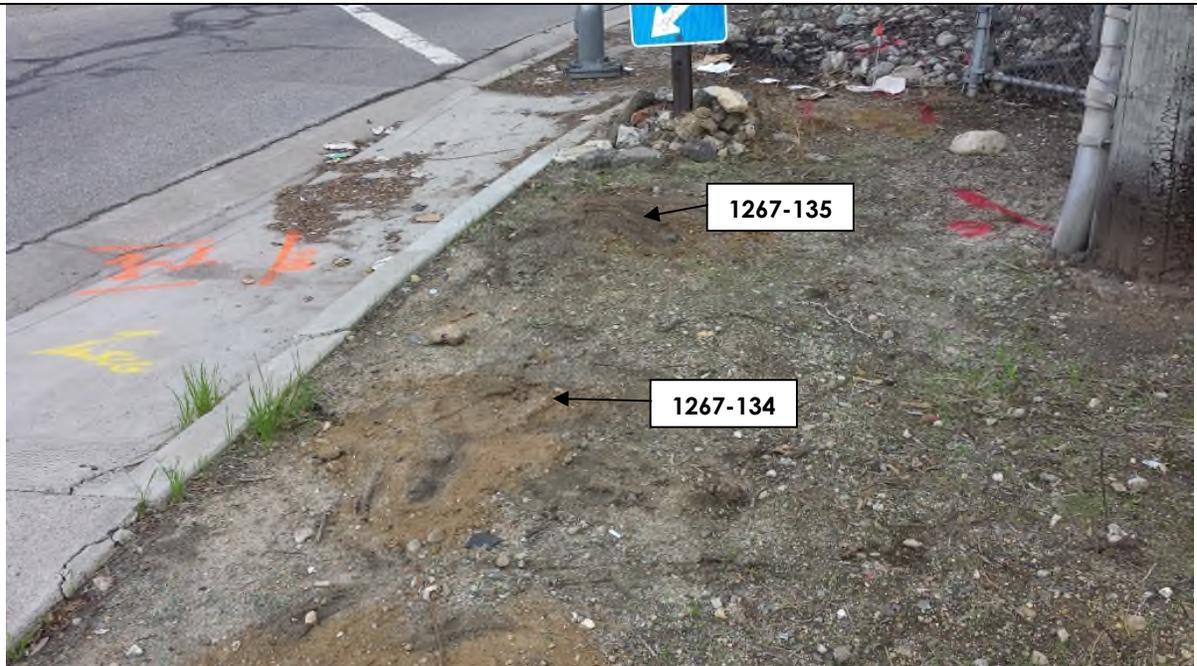
Photograph No. 22

Location 14 – On-Ramp from 7th Street (Right): View of location of borings 1267-134 and 1267-135 after soil sampling – Facing Southeast.

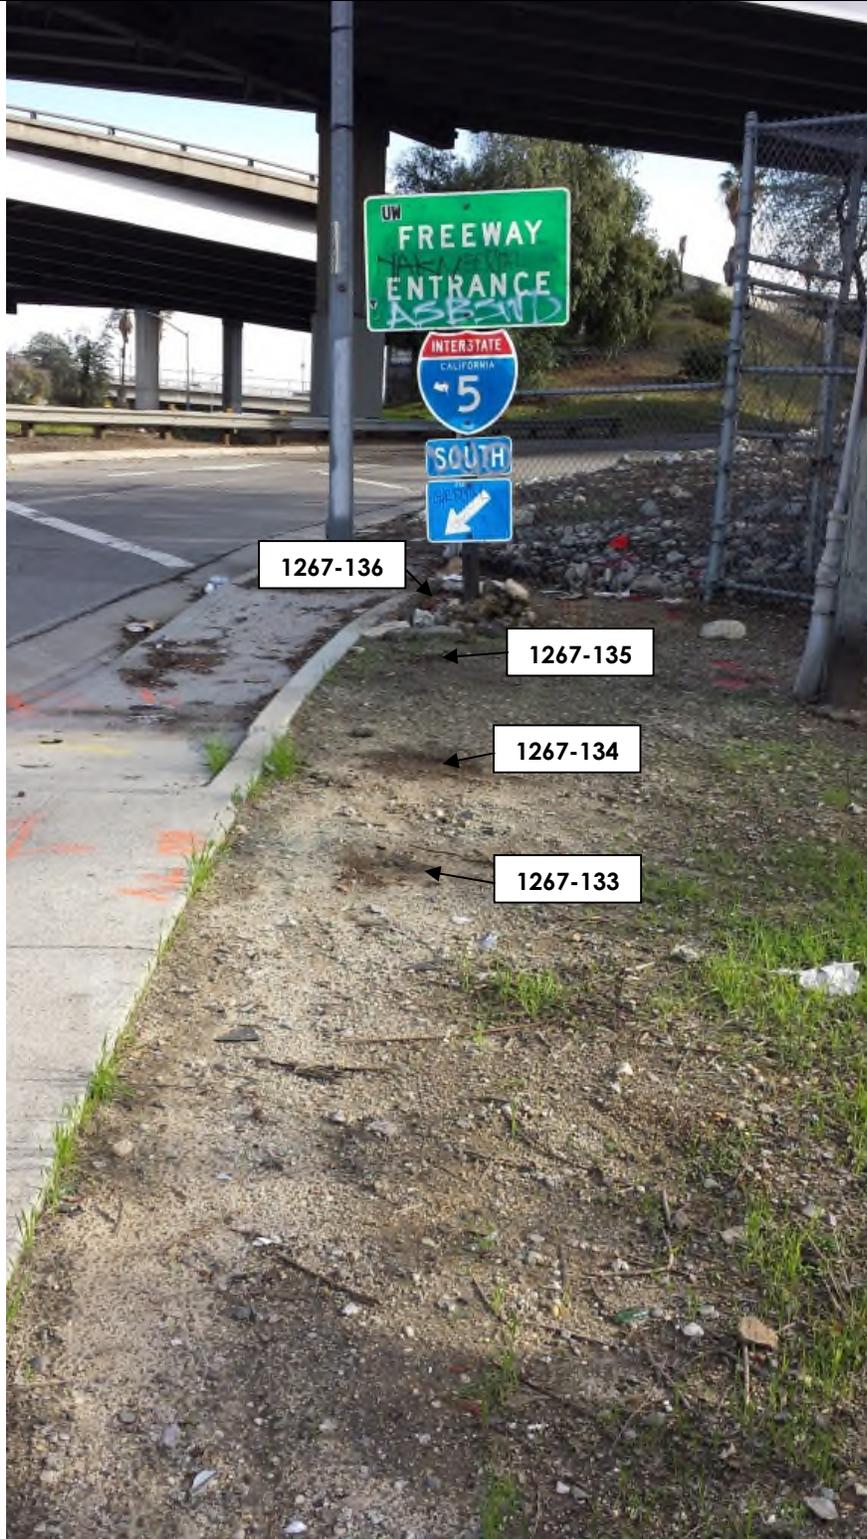
Photograph No. 23

Location 14 – On-Ramp from 7th Street (Right): View of location of borings 1267-133 through 1267-136 after soil sampling – Facing Southeast.

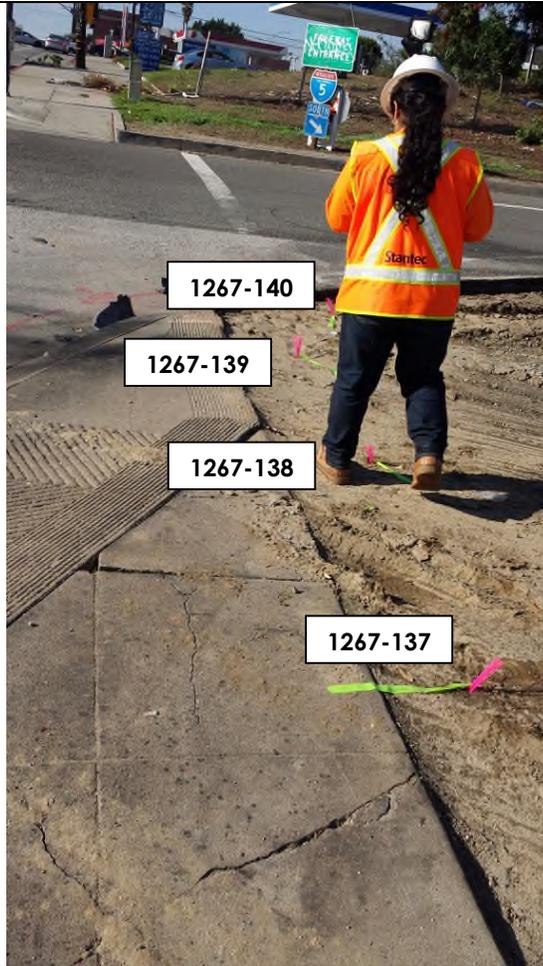
Photograph No. 24

Location 16 – On-Ramp from 8th Street (Right): View of location of borings 1267-137 through 1267-140 – Facing West.

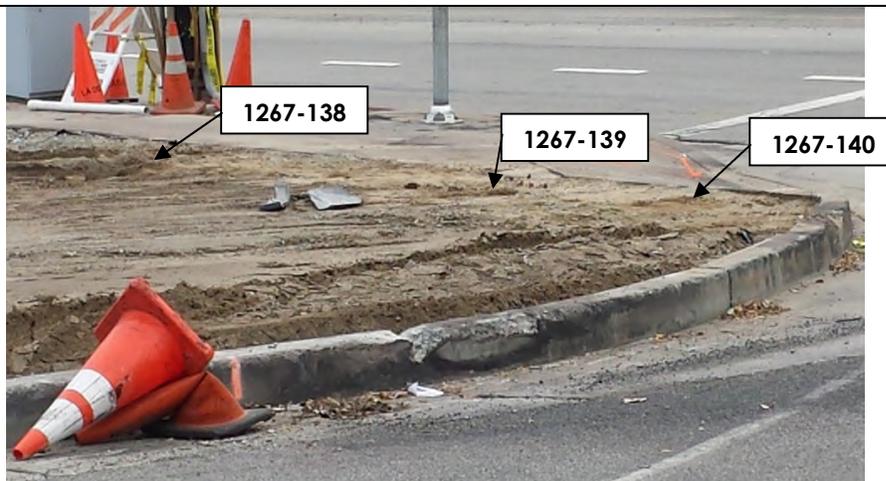
Photograph No. 25

Location 16 – On-Ramp from 8th Street (Right): View of location of borings 1267-138 through 1267-140 after sampling – Facing Southeast.

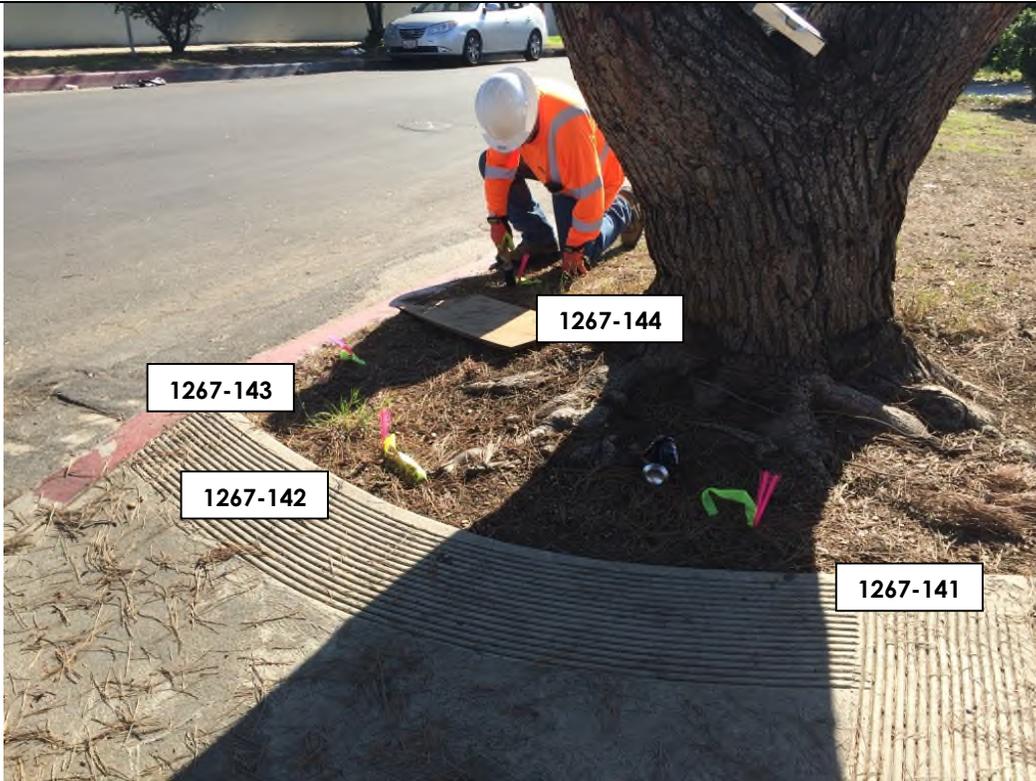
Photograph No. 26

Location 21 – On-Ramp from Concord Street (Left): View of location of borings 1267-141 through 1267-144 – Facing Southeast.

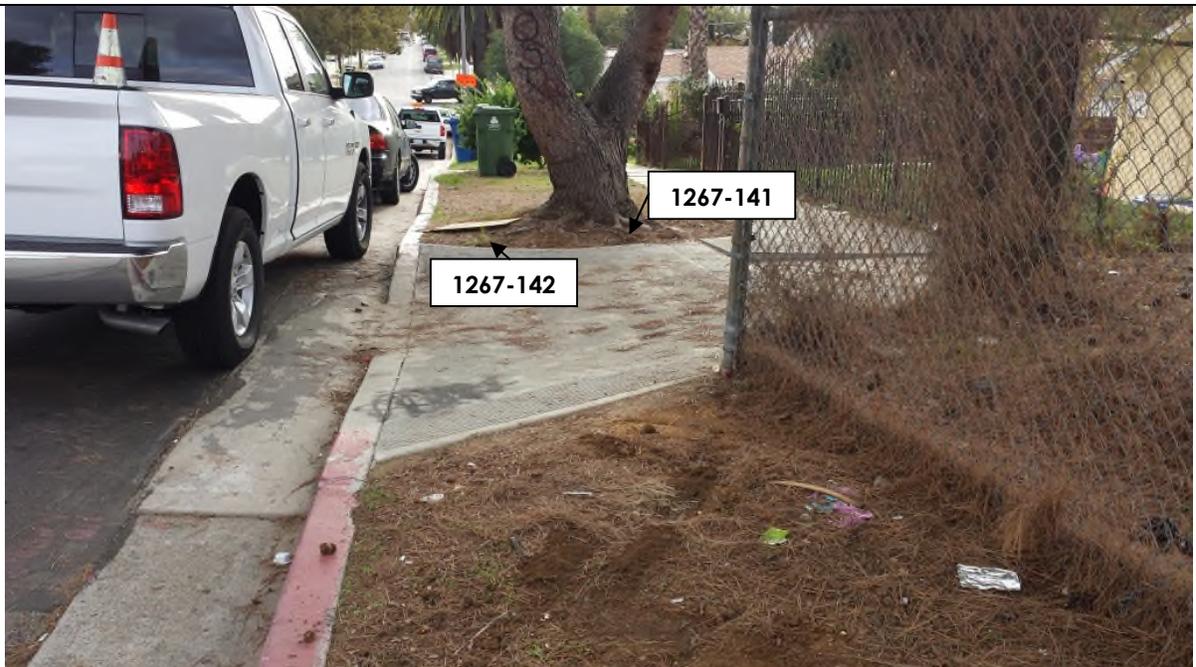
Photograph No. 27

Location 21 – On-Ramp from Concord Street (Left): View of location of borings 1267-141 and 1267-142 after soil sampling – Facing South.

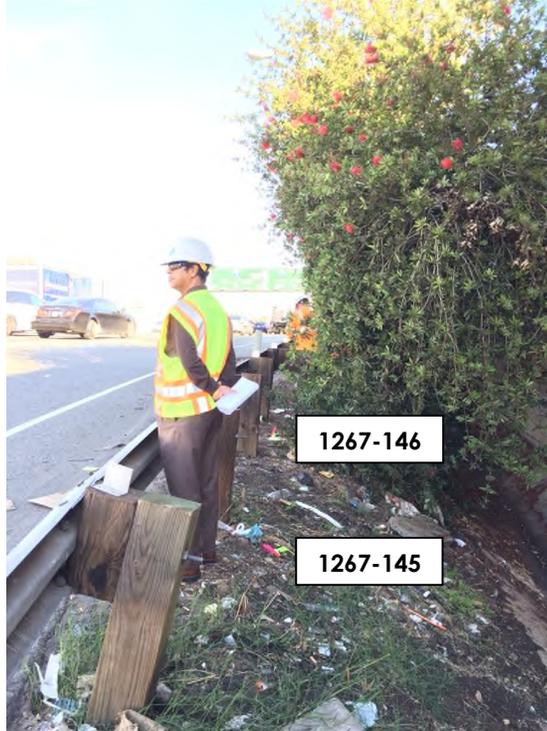
Photograph No. 28

Concrete Barrier– Along Route 5 (S. Ditman Avenue On-Ramp): View of location of borings 1267-145 and 1267-146 – Facing East.

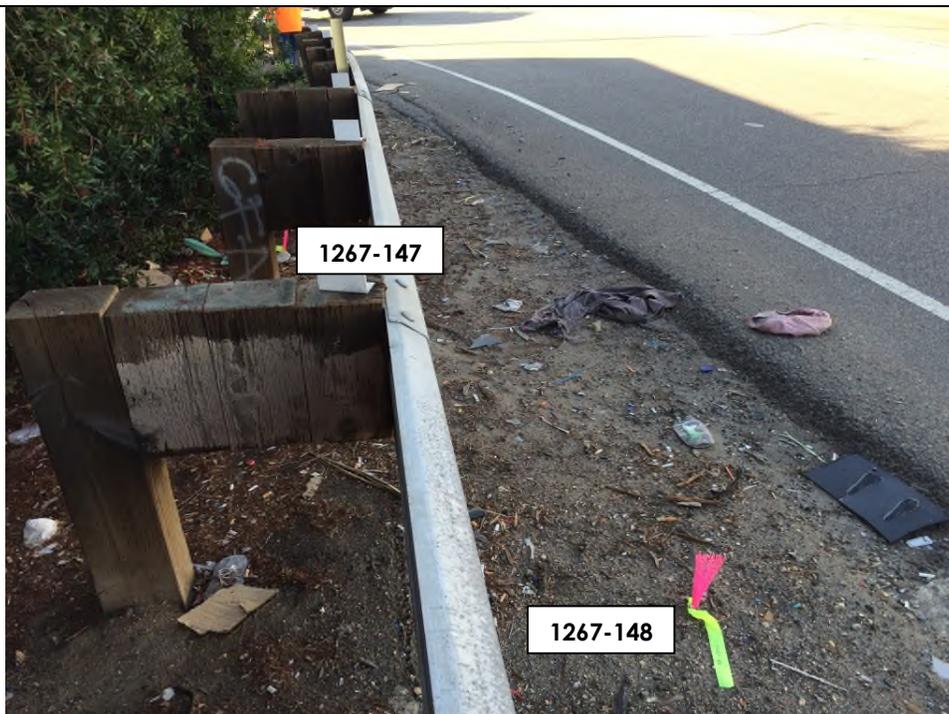
Photograph No. 29

Concrete Barrier– Along Route 5 (S. Ditman Avenue On-Ramp): View of location of borings 1267-147 and 1267-148 – Facing West.

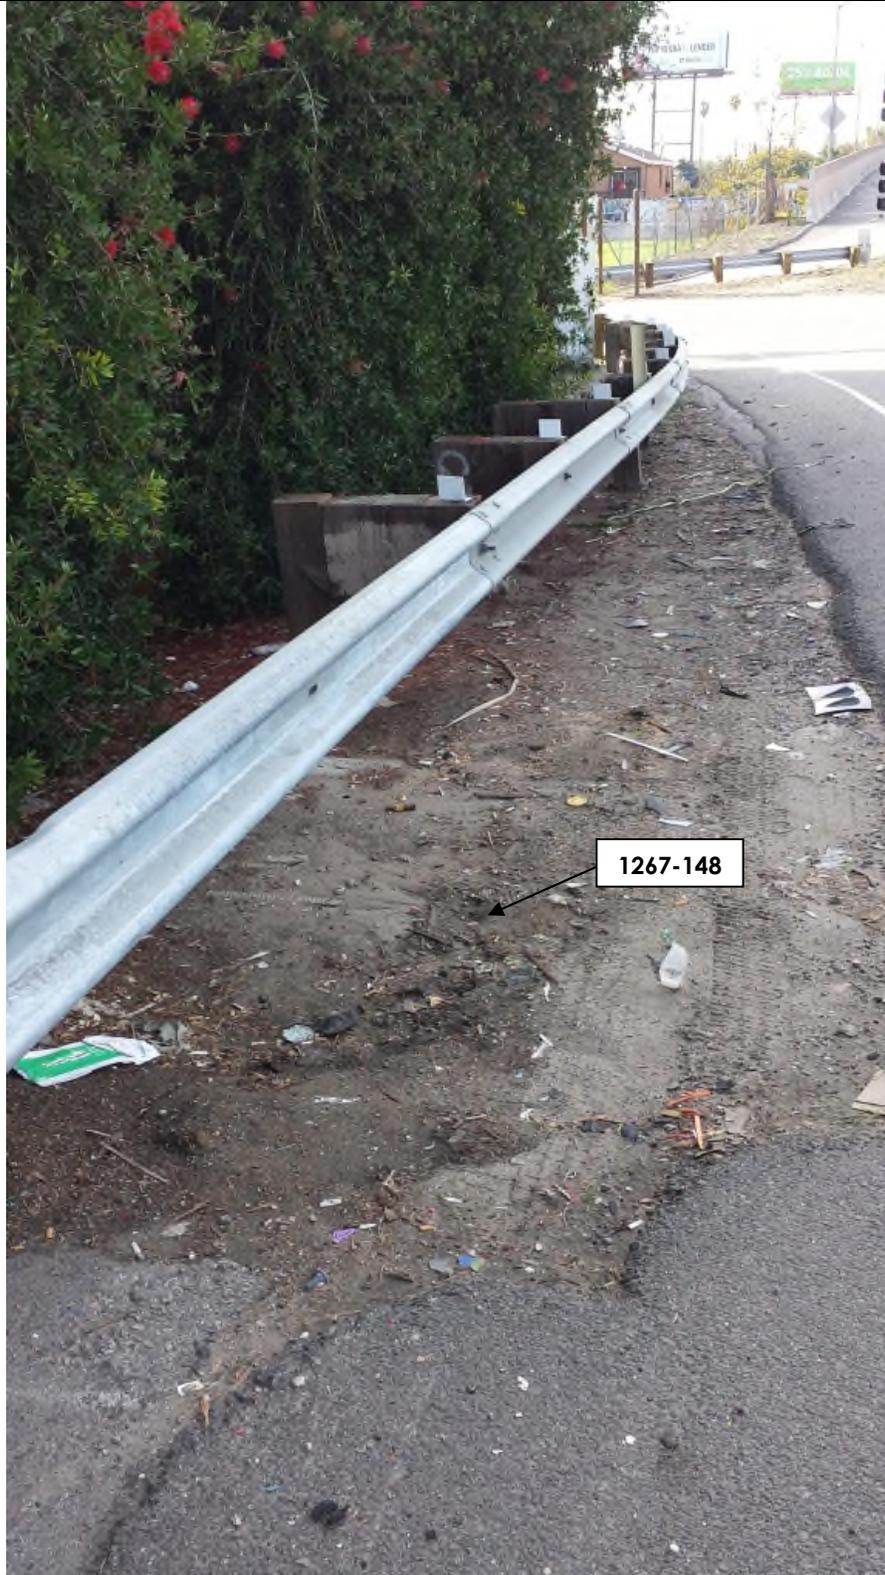
Photograph No. 30

Concrete Barrier– Along Route 5 (S. Ditman Avenue On-Ramp): View of location of borings 1267-148 after sampling – Facing West.

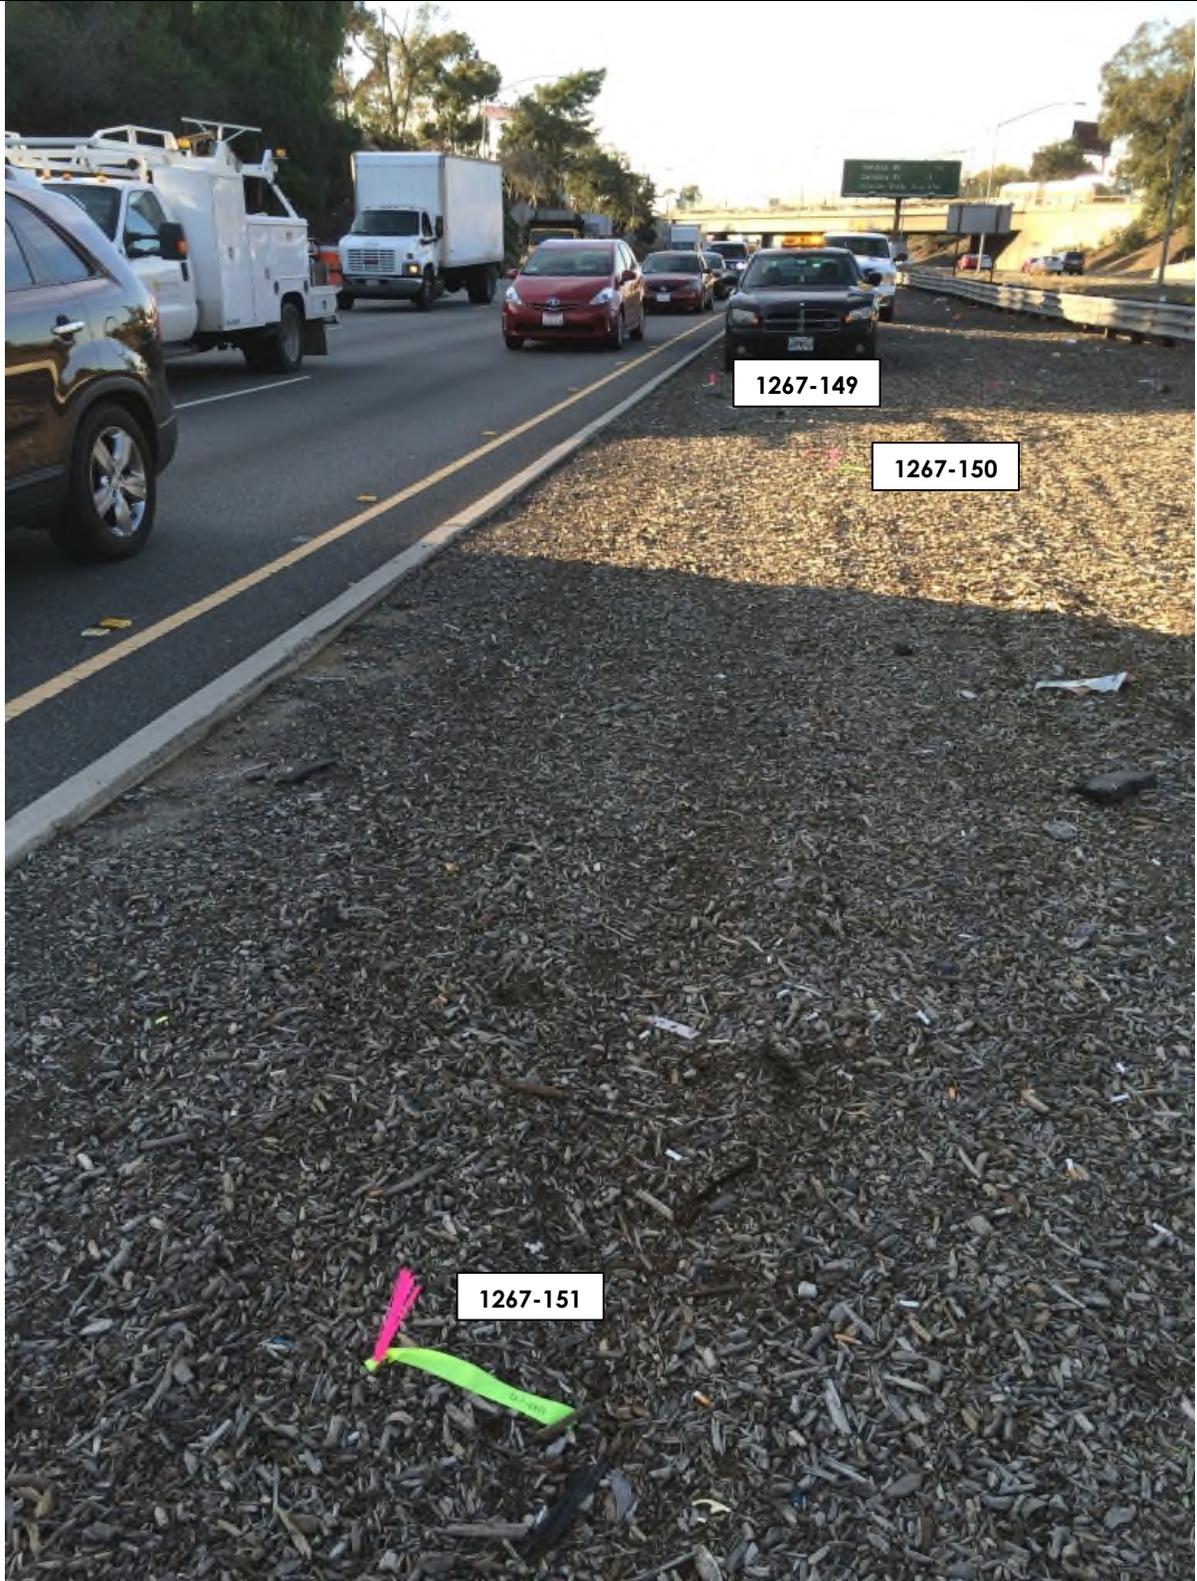
Photograph No. 31

MVP Southbound: View of location of borings 1267-149 through 1267-151 – Facing West.

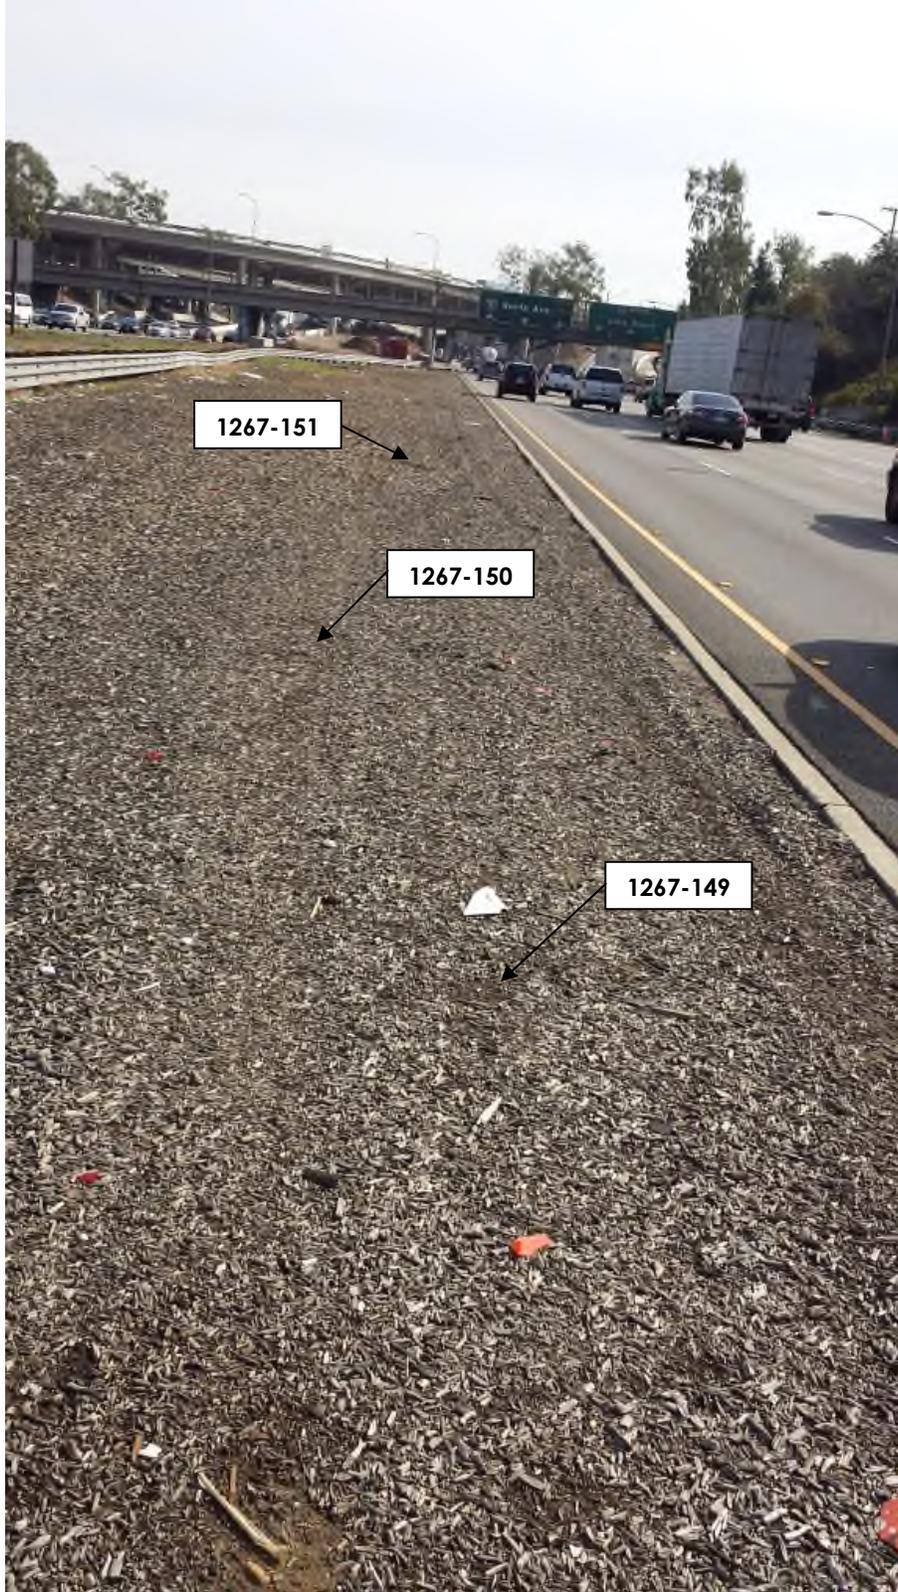
Photograph No. 32

MVP Southbound: View of location of borings 1267-149 through 1267-151 after sampling – Facing East.
