INFORMATION HANDOUT

For Contract No. 07-300704

Aerially Deposited Lead Site Report

**PAVEMENT REHABILITATION PROJECT- ADA
CURB RAMP RECONSTRUCTION,
CONSTRUCTION OF CONCRETE SAFETY
BARRIER, CONSTRUCTION OF MVPS AND
REPLACEMENT OF BRIDGE APPROACH AND
DEPARTURE PAVEMENT SLABS FROM ROUTE
5/710 SEPARATION TO MAIN STREET
UNDERCROSSING**

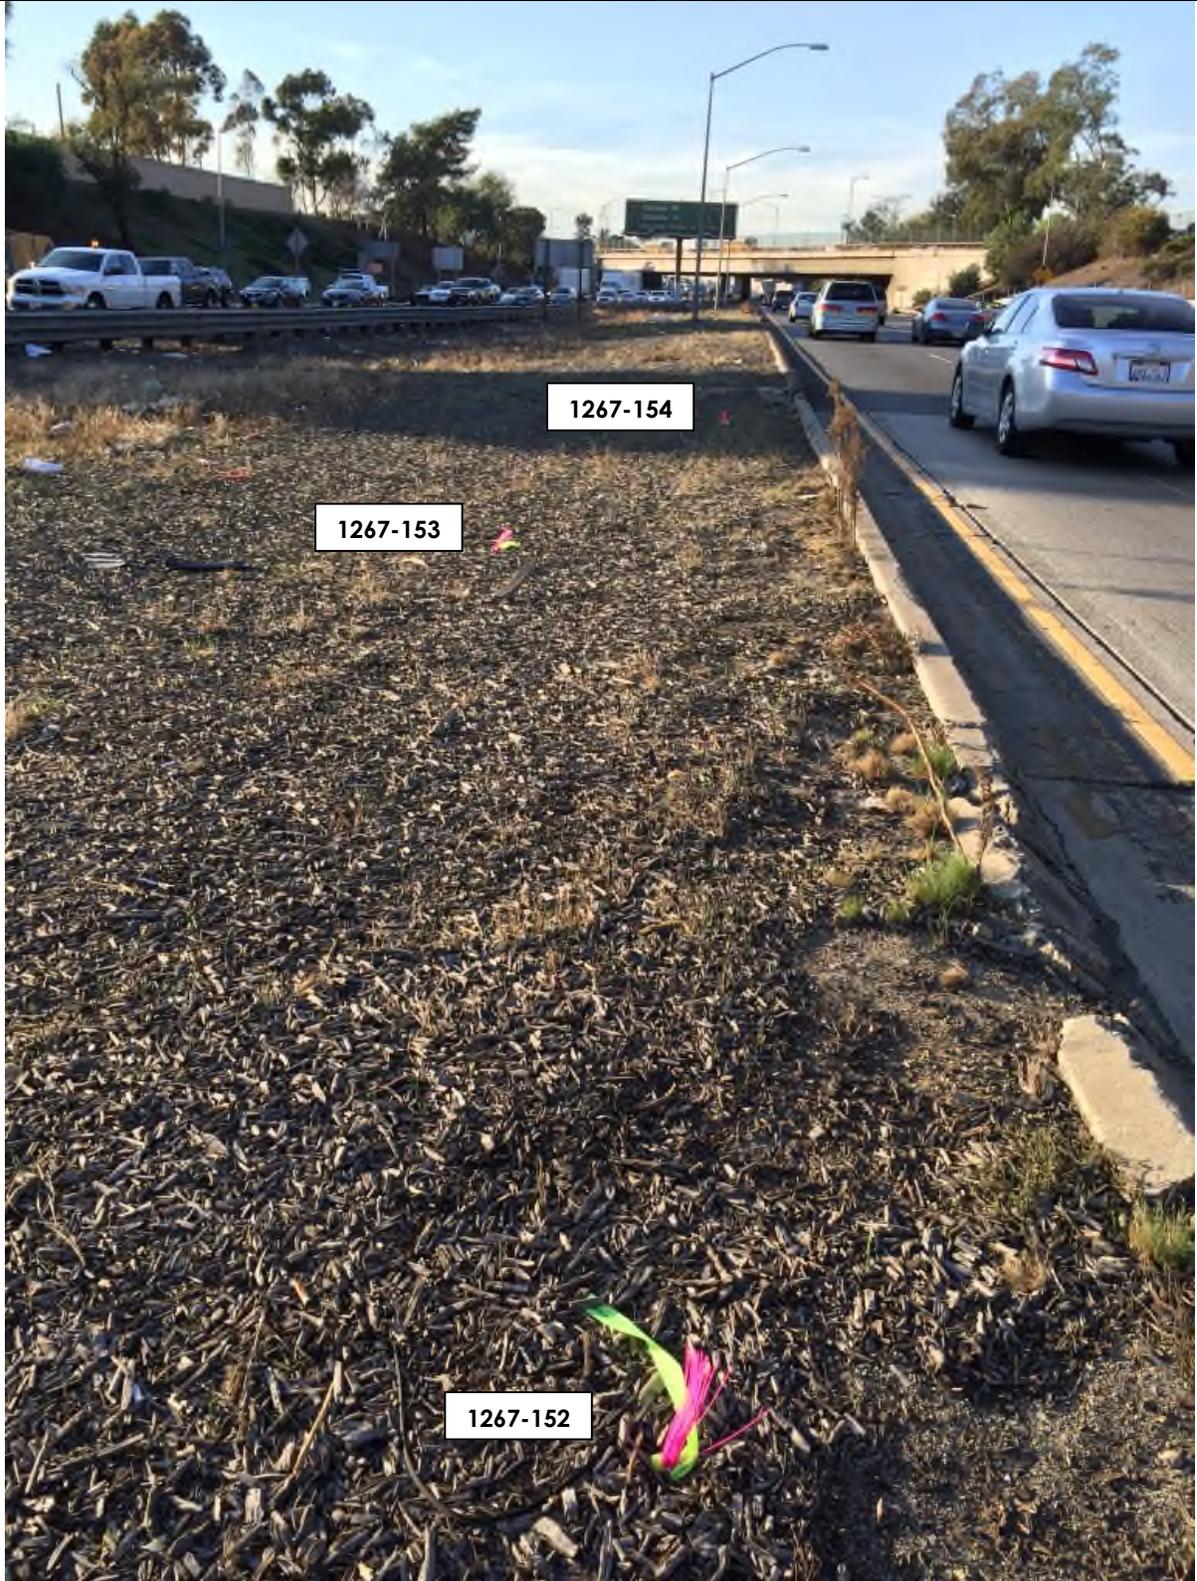
Photograph No. 33

MVP Northbound: View of location of borings 1267-152 through 1267-154 – Facing West.

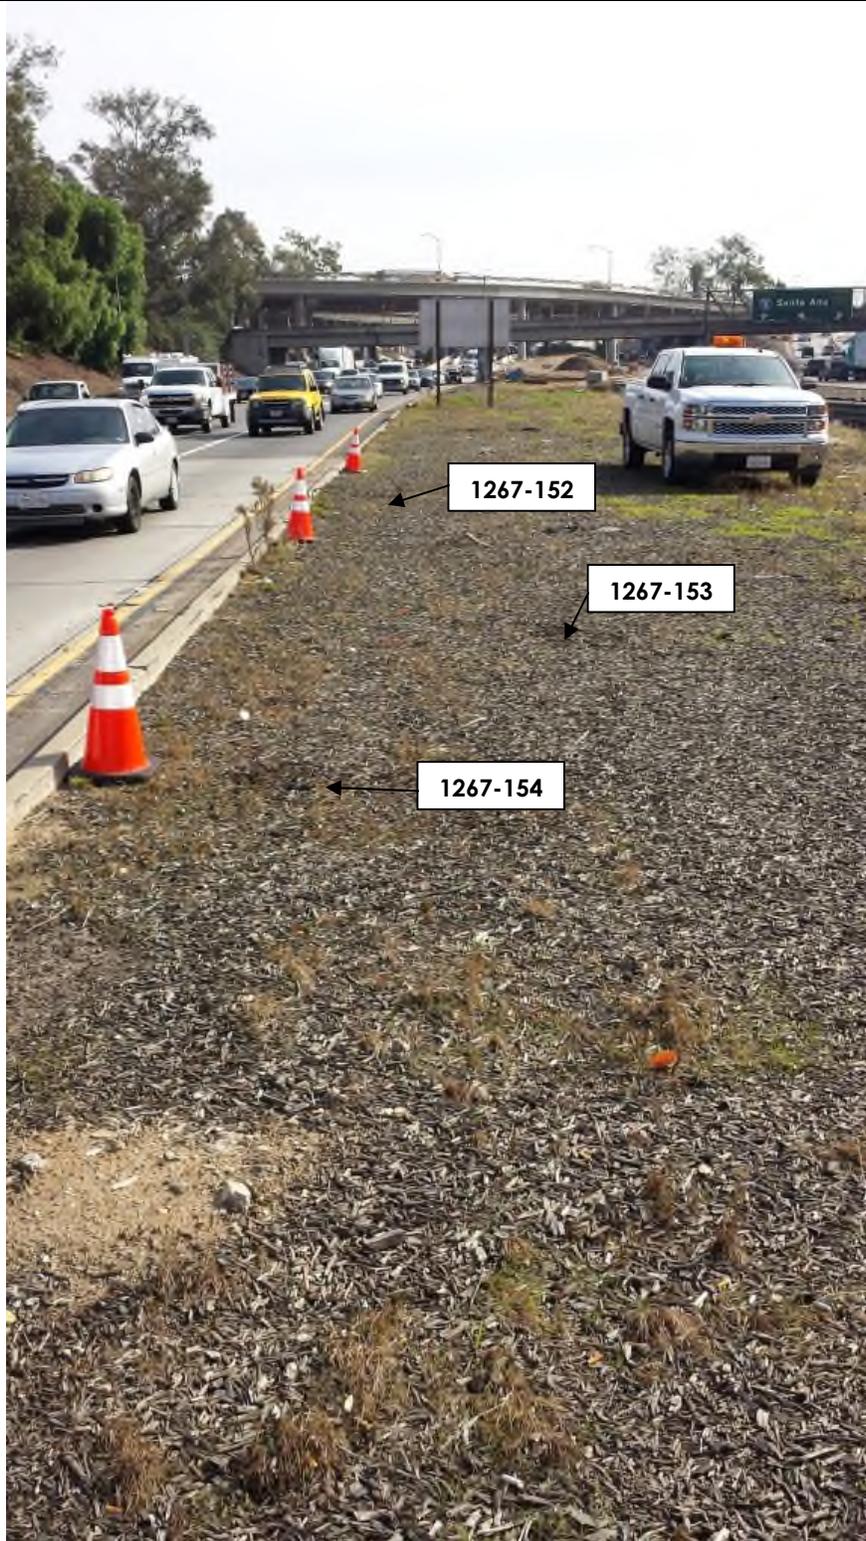
Photograph No. 34

MVP Northbound: View of location of borings 1267-152 through 1267-154 after soil sampling – Facing East.
