INFORMATION HANDOUT

**For Contract No. 11-288814
At 11-SD-11,125,905-variable**

**Identified by
Project ID 1113000167**

1. Preliminary Foundation Report for Otay Mesa Road Undercrossing, Caltrans Bridge Nos 571202R/L, State Route 125, Kilometer Post 1.09, San Diego County, California, dated September 27, 2007
2. Hazardous Materials Review, dated August 28, 2013
3. Laboratory Test Result Report, dated November 22, 2013
4. Letter from Otay Water District, dated July 23, 2014
5. Foundation Report for Otay Mesa Road Undercrossing, dated December 19, 2013
6. Materials Information Brochure, dated December 20, 2013
7. Geotechnical Design Report for State Route 905/State Route 125 Northbound Connectors Project, dated February 04, 2014
8. Underground Classification, No. C122-073-14T, dated April 8, 2014
9. Geotechnical Design Report for State Route 11/125/905 NB Connectors Project Addendum, dated July 18, 2014
10. Optional Imported Borrow Site Exhibit

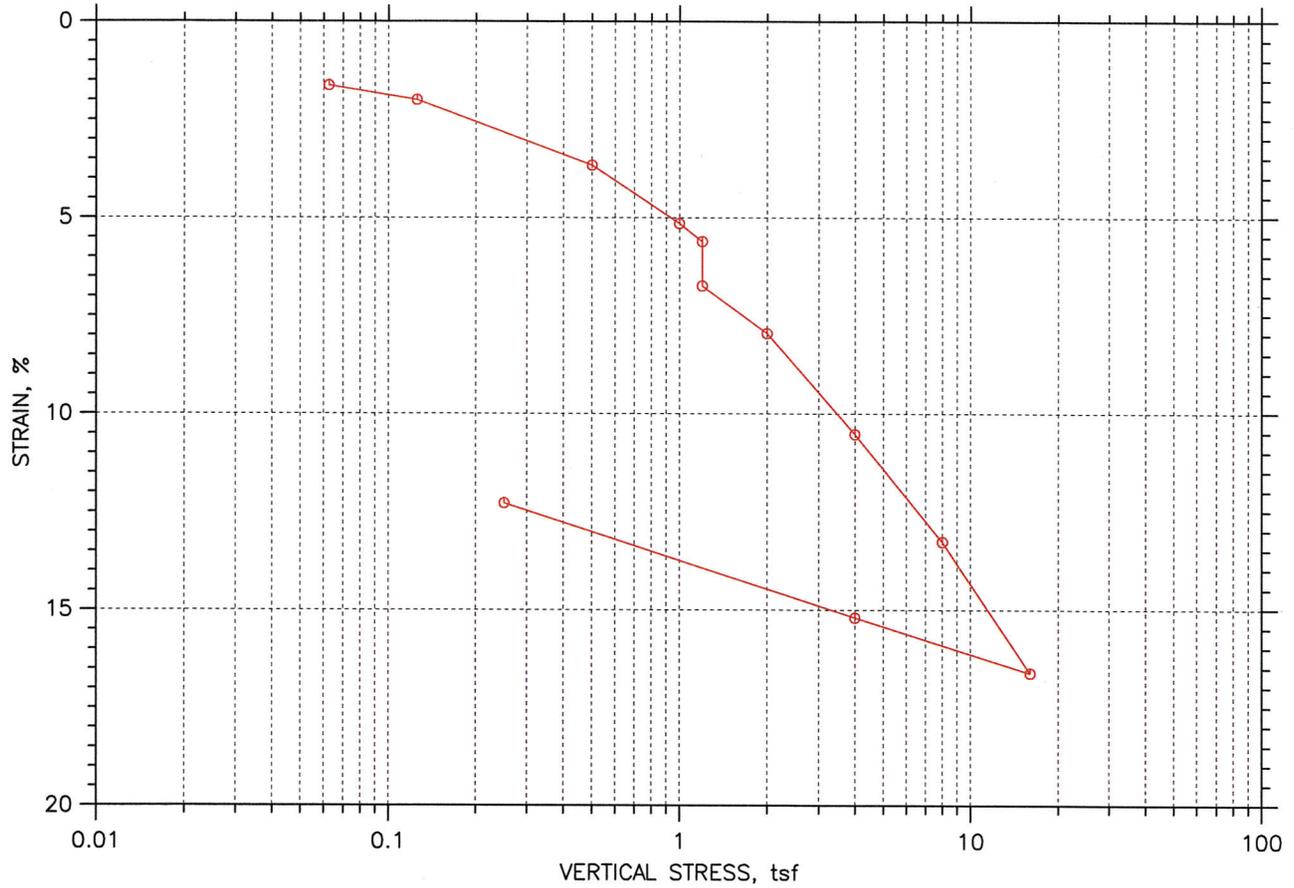
SUMMARY REPORT

Project: Otay Mesa Road UC	Location: 11-SD-125-0.9-	Project No.: 11-288811
Boring No.: RC-13-001	Tested By: jg	Checked By:
Sample No.: 09	Test Date: 11/18/13	Depth: -----
Test No.: 13-007-G3	Sample Type: 2"core/soil	Elevation: 13-068
Description: Moist: Gray: Sand silty		
Remarks: Swell V inundated @ 2400 psf

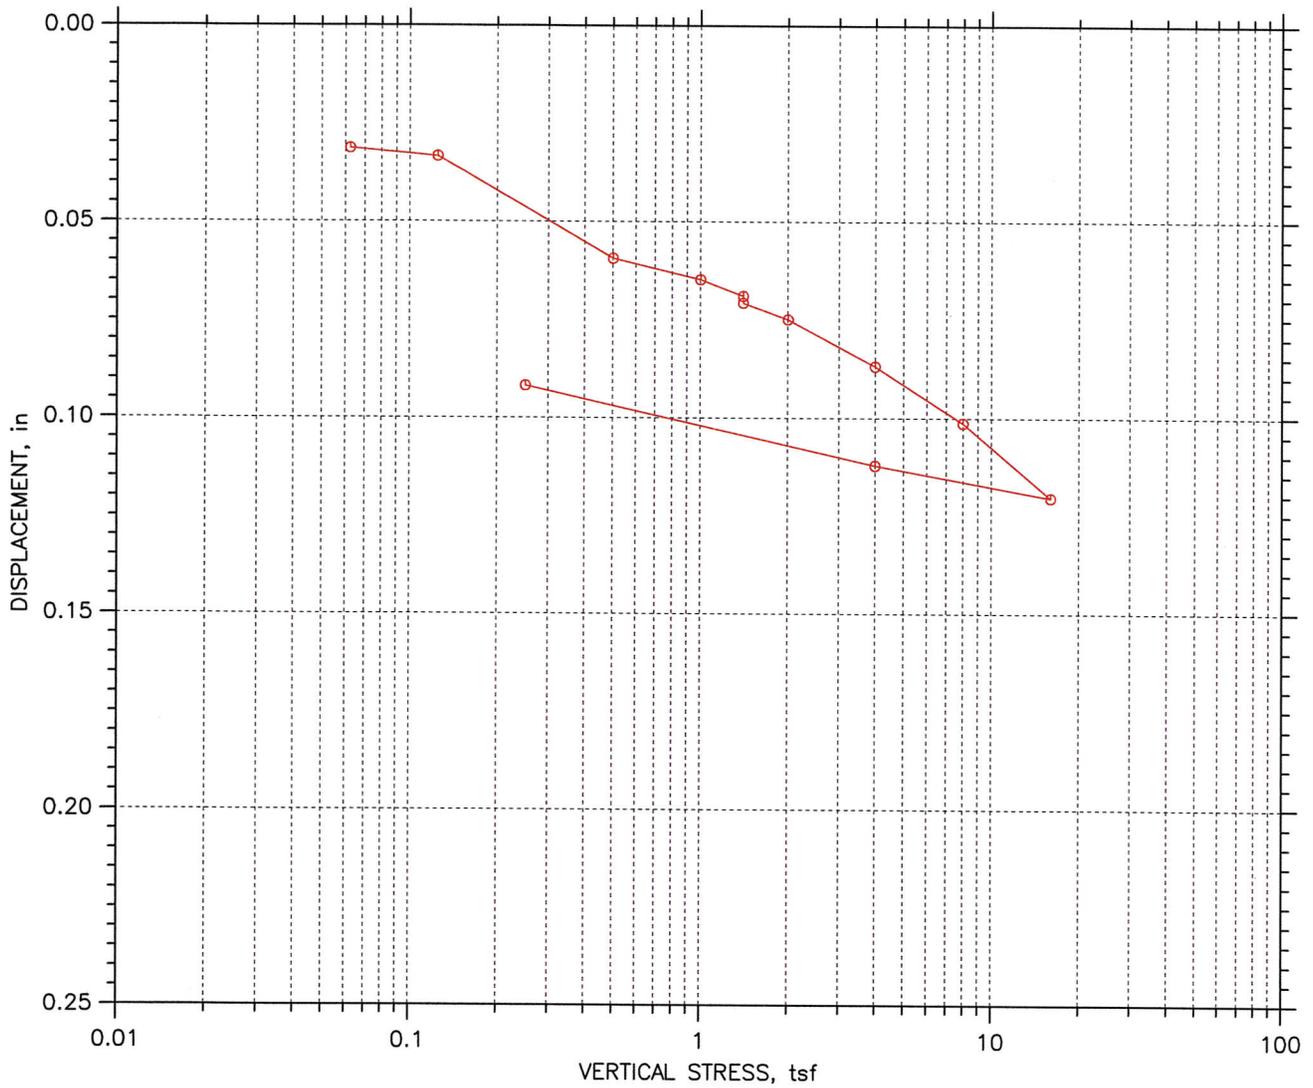
SUMMARY REPORT

Before Test	After Test
Overburden Pressure: 0 tsf		28.49	28.00
Preconsolidation Pressure: 0 tsf		88.74	97.72
Compression Index: 3.81959e-313		82.57	99.87
Diameter: 2.375 in	Height: 1 in	0.96	0.78
LL: ---	PL: ---		
PI: ---	GS: 2.79

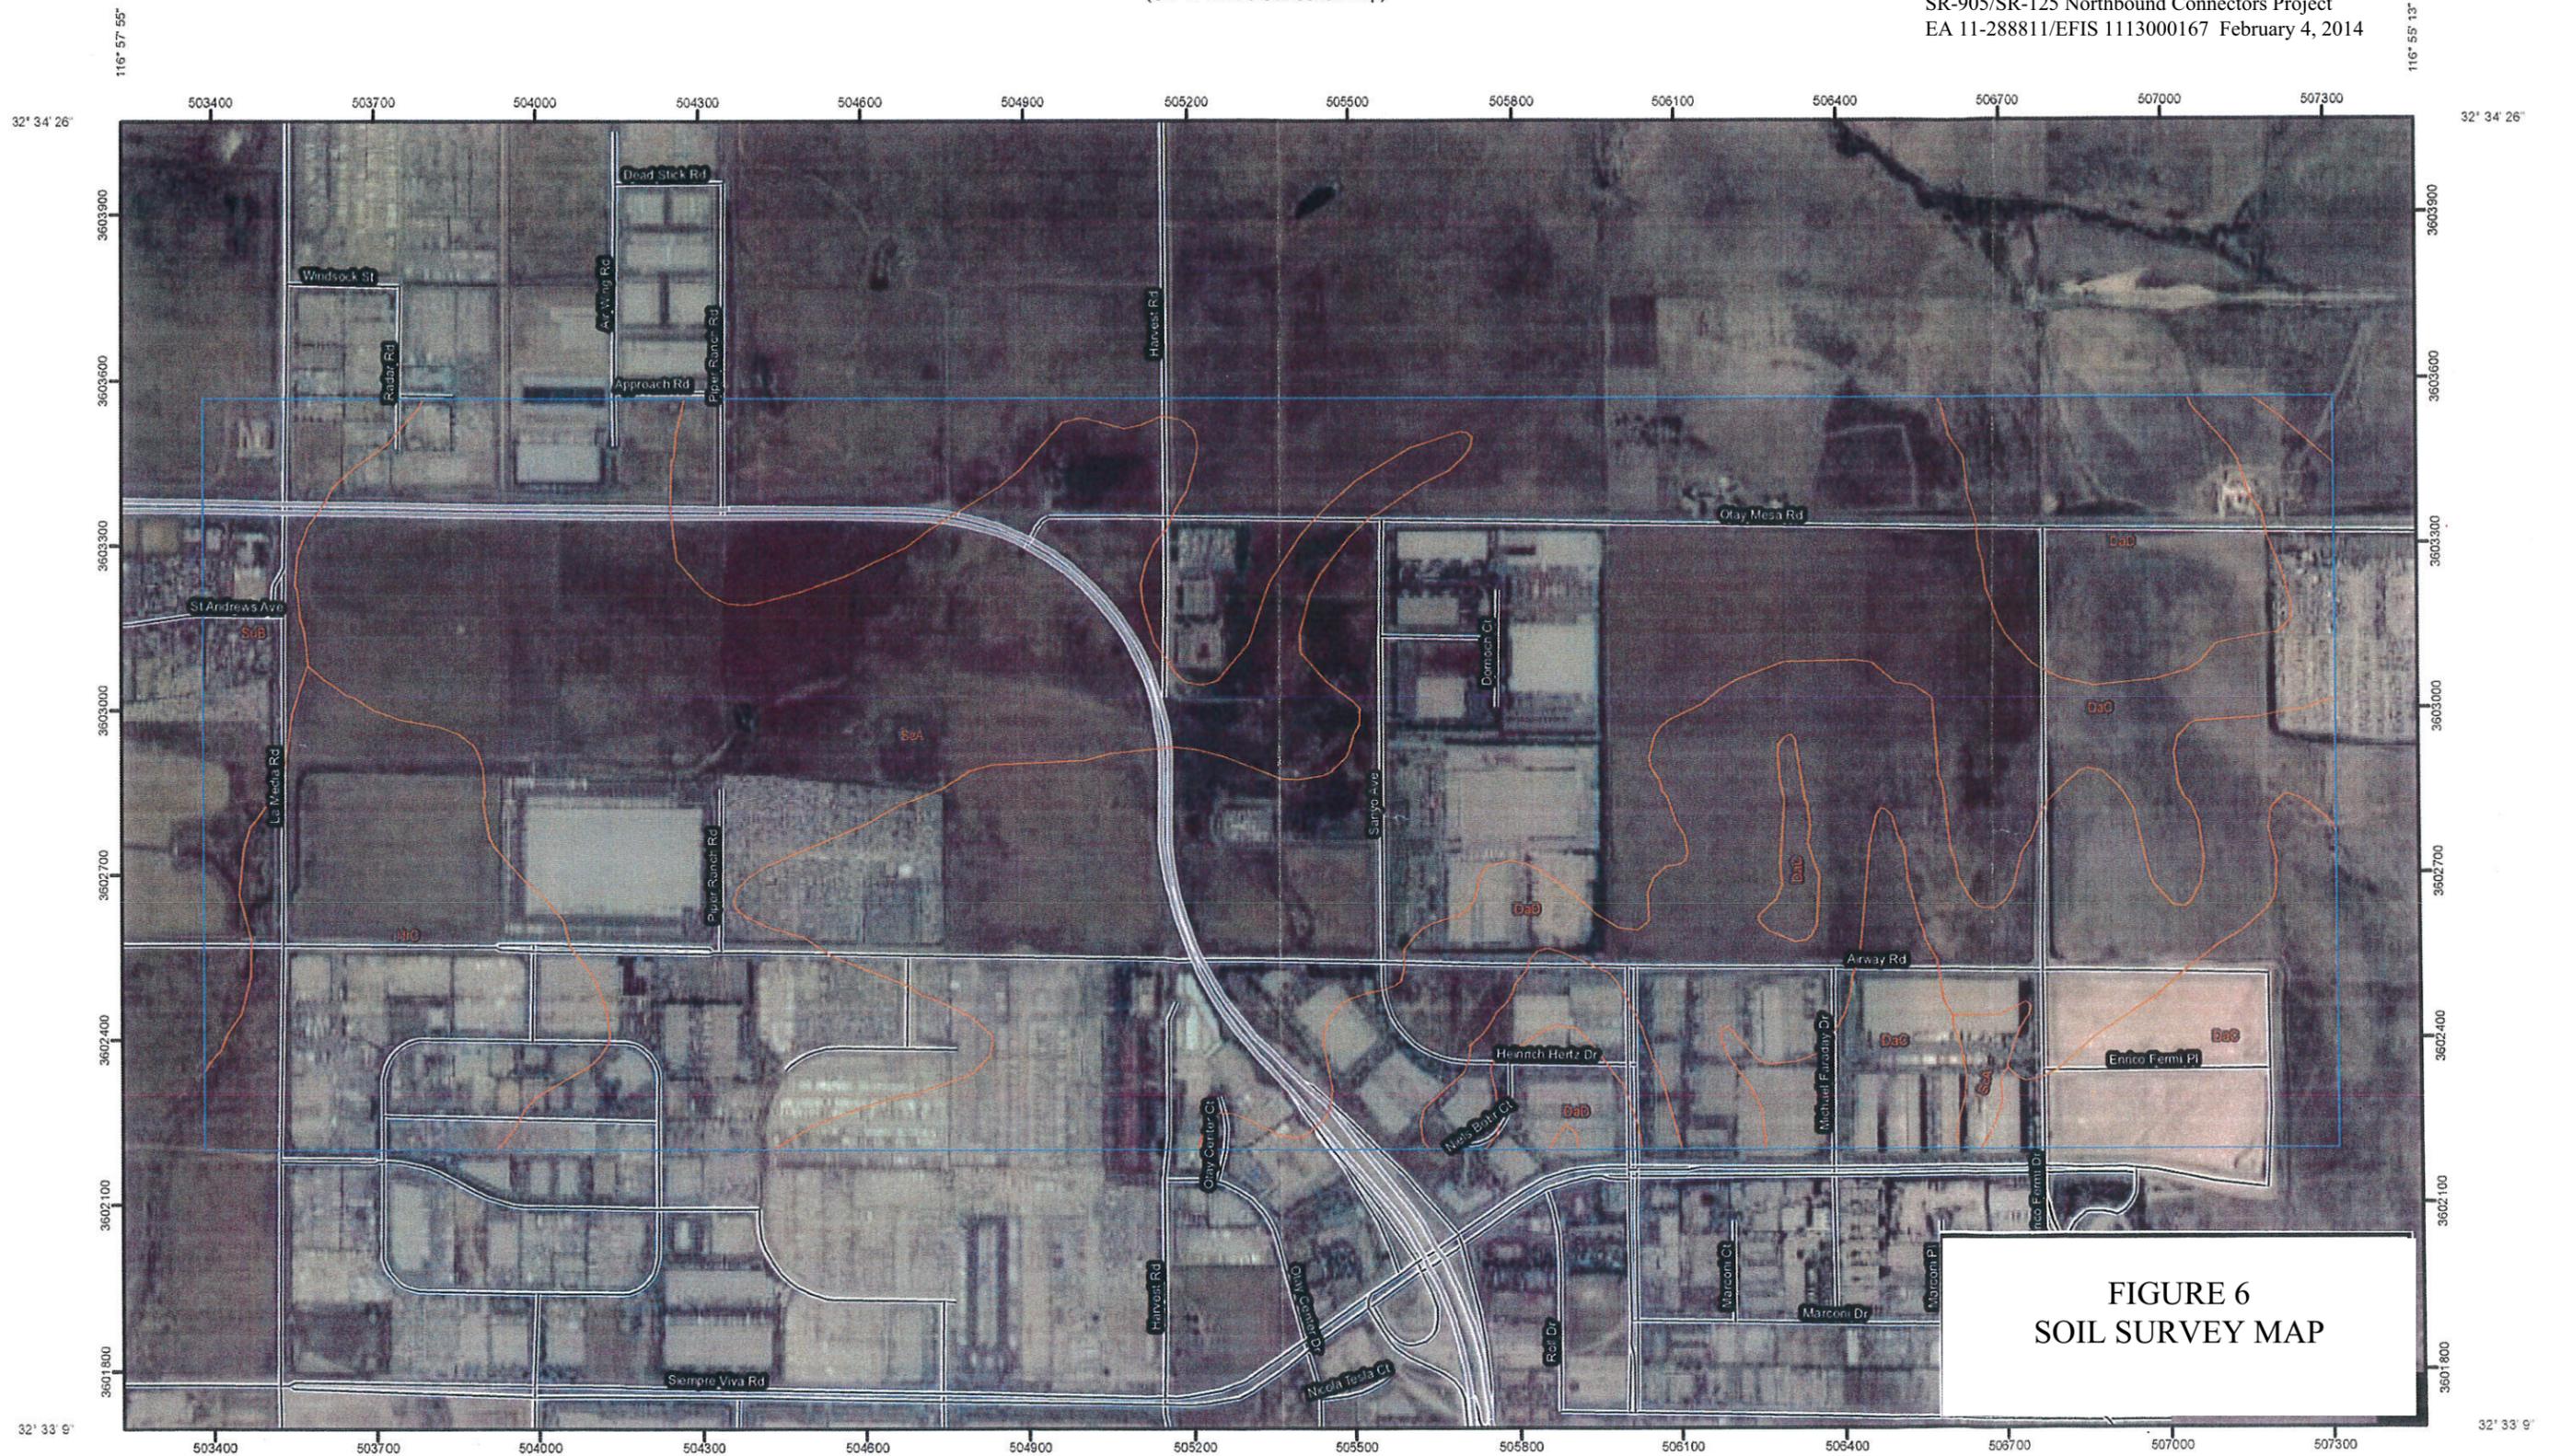
FIGURE 6
SOIL SURVEY MAP

According to the USDA-SCS publication the Salinas clay has low permeability, very slow runoff and a slight erosion hazard. The Diablo clay has low permeability, slow to medium runoff and a slight to moderate erosion hazard. Figure 6 presents the Soil Survey Map for the site.
