INFORMATION HANDOUT

For Contract No. 12-0N1101

At 12-Ora-133-9.5

**AERIALY DEPOSITED LEAD SITE INVESTIGATION
SR-133/I-5 INTERCHANGE
IRVINE, CALIFORNIA
TASK ORDER NO. 12-0L4100-51
EA NO. 0L4100, CONTRACT NO. 12A1139**

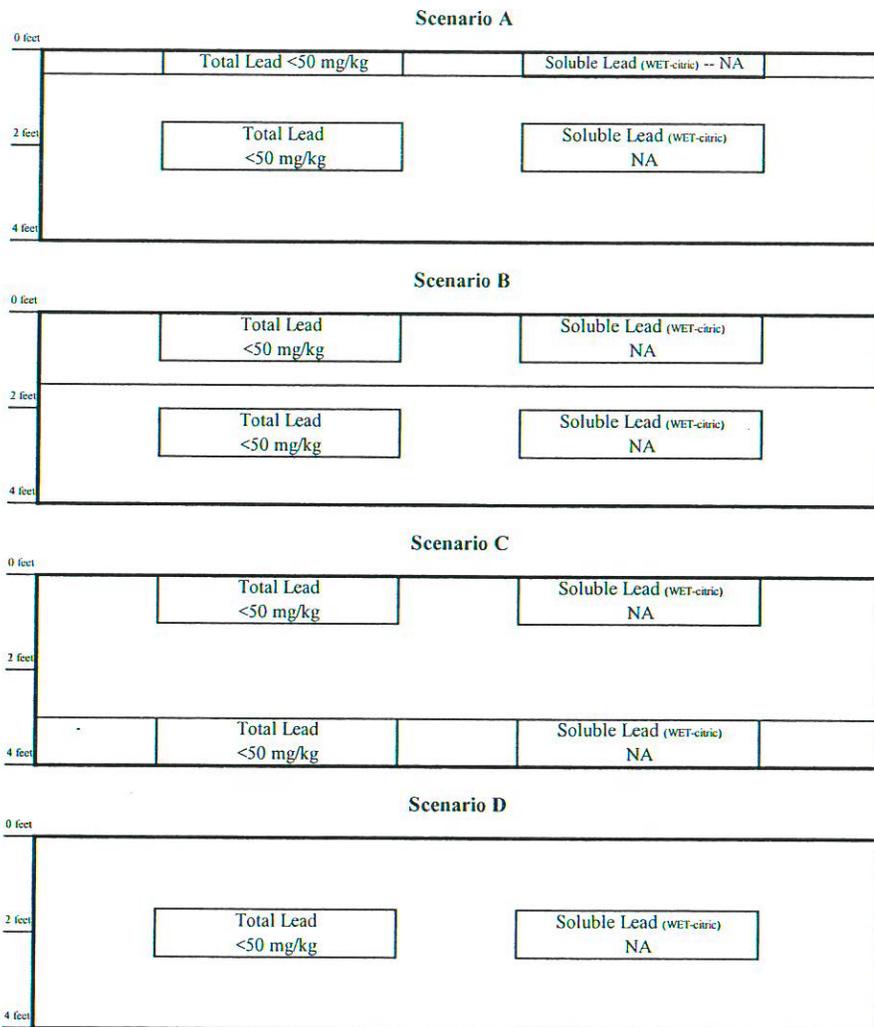
FIGURE C1 – BLOCK DIAGRAM FOR POTENTIAL DEPARTMENT RIGHT-OF-WAY RE-USE

– Non-hazardous soil with respect to total and soluble lead
-

– Reuse Condition 1 [Hazardous. Variance applies. Use material on job site. Place a minimum of 5 feet above maximum water table elevation and cover with at least 1 foot of non-hazardous soil]

– Reuse Condition 2 [Hazardous. Variance applies. Use material on job site. Place a minimum of 5 feet above maximum water table elevation and protect from infiltration with a pavement structure which will be maintained by the Department]

– Hazardous. Class 1 disposal site, all other Title 22 CCR requirements apply
-

Based on the findings of this study, recommendations are summarized on block diagrams in Appendix C and discussed below.

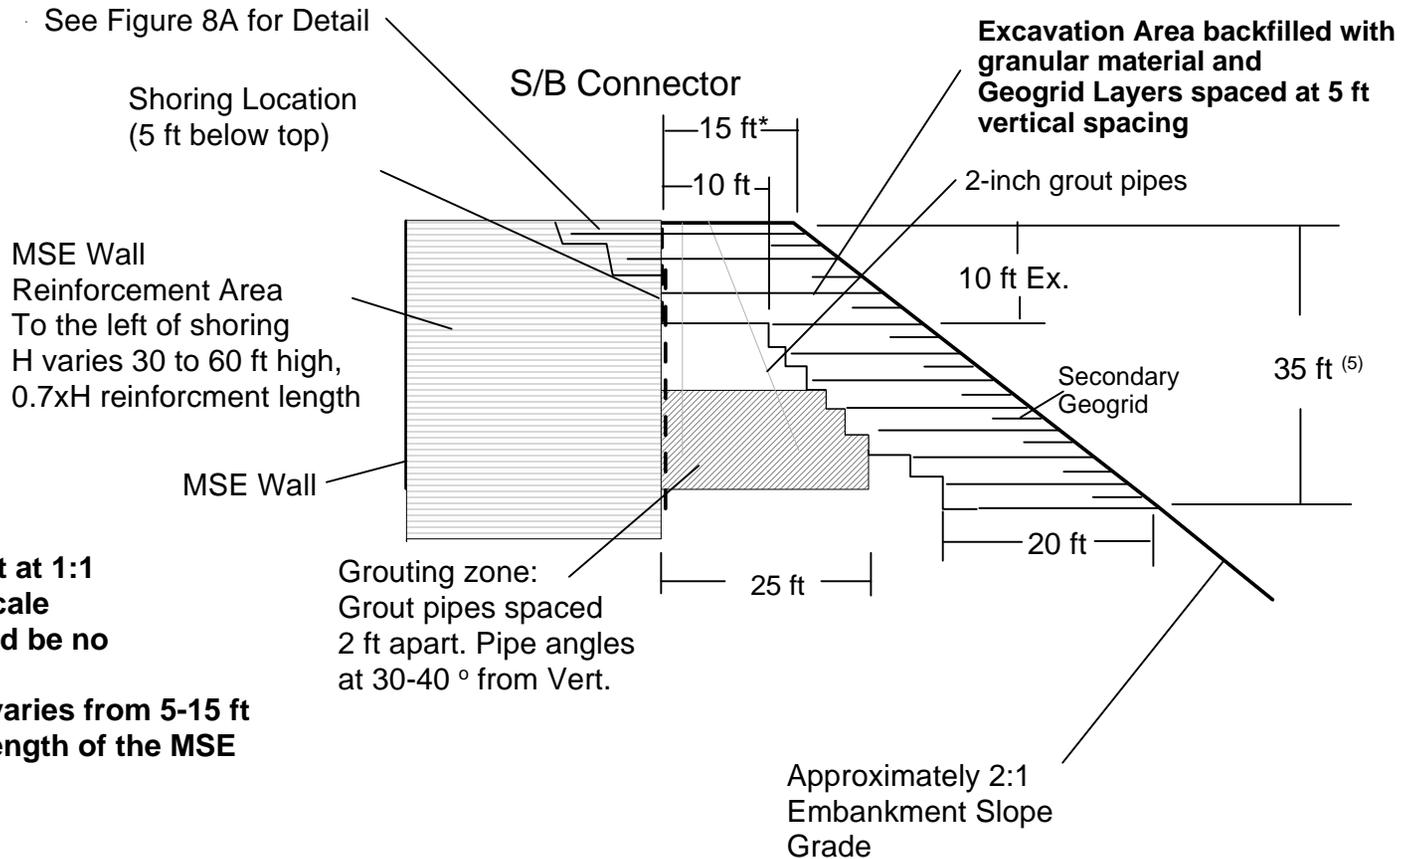
**Location 1 - S/B 133 to S/BI-5 - Repair Schematic
Station 4067+00 to 4071+00 (SE Line)
Void Filling Zone from 4068+70 to 4070+10**

Temporary Back-cut at 1:1

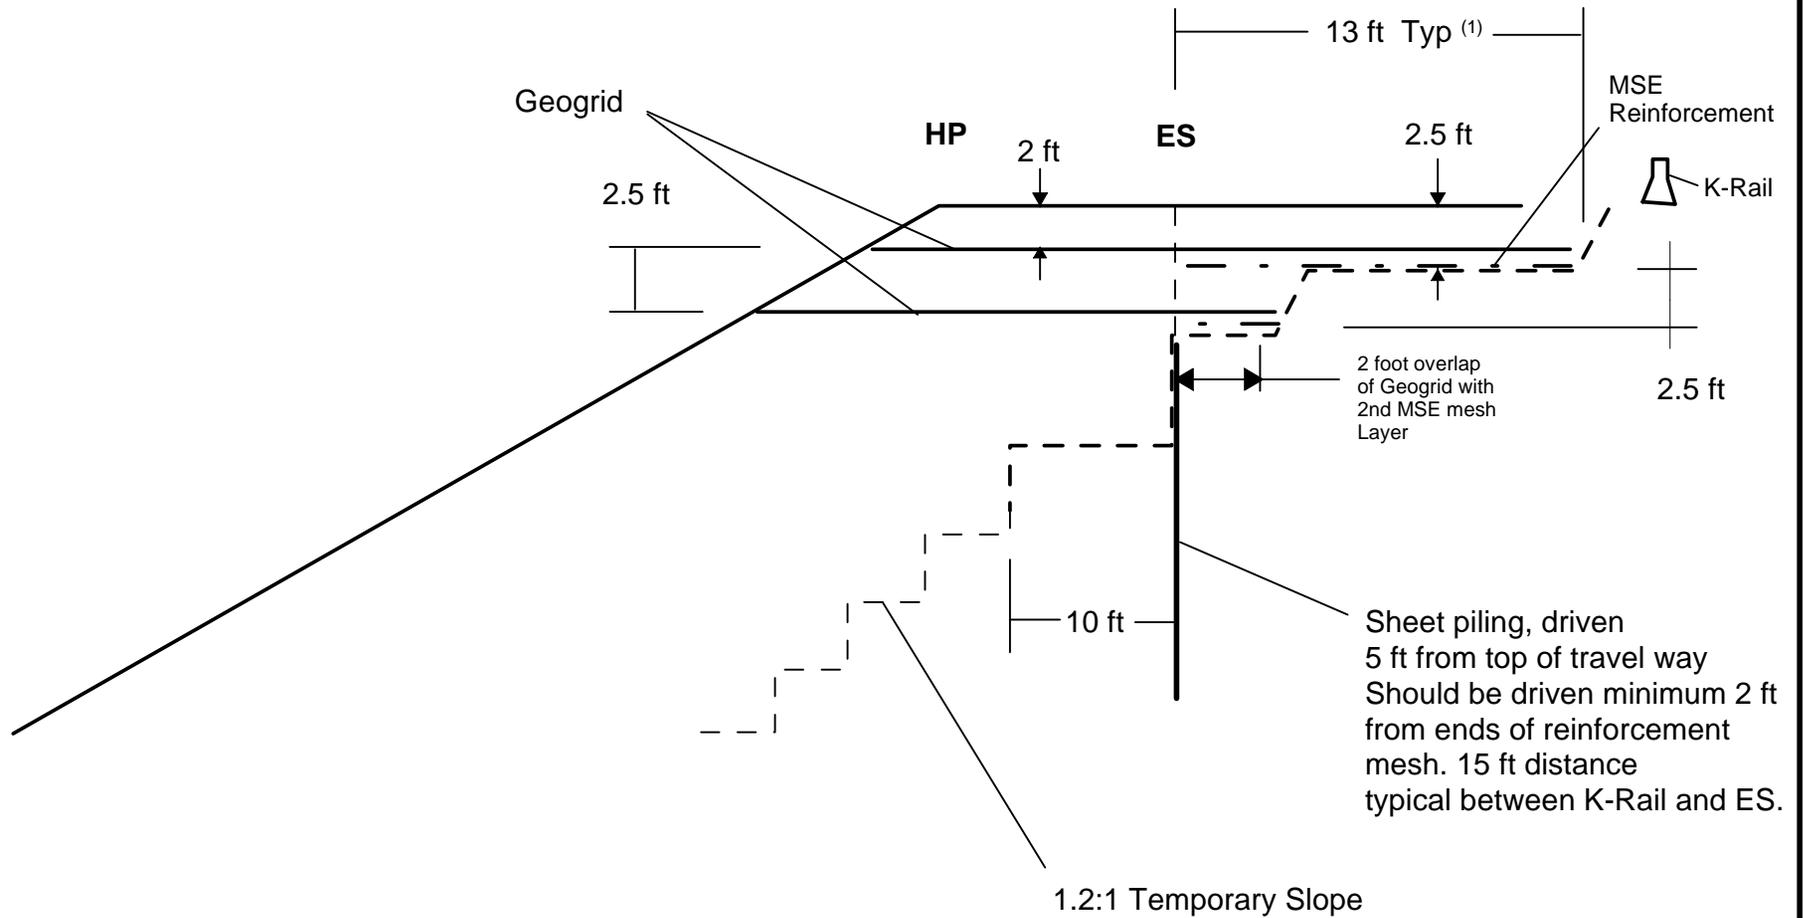
Location 2 Typical Connection Detail for Slope Backfill and MSE Reinforcement

(1) 13 foot typical overlap of Mesh and Geogrid for top layer only.

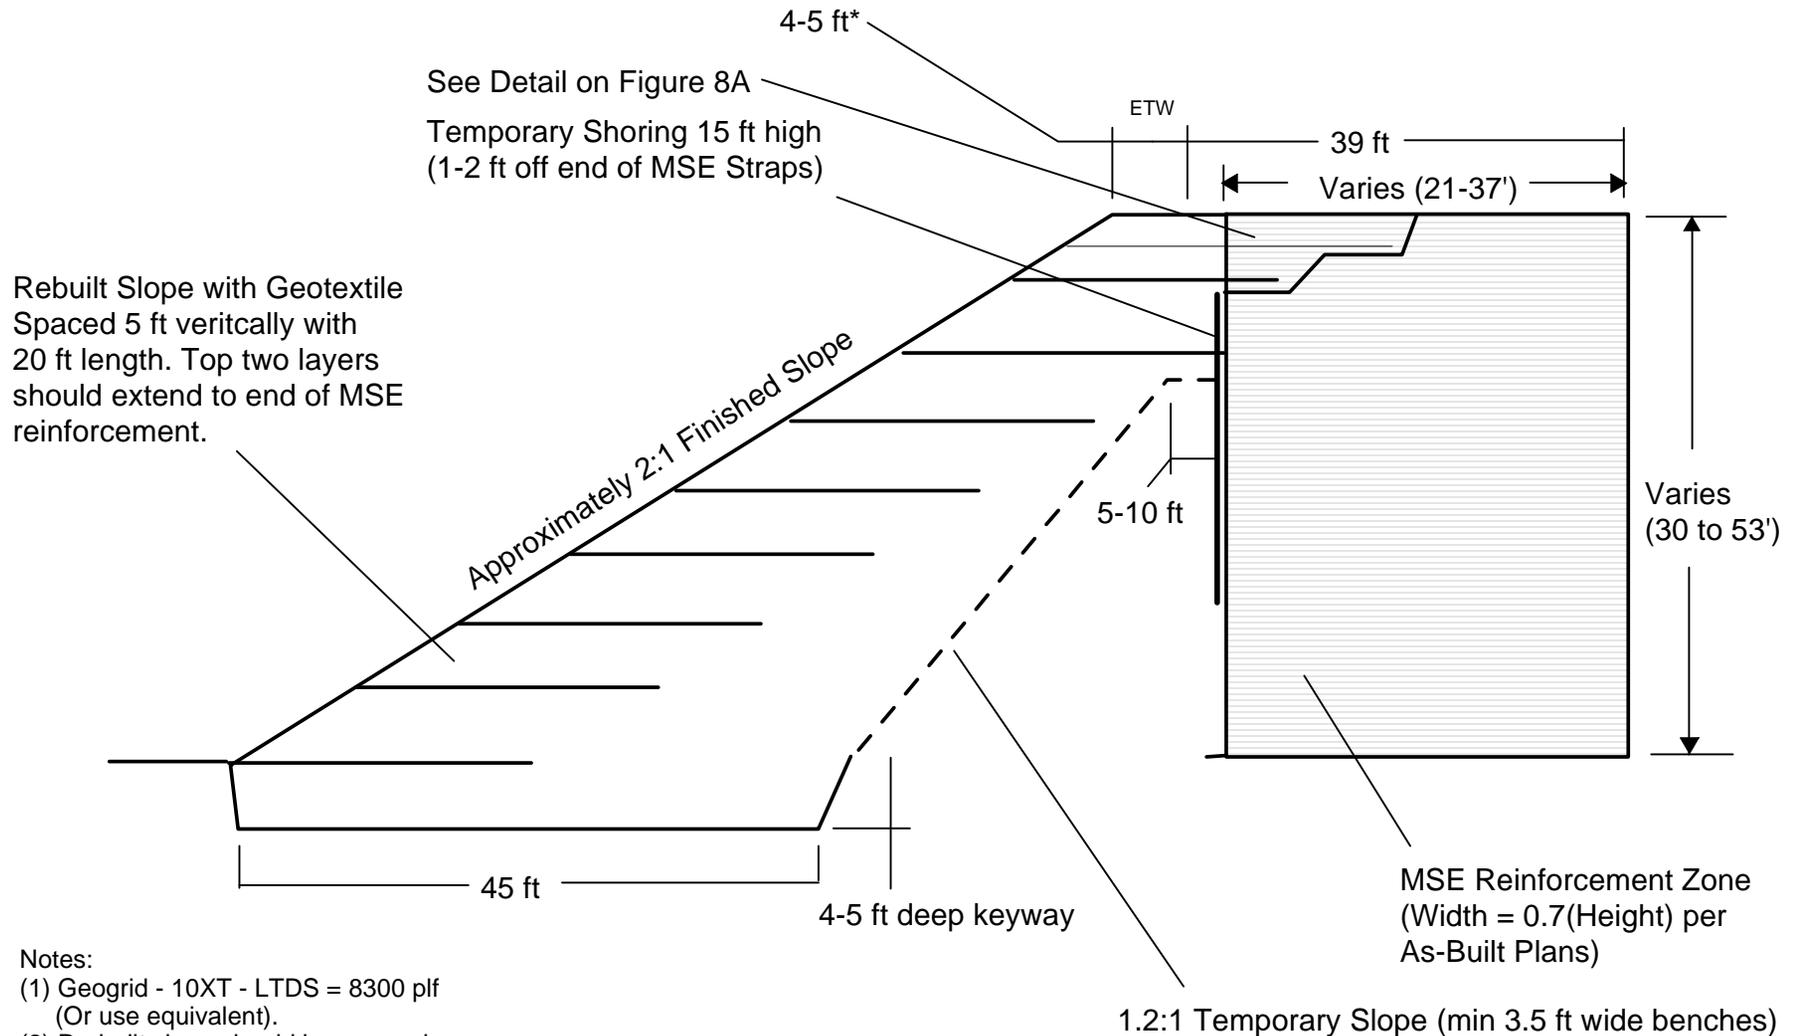
12-ORA-133-9.1/10.05
Location 2 - Alternate 2 Embankment
distress Repair Plan Station between
4042 to 4049+91.6 (SE Line)

- (1) Geogrid - 10XT - LTDS = 8300 plf
(Or use equivalent).
- (2) Re-built slope should be covered
with vegetation and wood chips or
fiber mesh to prevent erosion.
- (3) Backfill will be pre-dominantly granular (60% or more)
with an Expansion Index less than 50.

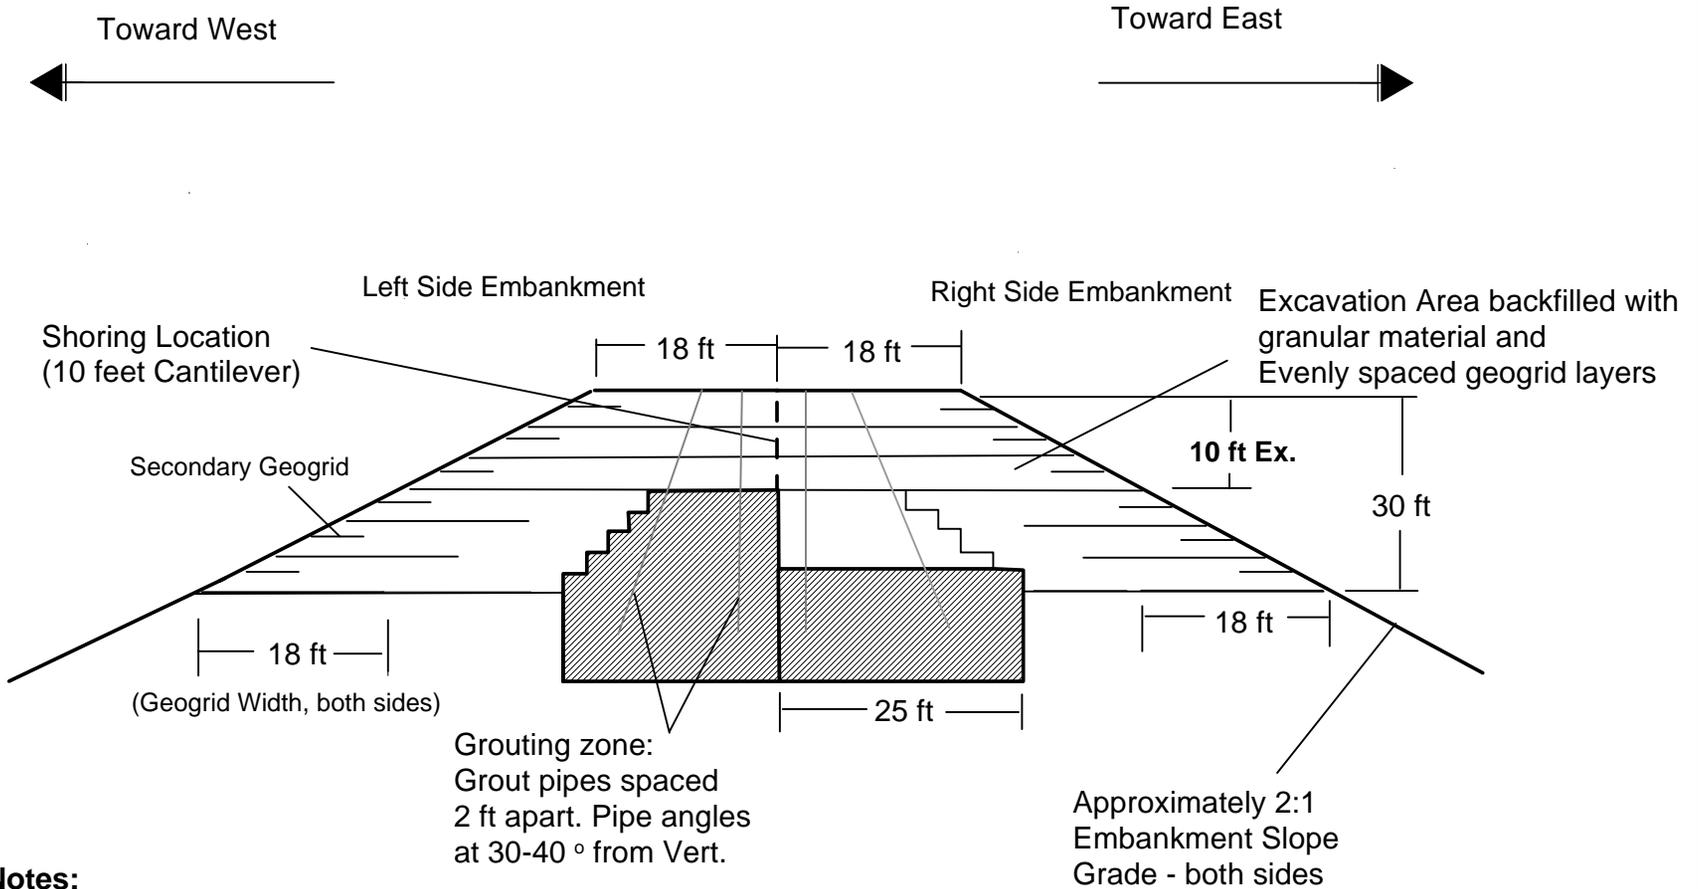
Location 3 Sections 1 and 2 - N/B I-5 to N/B133 - Repair Schematic
Station 5110+86 to 5111+35 (ALN 541, Sect 1), Station 5111+00 to 5111+30 ALN 541, Sect 2)

- (1) Temporary Back-cut at 1:1
- (2) Schematic Not to Scale
- (3) Bench widths should be no less than 3 feet.
- (4) Left side Embankment Geogrid and Grout recommendations for Station 5111+00 to 5111+30
- (5) Right Side Embankment Recommendations for Station 5110+86 to 5111+36

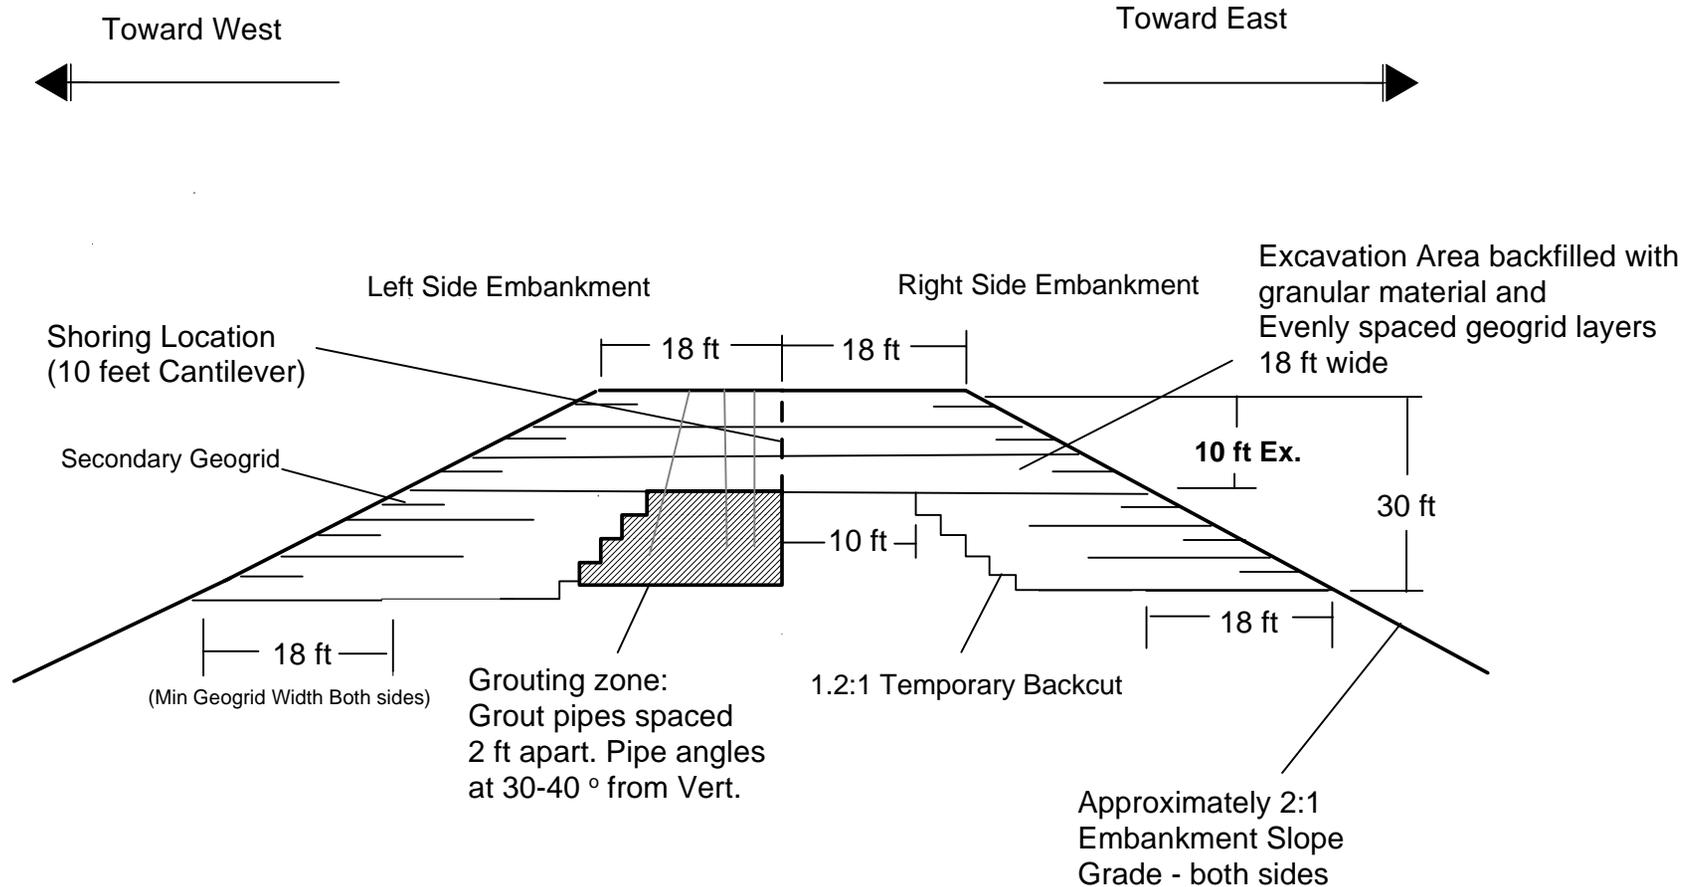
**Location 3 Section 3 - N/B I-5 to N/B133 - Repair Schematic
Station 5112+60 to 5113+75 (ALN 541)**

- (1) Temporary Back-cut at 1:1
- (2) Schematic Not to Scale
- (3) Bench widths should be no less than 3 feet.
- (4) Left side Embankment Geogrid and Grout recommendations for Station 5112+50 to 5113+00

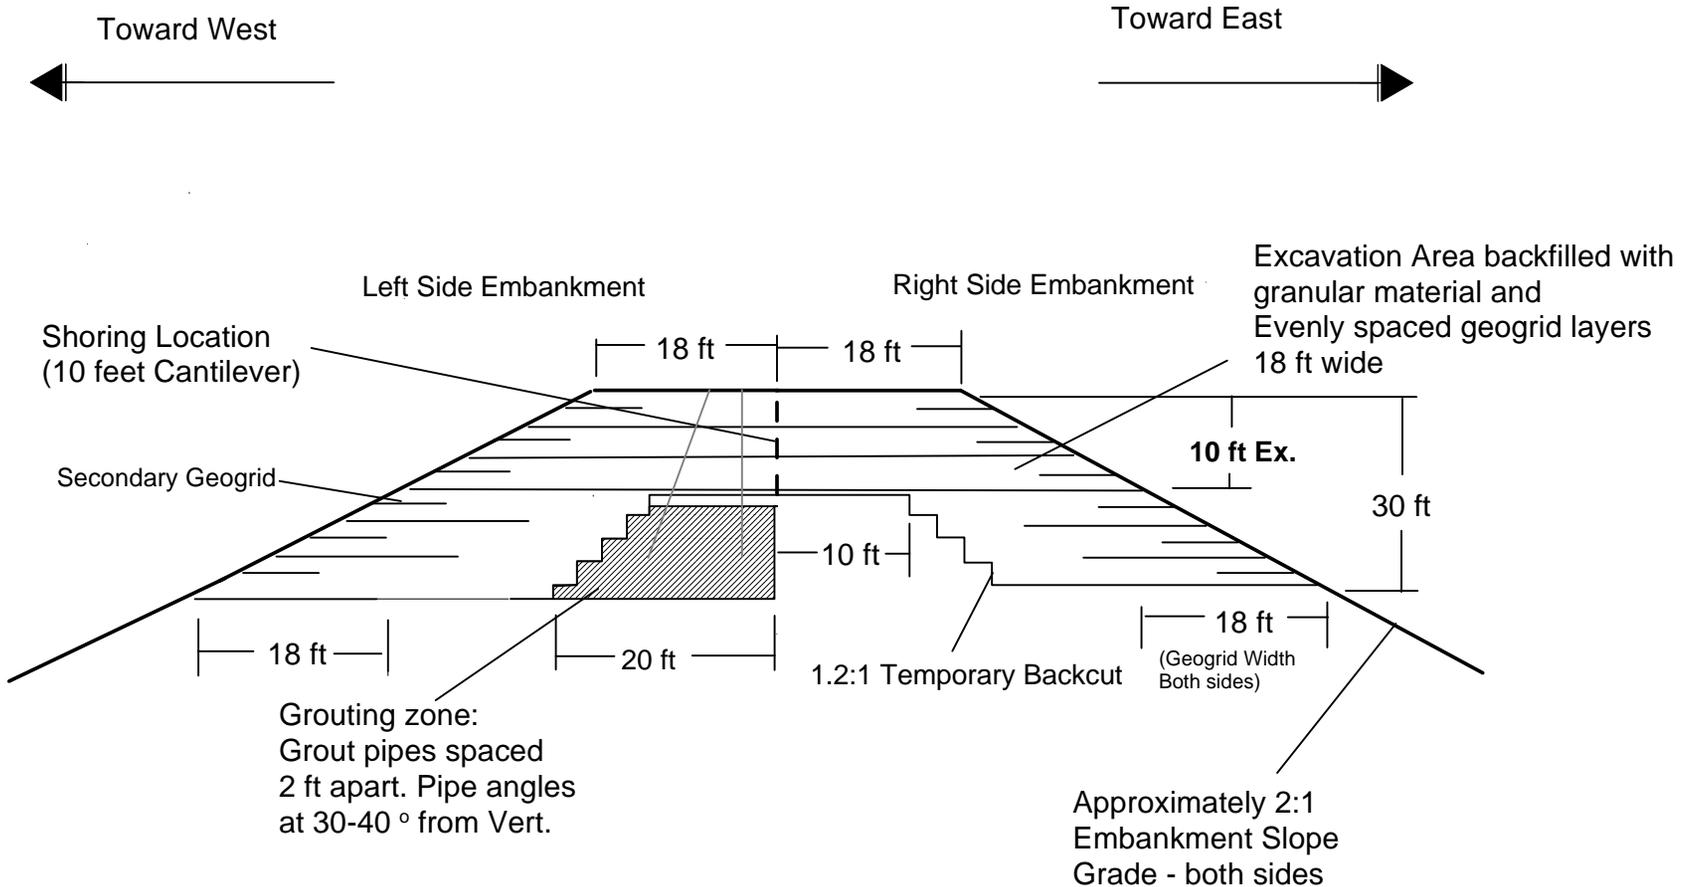
**Location 3 Section 4 - N/B I-5 to N/B133 - Repair Schematic
Station 5114+50 to 5115+25 (ALN 541)**

- (1) Temporary Back-cut at 1:1
- (2) Schematic Not to Scale
- (3) Bench widths should be no less than 3 feet.
- (4) Left side Embankment Geogrid and Grout recommendations for Station 5113+00 to 5113+90

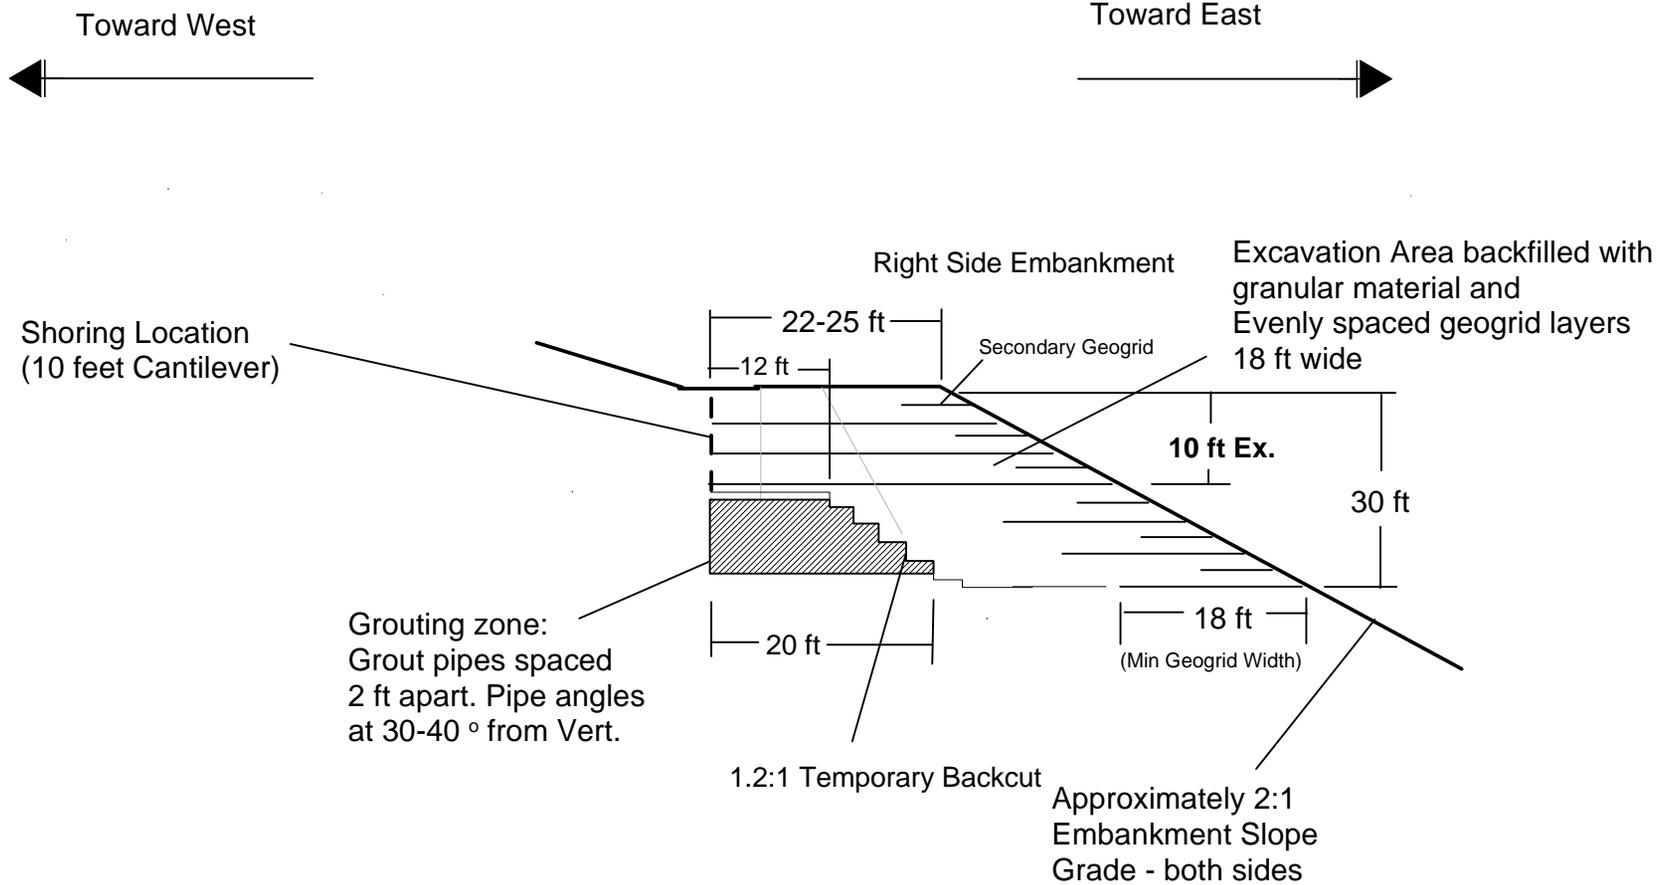
**Location 3 Section 5 - N/B I-5 to N/B133 - Repair Schematic
Station 5118+75 to 5119+50 (ALN 541)**

- (1) Temporary Back-cut at 1:1
- (2) Schematic Not to Scale
- (3) Bench widths should be no less than 3 feet.
- (4) Left side Embankment Geogrid and Grout recommendations for Station 5113+00 to 5113+90

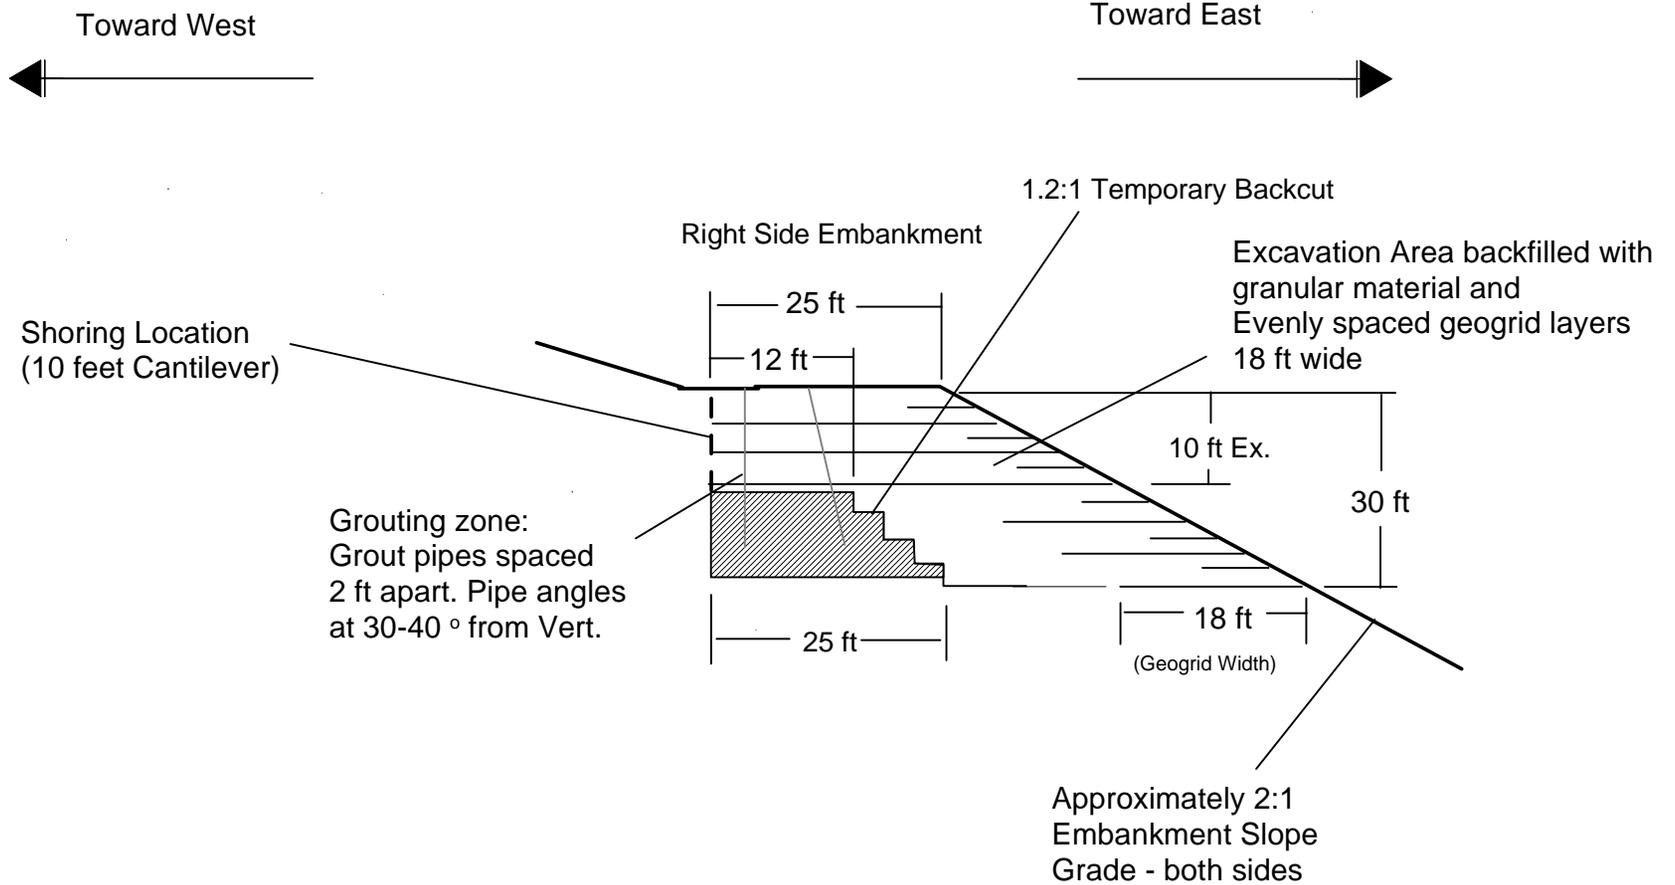
**Location 3 Section 6 - N/B I-5 to N/B133 - Repair Schematic
Station 5119+70 to 5120+20 (ALN 541)**

- (1) Temporary Back-cut at 1:1
- (2) Schematic Not to Scale
- (3) Bench widths should be no less than 3 feet.

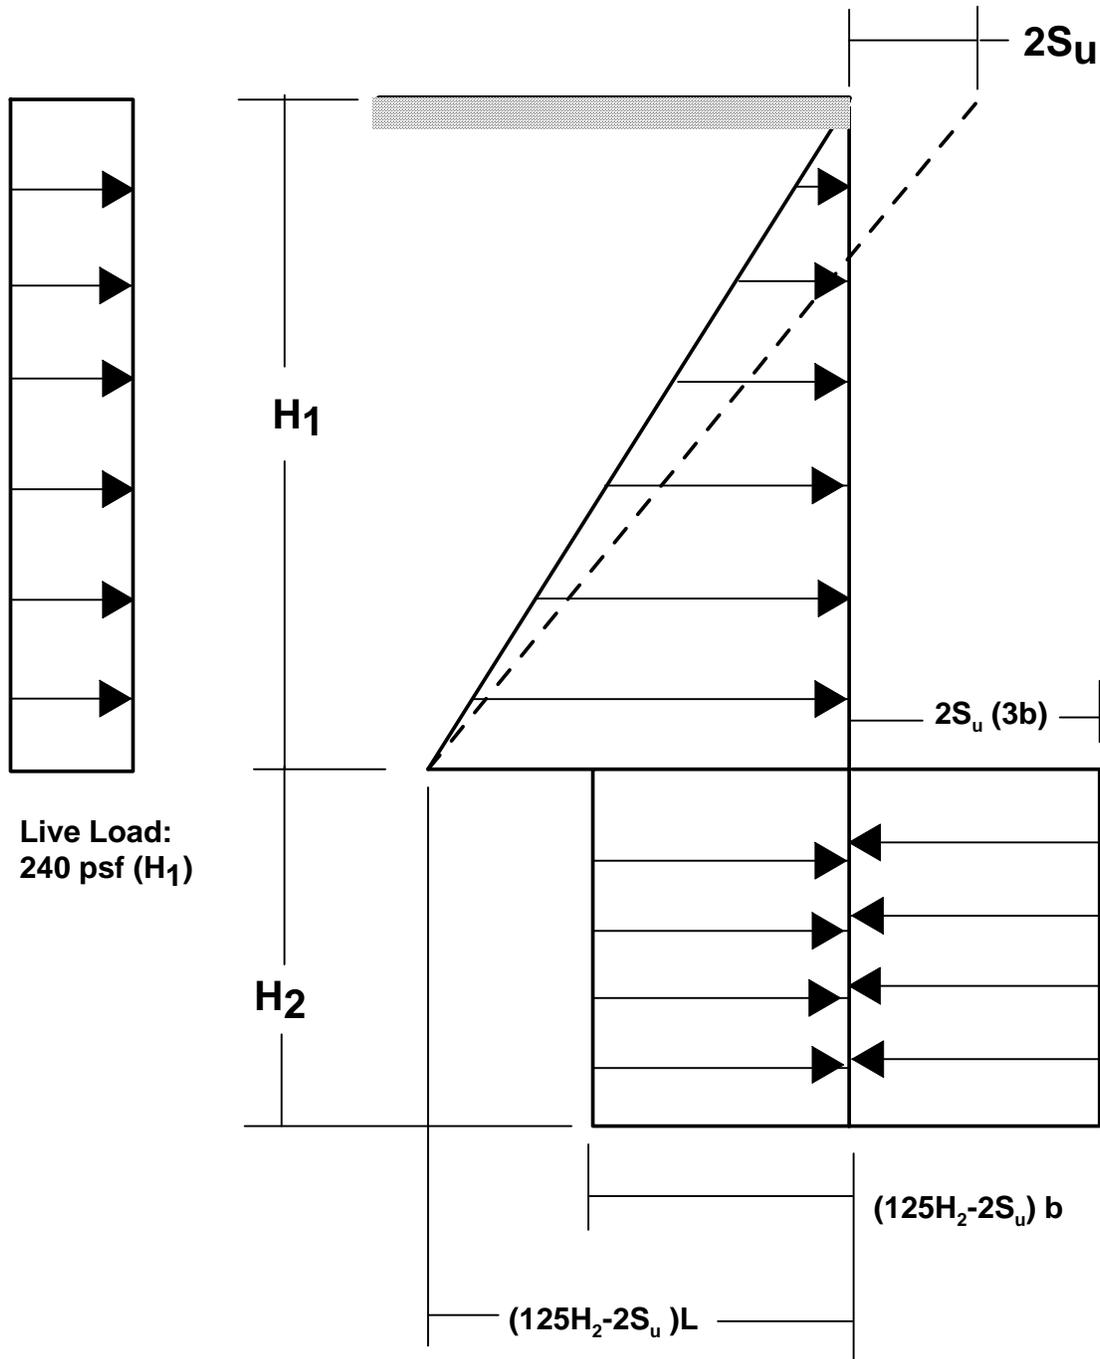
Earth Pressure Diagram for Cantilevered Shoring (Location 1)

- L = Center to Center spacing (ft)
- b = embedded width element (ft)
- S_u = 700 psf for Location 1
- H_1 = Depth to bottom of excavation (ft)
- H_2 = Embedded depth below excavation (ft)
- Based on Figure 3.11.5.6-5 (LRFD BDS, Section 3)

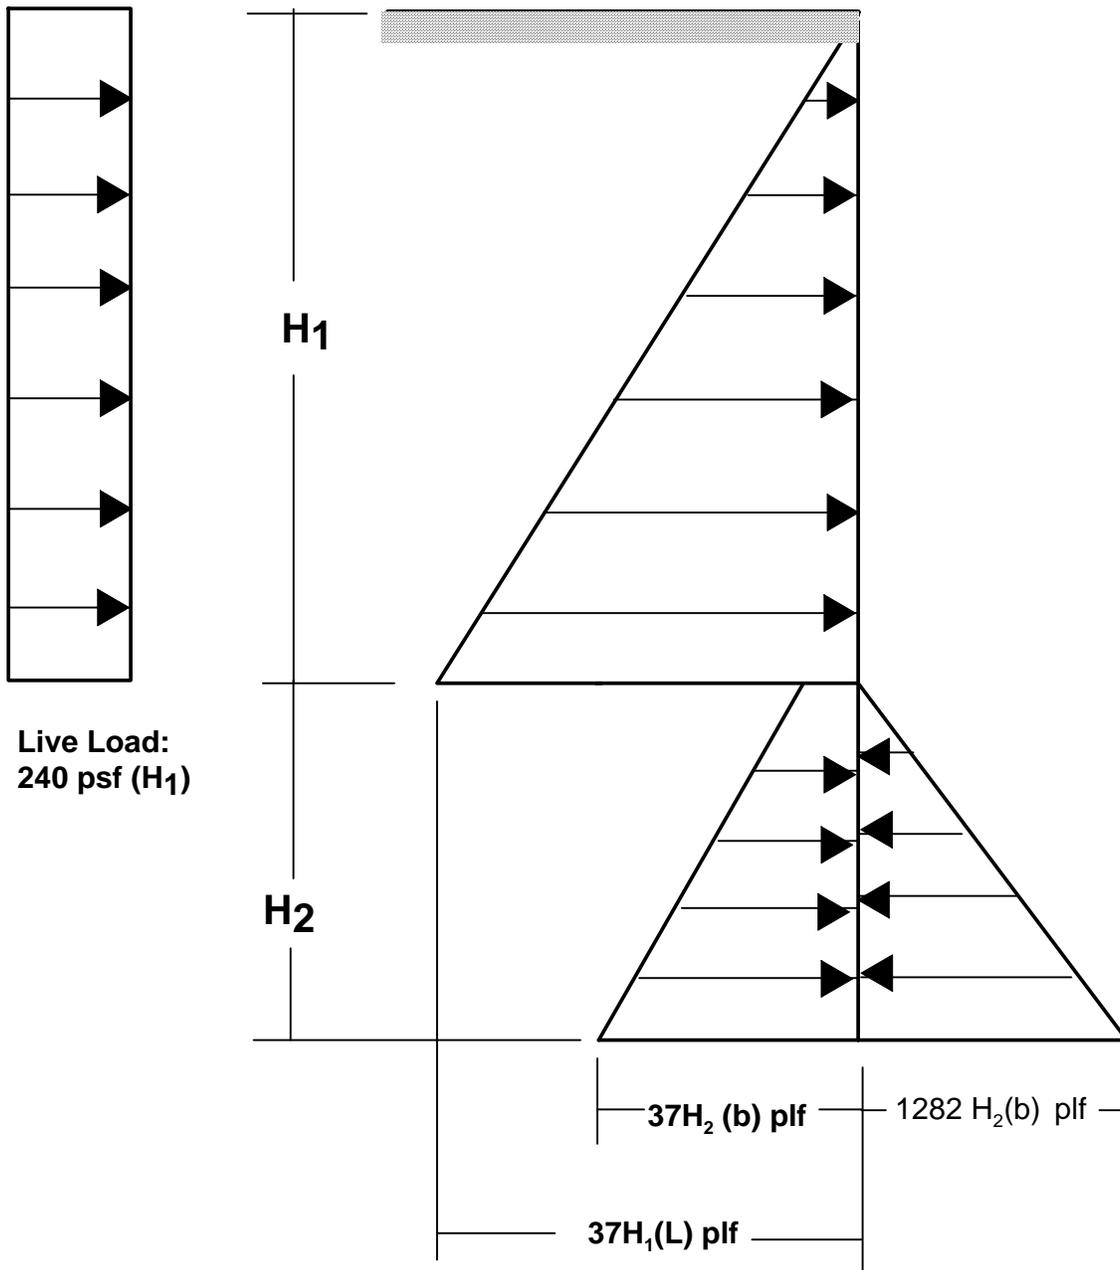
Earth Pressure Diagram for Cantilevered Shoring (Location 2)

- L = Center to Center spacing (ft)
- b = embedded width element (ft)
- $\phi = 33^\circ$ and $\gamma = 126$ pcf for full height of embankment
- H_1 = Depth to bottom of excavation (ft)
- H_2 = Embedded depth below excavation (ft)
- Based on Figure 3.11.5.6-1 (LRFD BDS, Section 3)

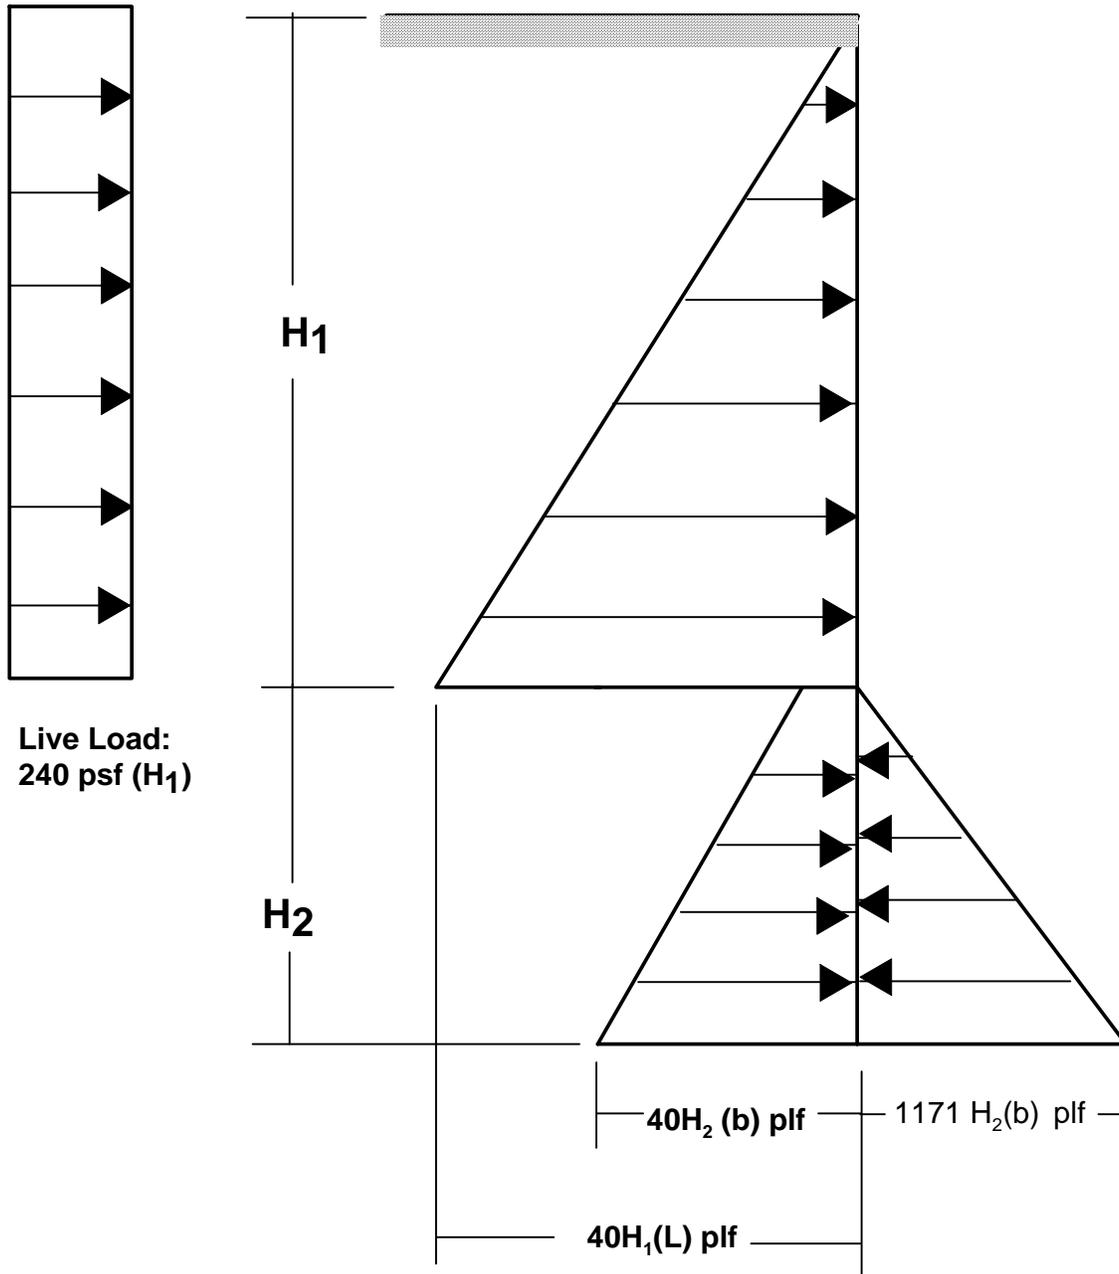
Earth Pressure Diagram for Cantilevered Shoring (Location 3) Station 5108+70 to 5116+20

- L = Center to Center spacing (ft)
- b = embedded width element (ft)
- $\phi = 31^\circ$ and $\gamma = 126$ pcf for full height of embankment
- H_1 = Depth to bottom of excavation (ft)
- H_2 = Embedded depth below excavation (ft)
- Based on Figure 3.11.5.6-1 (LRFD BDS, Section 3)

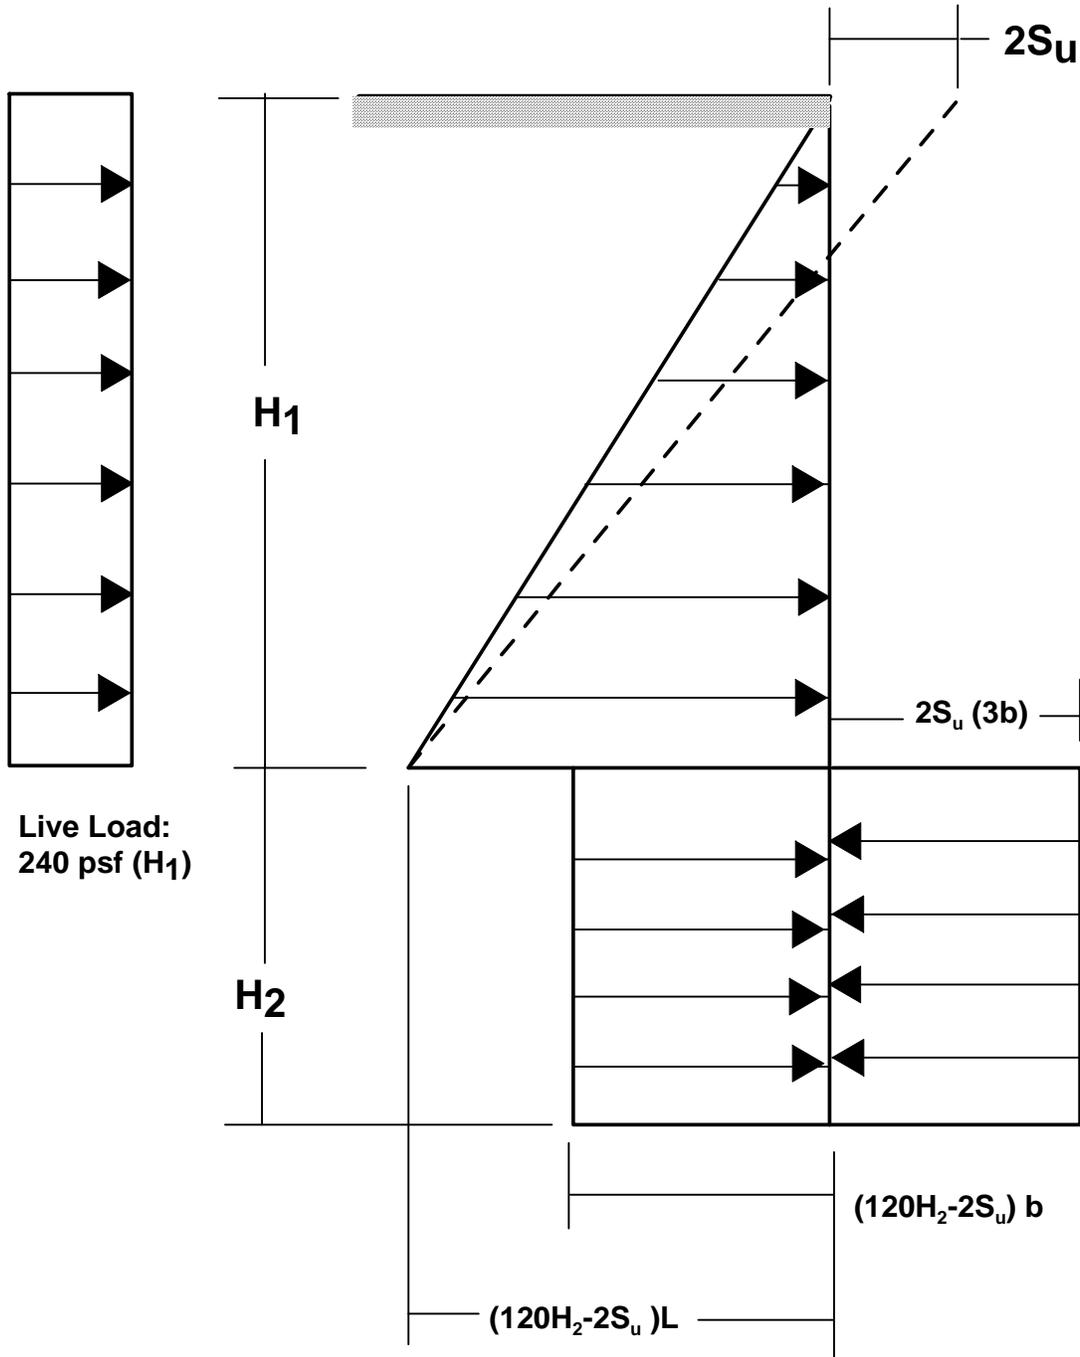
Earth Pressure Diagram for Cantilevered Shoring (Location 3) Station 5116+20 to 5122+70

- L = Center to Center spacing (ft)
- b = embedded width element (ft)
- S_u = 1200 psf for Location 3 (Sta 5121+00 to Marine Way)
- H_1 = Depth to bottom of excavation (ft)
- H_2 = Embedded depth below excavation (ft)
- Based on Figure 3.11.5.6-5 (LRFD BDS, Section 3)

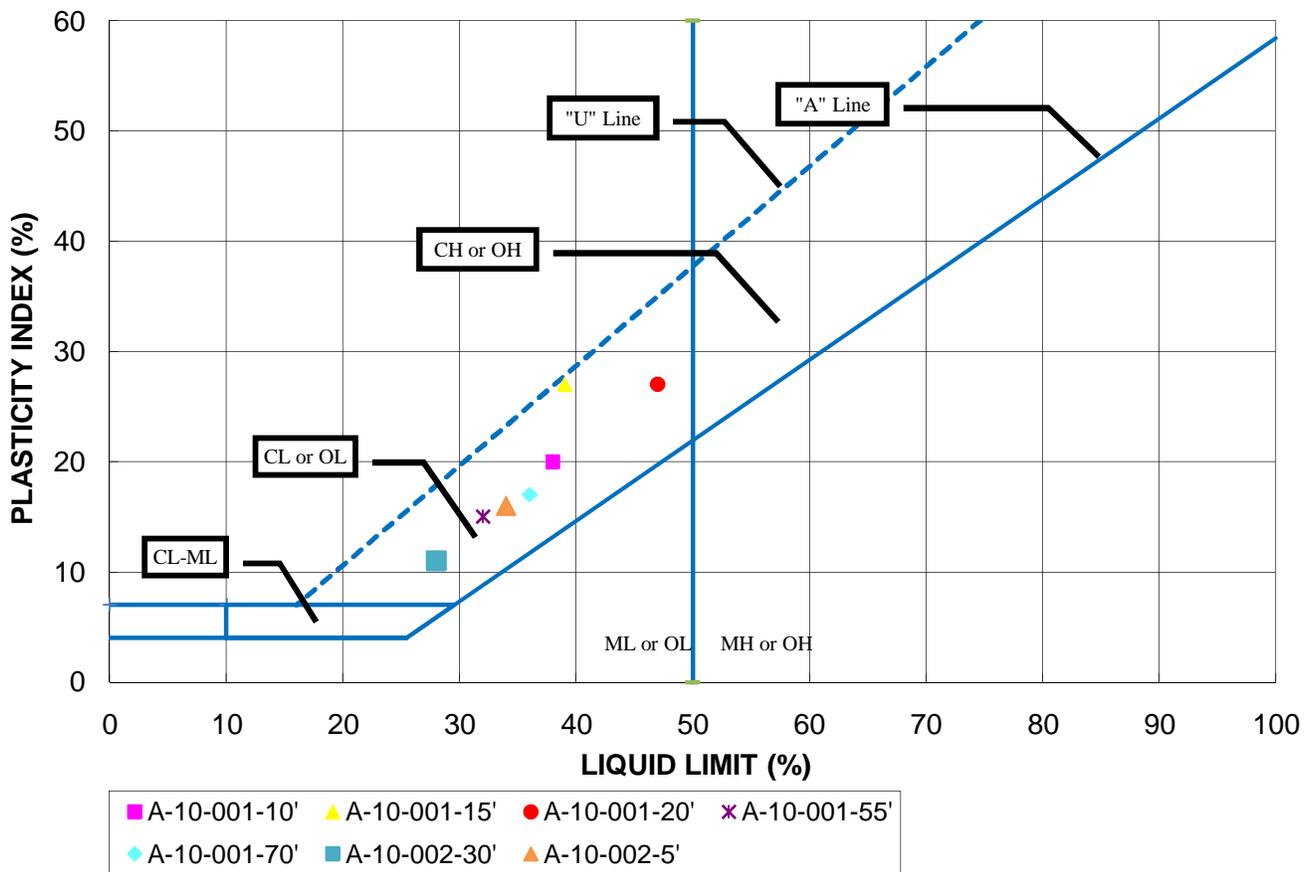
Atterberg Limits Test Results

Boring No.	Sample No.	Depth (ft)	LL	PL	PI	Classification
A-10-001 (3)	2	10'	38	20	18	CL
A-10-001 (3)	3	15'	39	21	18	CL
A-10-001 (3)	4	20'	47	27	20	CL/CH
A-10-001 (3)	11	55'	32	15	17	CL
A-10-001 (3)	14	70'	36	17	19	CL
A-10-002 (3)	6	30'	28	11	17	CL
A-10-002 (3)	1	5'	34	16	18	CL

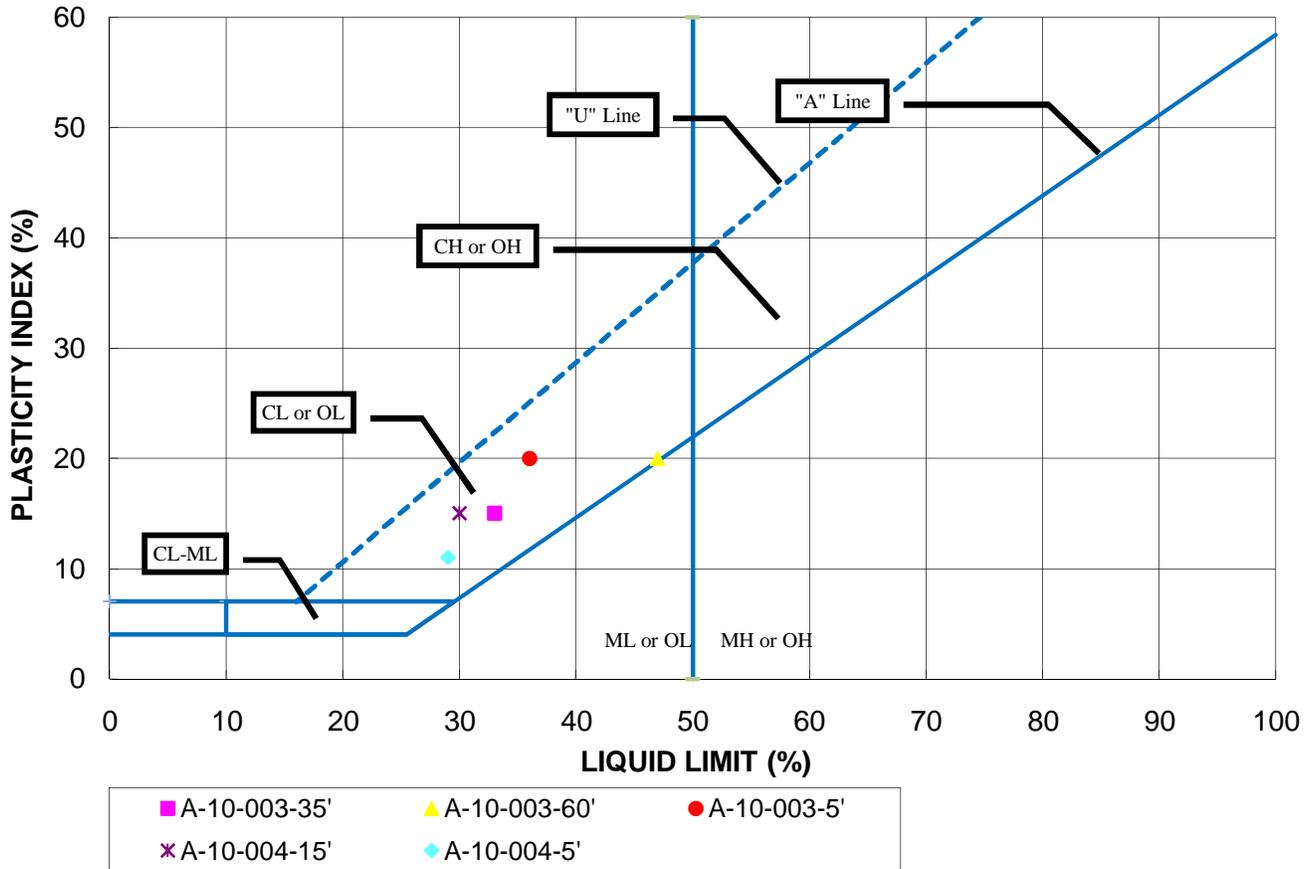
Atterberg Limits Test Results

Boring No.	Sample No.	Depth (ft)	LL	PL	PI	Classification
A-10-003 (3)	7	35'	33	15	18	CL
A-10-003 (3)	12	60'	47	26	21	CL/ML
A-10-003 (3)	1	5'	36	20	16	CL
A-10-004 (3)	3	15'	30	15	15	CL
A-10-004 (3)	1	5'	29	11	18	CL
