INFORMATION HANDOUT

For Contract No. 12-0N1101

At 12-Ora-133-9.5

**AERIALY DEPOSITED LEAD SITE INVESTIGATION
SR-133/I-5 INTERCHANGE
IRVINE, CALIFORNIA
TASK ORDER NO. 12-0L4100-51
EA NO. 0L4100, CONTRACT NO. 12A1139**

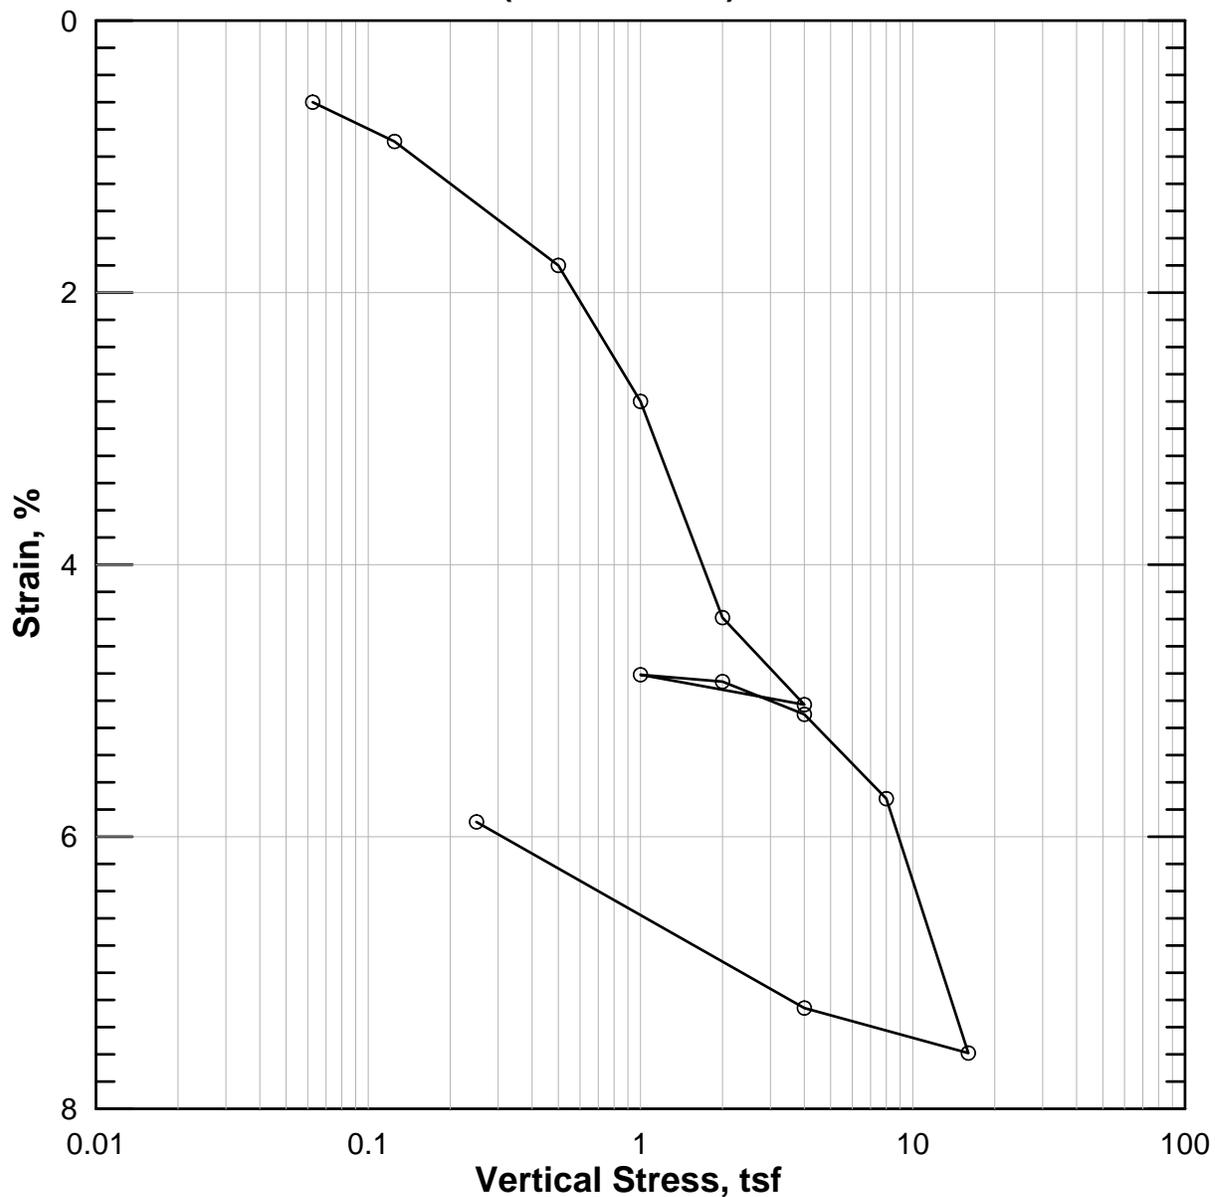
Consolidation Test Result (ASTM D2435)

Notes:
Boring/Sample No : A-10-003/10
Depth: 50 feet
Soil Type: Sandy Clay
Location: 2
Average C_v : 10^{-3} in²/sec

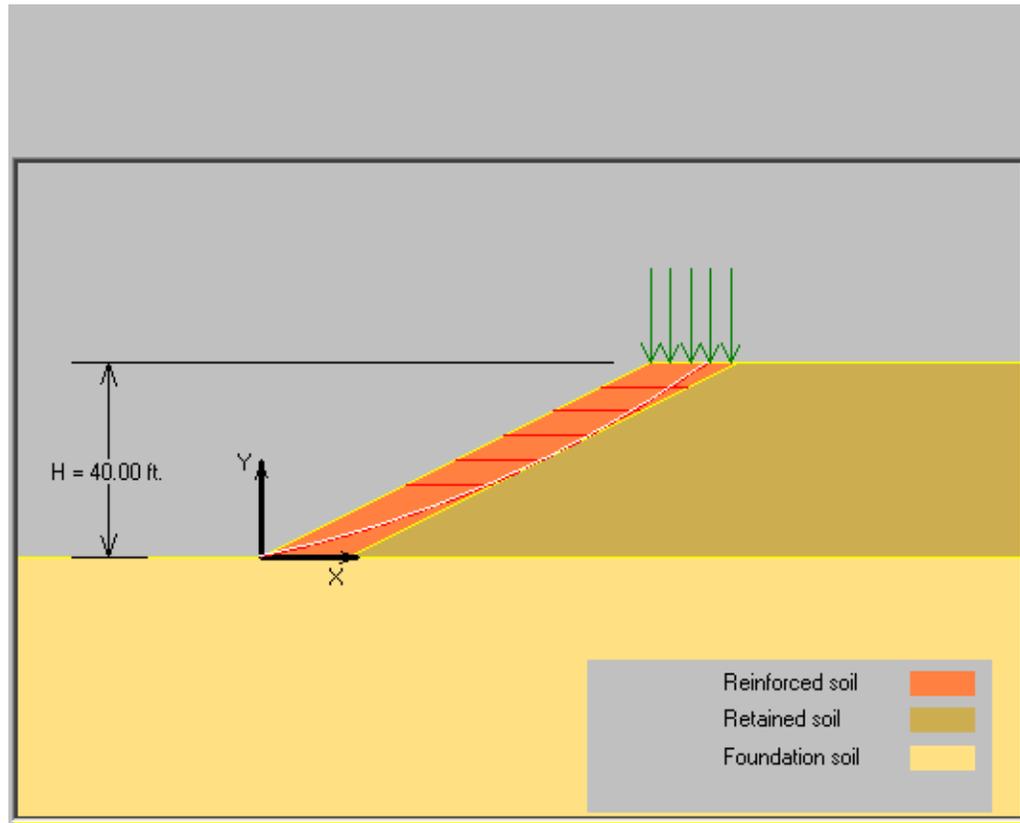
Location 3 (Station 5116+20 to 5122+70) Slope Stability Check

Notes:
Slope Stability Analysis by Bishops Method
Factors of Safety:
Static: 1.74
Seismic: 1.35
Surcharge Used: 240 psf
Reinforced Soil Slope (RSS) Version 1.0

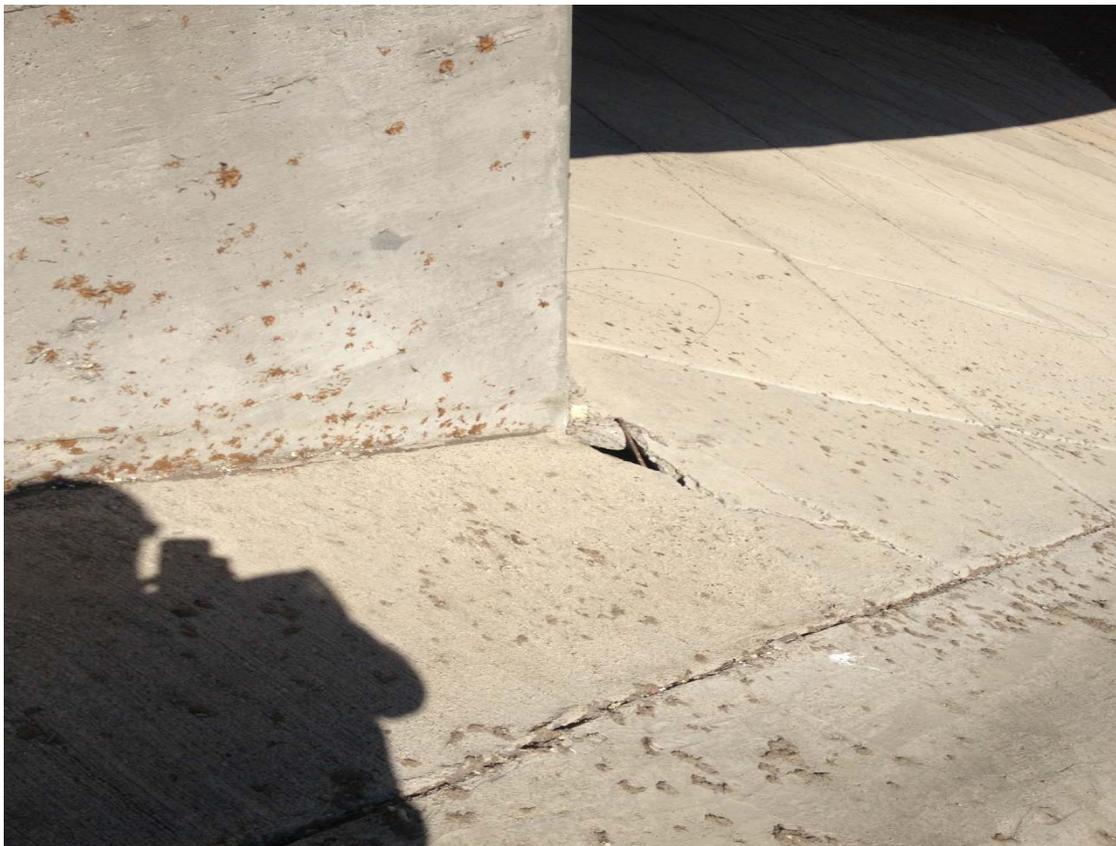
Photograph 4 – 55-0772R, Abutment 1R. View of right side of apron with damage shown center.

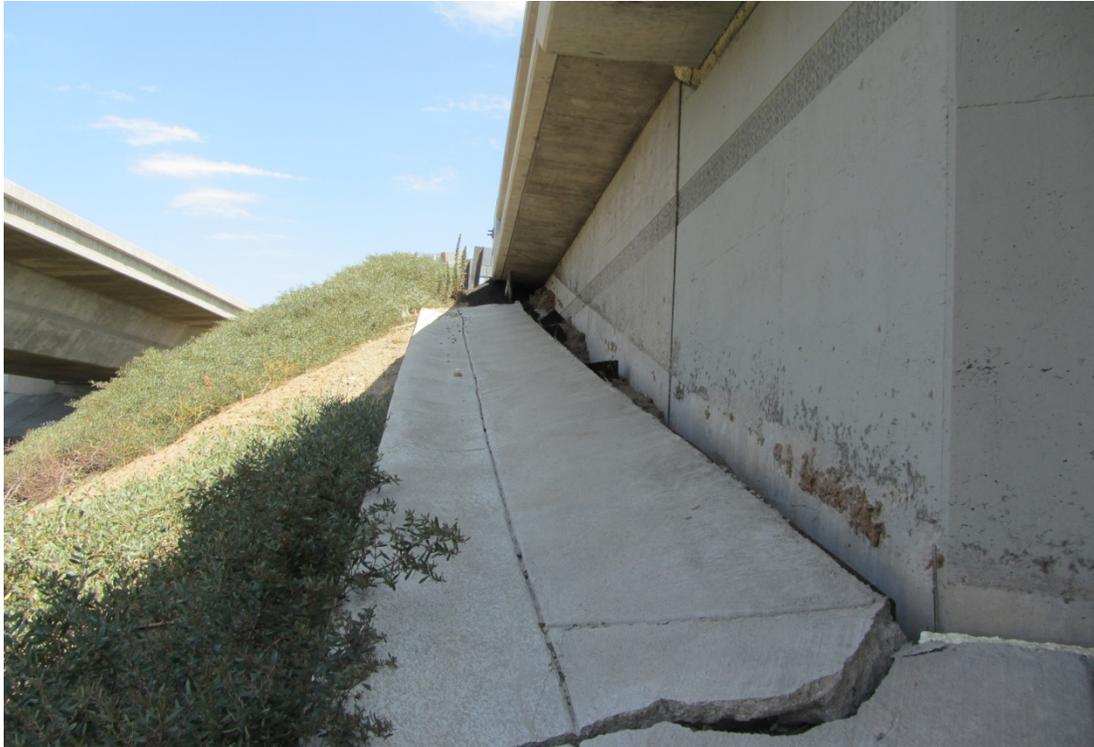
Photograph 5 – Bridge No. 55-0772L – Abutment 6L. Left side of upper apron separating from abutment.

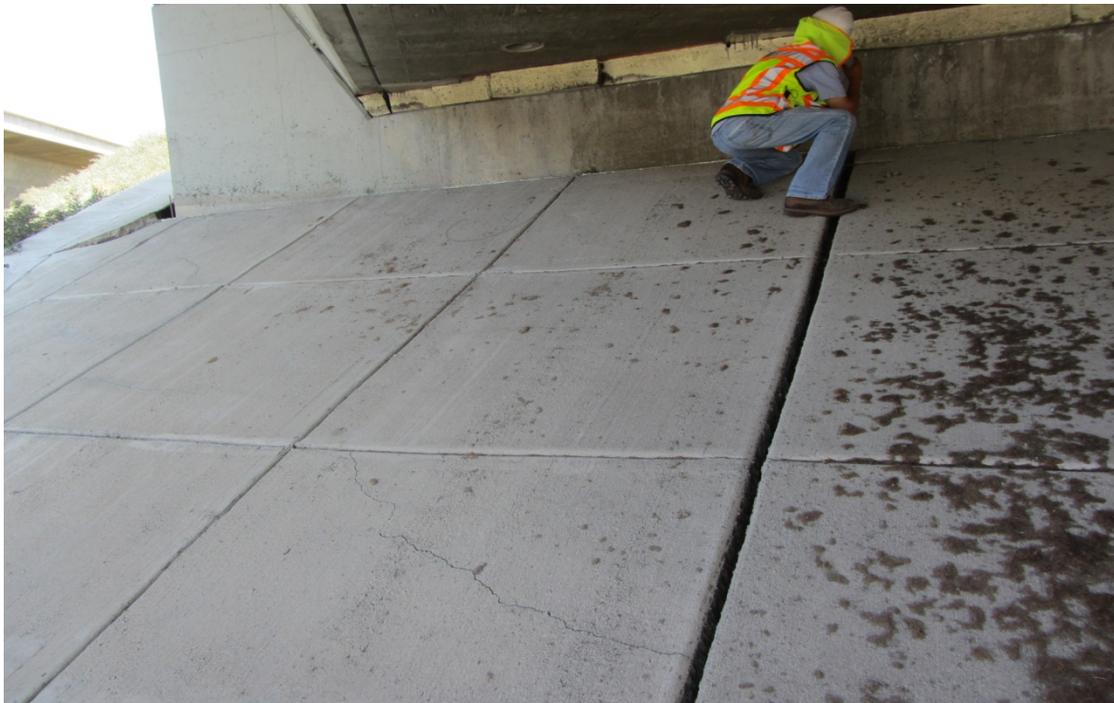
Photograph 6 – Bridge No. 55-0772L – Abutment 6L. Separation of Apron panels

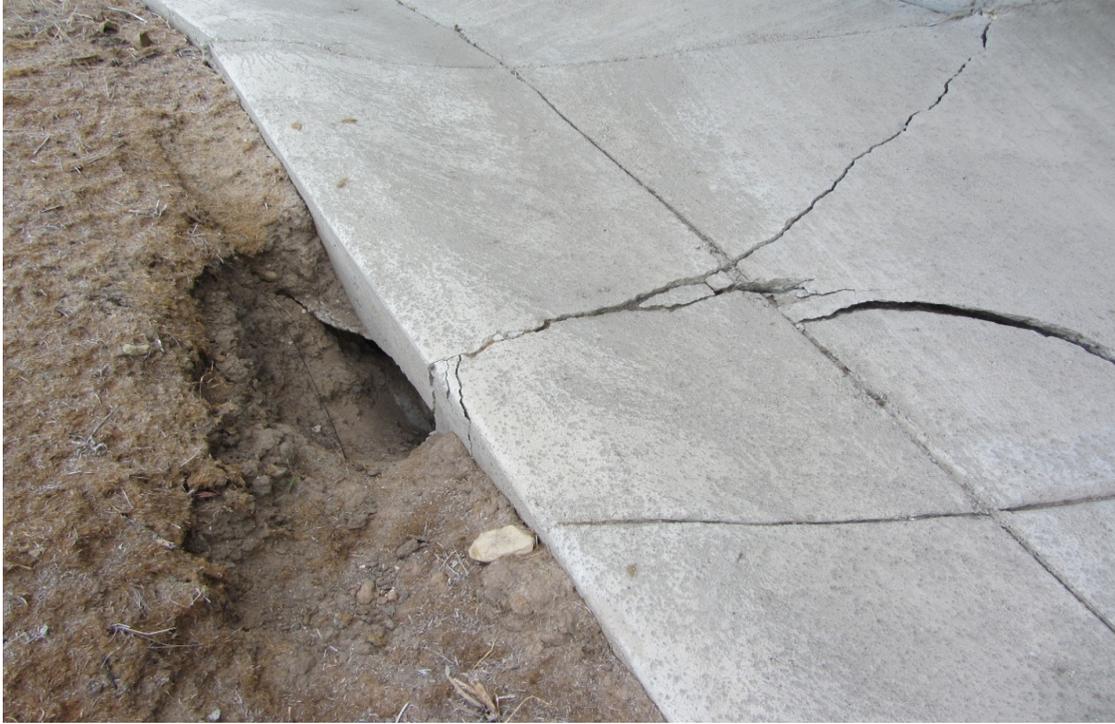
Photograph 7 – Bridge No. 55-0772R – Abutment 6R. Damage and erosion on left side of apron.

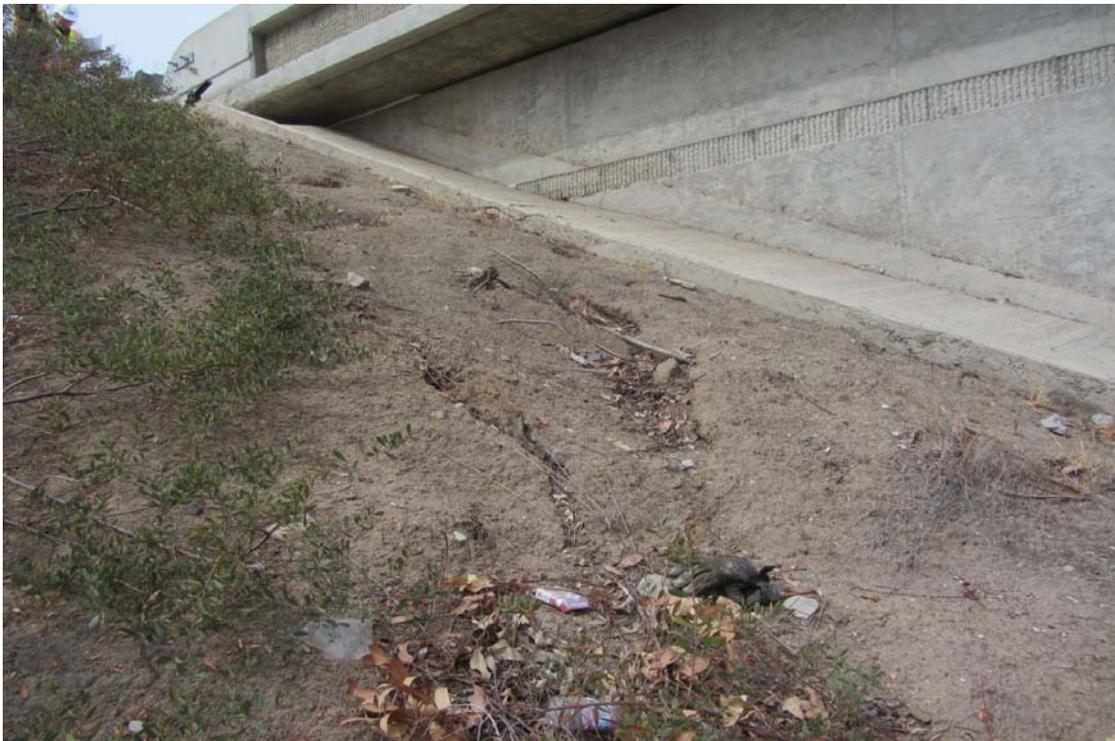
Photograph 8 – Bridge No. 55-0773R – Abutment 1R – Erosion on right side of Abutment.

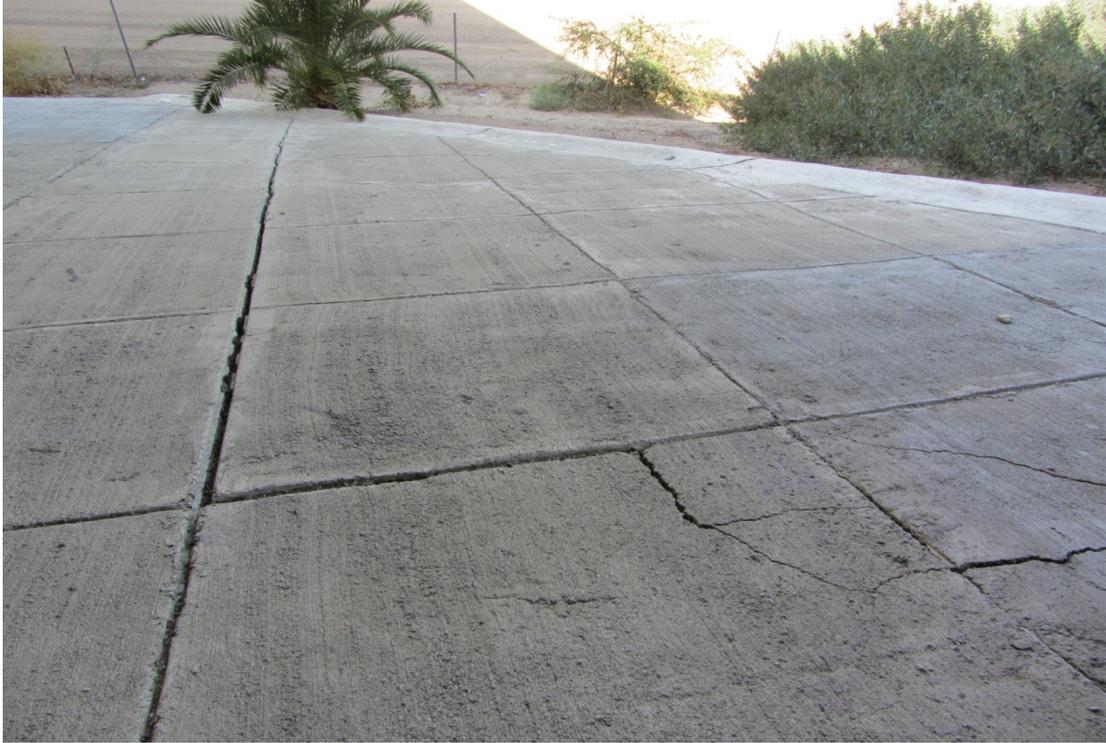
Photograph 9 – Bridge No. 55-0773L – Abutment 3L – Damaged apron looking toward toe.

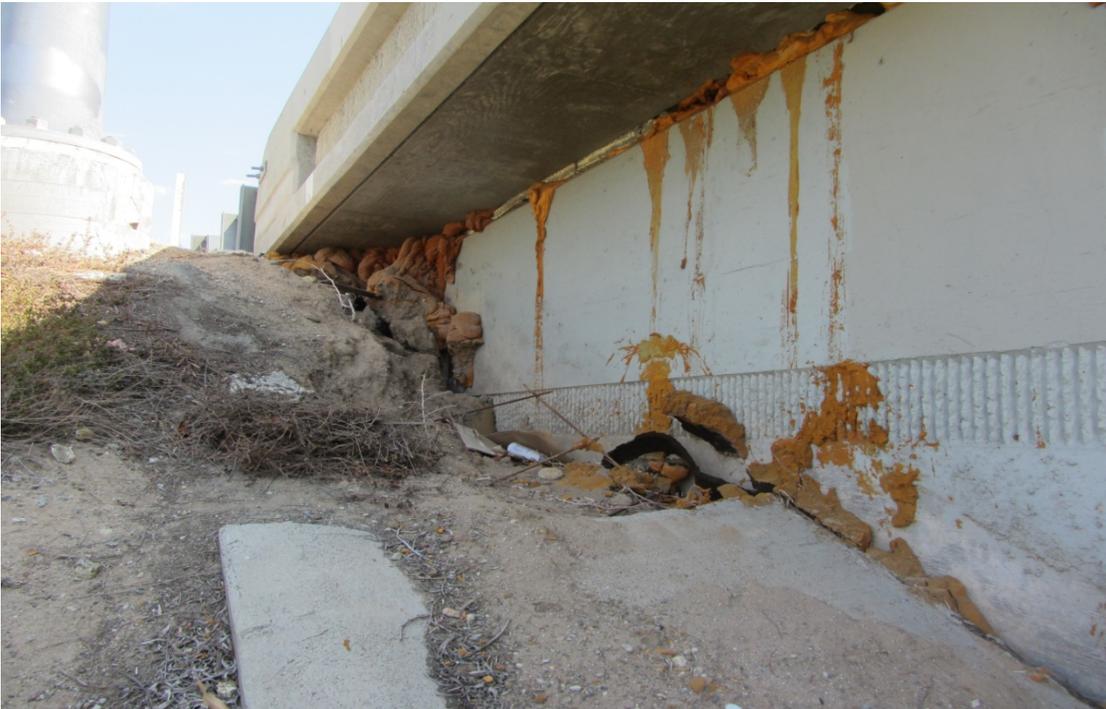
Photograph 10 – Bridge No. 55-0773L – Abutment 3L – Upper apron on left side experiencing severe erosion due to unfinished construction.

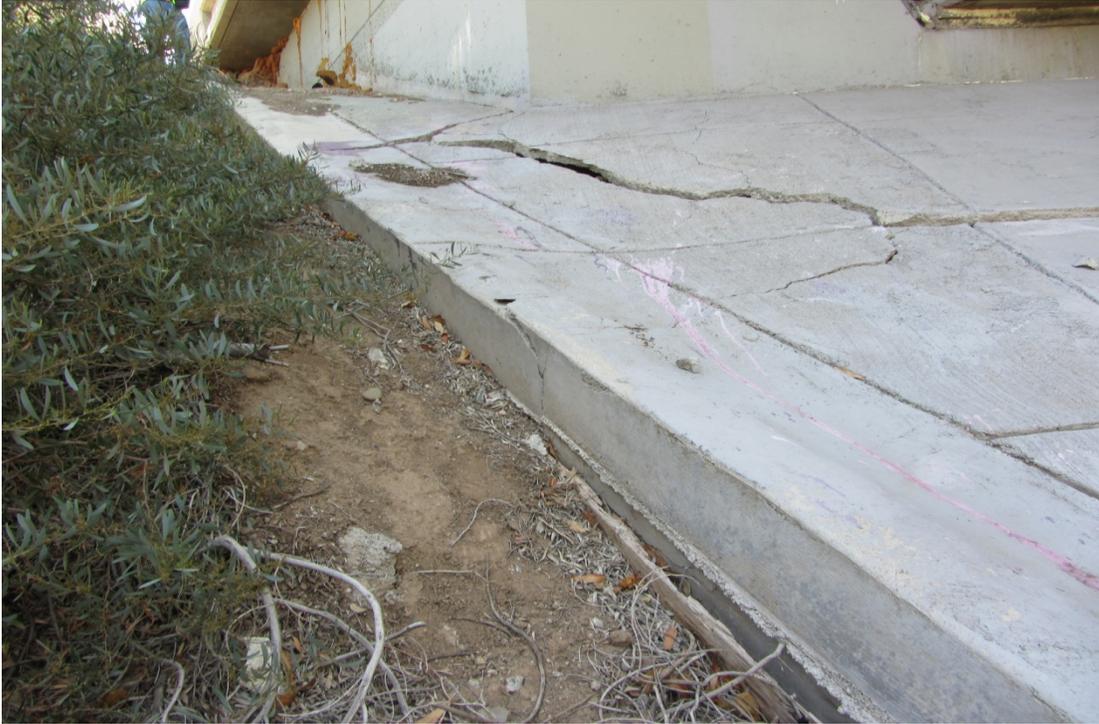
Photograph 11 – Bridge No. 55-0773R – Abutment 3R, Damage to left side of Apron and adjacent erosion.

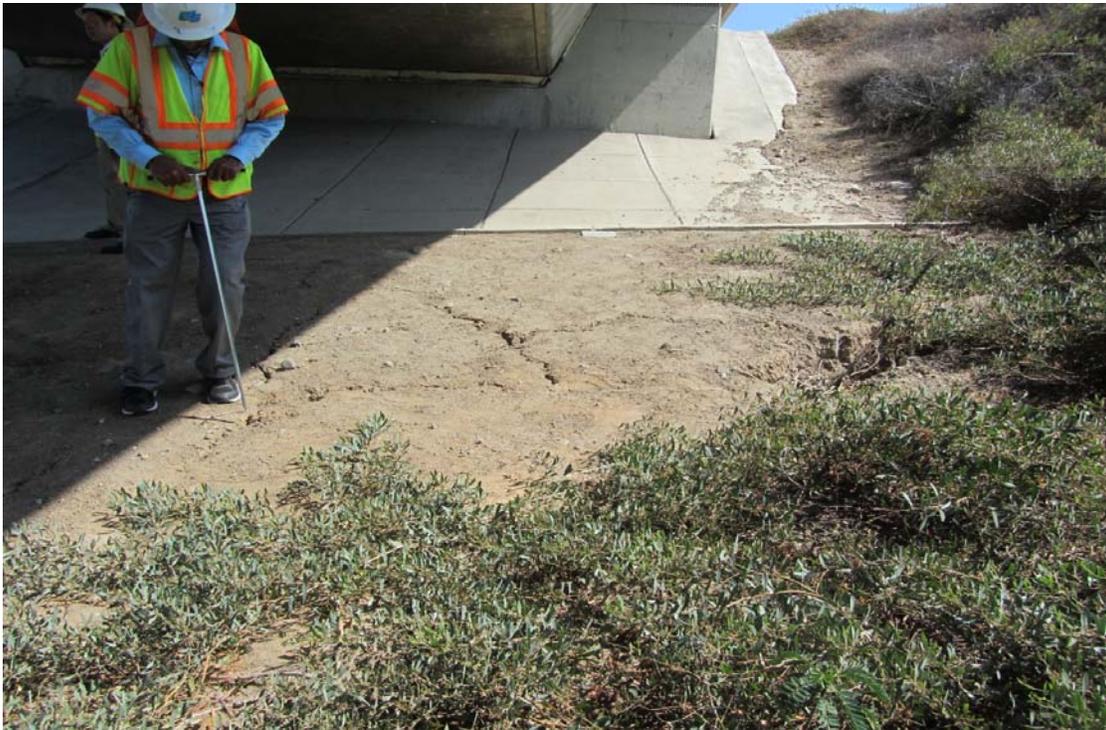
Photograph 12 – 55-0771F, Abutment 11. View of Loose Soil Around Apron. Soil is shown encroaching on apron on right side.

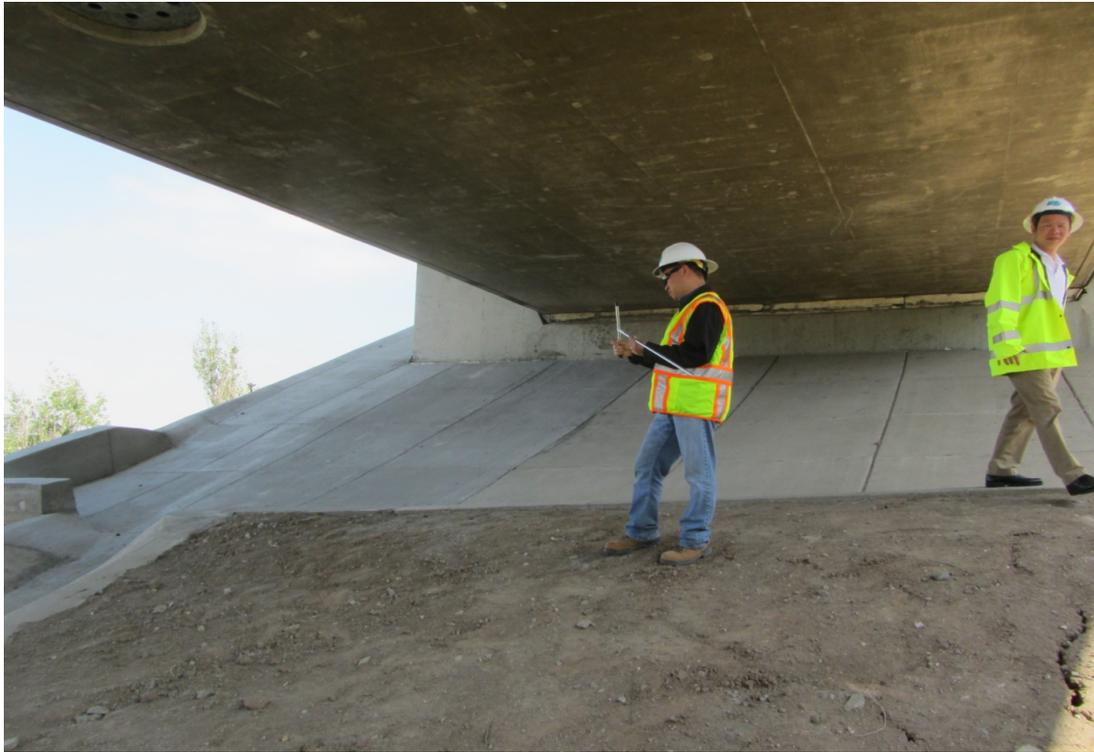
Photograph 13 – Bridge No. 55-0771F, Abutment 11. Rebuilt portion of Apron is shown center Left.
