CA-DOT-TL-6490-1-75-47

Dynamic Tests Of Breakaway Lighting Standards Using Small Automobiles

December 1975

Office of Transportation Laboratory
California Department of Transportation
Sacramento, California 95819

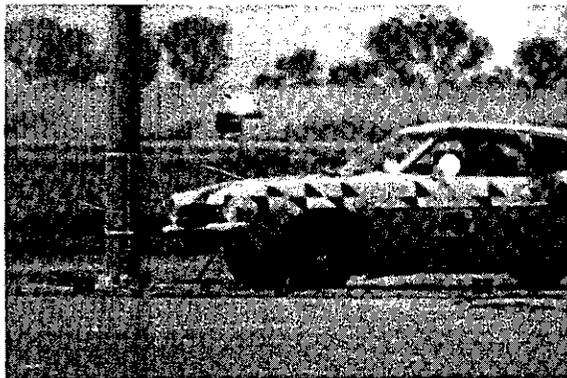
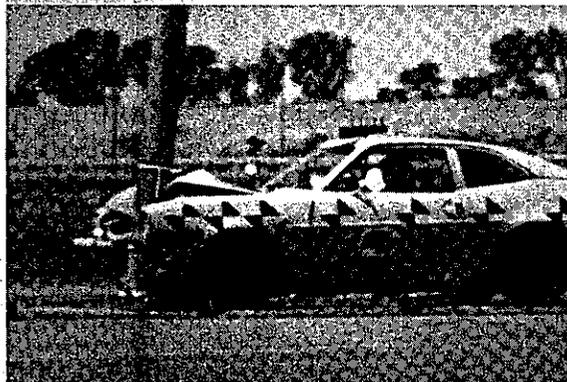
VEHICLE.....	1971 Pinto coupe
VEHICLE WEIGHT.....	2265 lbs.
(including dummy and instrumentation)	
DUMMY RESTRAINT.....	Lap belt only
IMPACT VELOCITY.....	34.5 mph
IMPACT ANGLE.....	30° from edge of pavement
MOMENTUM CHANGE.....	.746 lb. sec.
VEHICLE DAMAGE (measured at bumper ht.).....	18.5"
VEHICLE DECELERATION (max. 50 msec avg.)	
LATERAL.....	1.00 G's
LONGITUDINAL.....	4.85 G's
VERTICAL.....	3.55 G's

TEST NO.....	312
DATE.....	May 30, 1975
TYPE OF LIGHT STD.....	31
POLE BASE OUTSIDE DIAM.....	10 3/4"
MOUNTING HEIGHT.....	40'-0" ±
PROJECTED LENGTH OF MAST ARM.....	30'-0" ±
BREAKAWAY DEVICE.....	typical for Caltrans
Type 30 and 31 lighting standards

Figure 11. TEST 312 DATA SUMMARY SHEET.

Figures 10 and 11 illustrate details of the two tests. The mast arm was at an angle of 60° to the vehicle approach line which results in the base being oriented in the direction that provides the greatest resistance to slip.

The proposed velocity of 40 mph (64.4 km/hr) was not attained due to missfiring of the engine of the vehicle. The vehicle impacted the pole at 34.5 mph (55.5 km/hr), similarly crushing the front of the car as in crash Test 311. The car slowed to 27.3 mph (43.9 km/hr), which occurred .218 seconds and 9.0 ft (2.74 m) after impact. The pole began to uplift about 7 ft (2.1 m) after impact and kicked up, clearing the roof by 6.5 ft (2.0 m). The top of the main pole hit the ground first, adjacent to the footing, and the pole came to rest at an angle of about 25° to the vehicle path. The luminaire arm and main pole remained intact with the tip of the luminaire arm located 3.5 ft (1.1 m) outside the imaginary traffic lane. The luminaire broke off of the luminaire arm immediately after car/pole impact and shattered upon hitting the asphalt concrete surface. Slip base bolt No. 5 (see figure 8) stayed with the bottom half of the slip base. The other two slip base bolts flew forward, one remaining with the keeper plate. The keeper plate and base plate after Test 312 (Test 311 similar) are shown in Figures 14 and 15. The emergency braking system in the car was finally applied to stop the vehicle 100 ft (30.5 m) past the impact point with the left rear wheel coming to rest about 3 ft (0.9 m) to the right of the approach line.
