Development And Evaluation Of Raised Traffic Lane Markers,  
1968 to 1971

# HIGHWAY RESEARCH REPORT

## DEVELOPMENT AND EVALUATION OF RAISED TRAFFIC LANE MARKERS

71-20

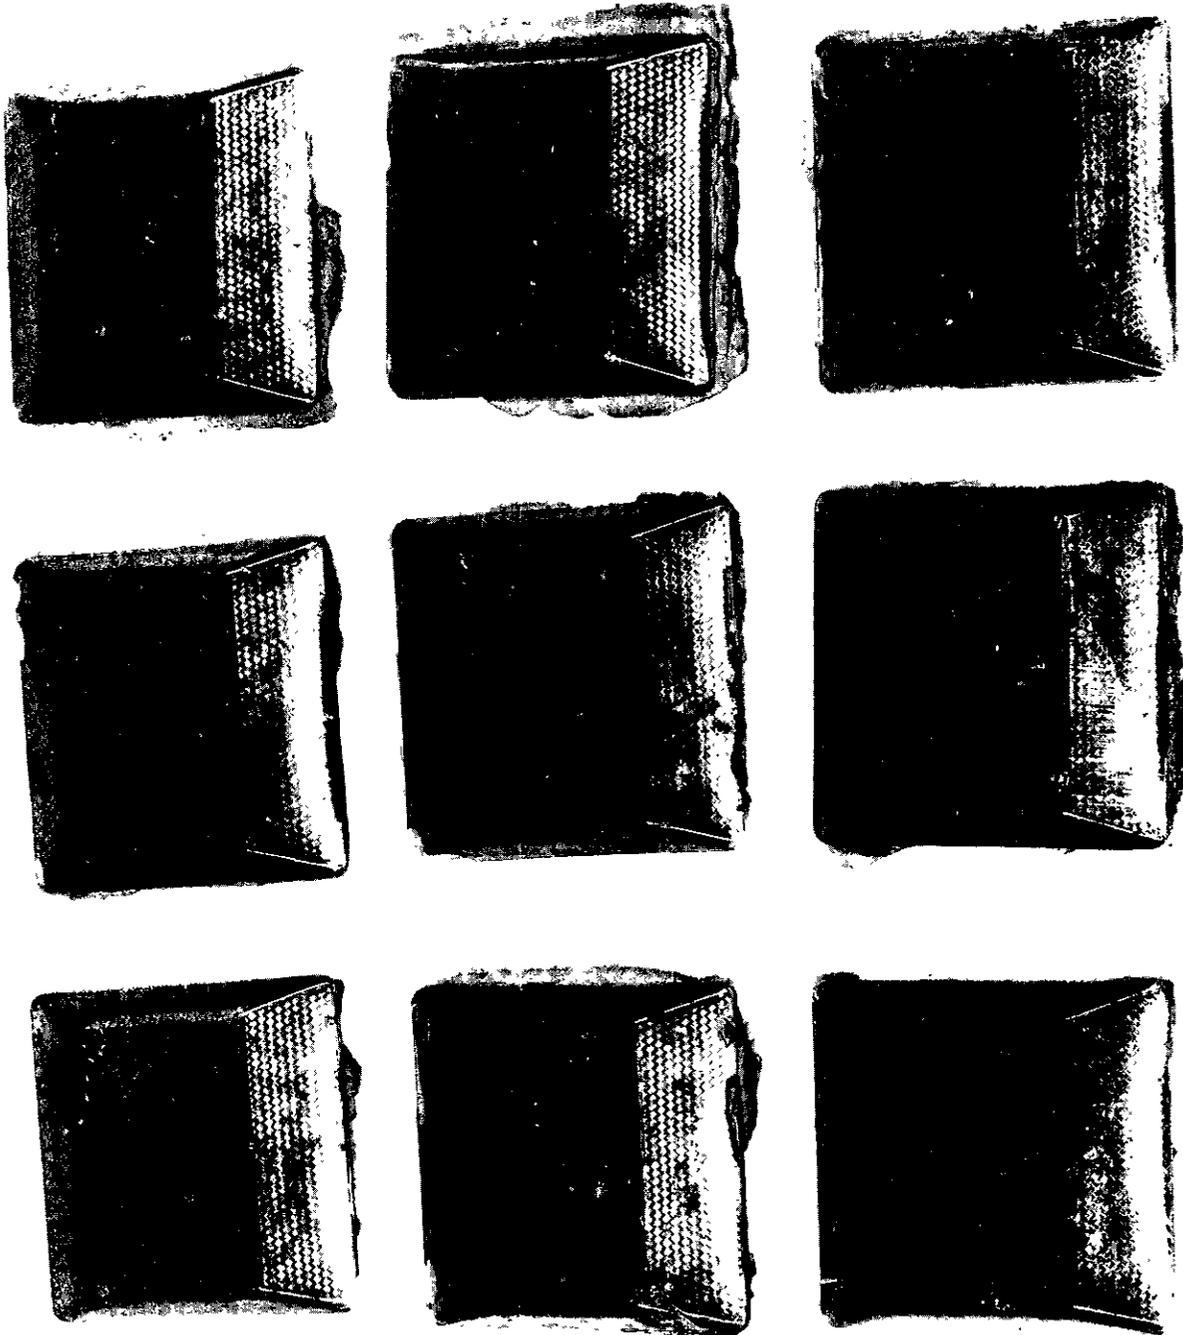
FIGURE 1

The average reflectance of these markers after 3-1/2 years of road service was 0.07. All markers had only very slight damage to the lens area. Most of the damage consisted of small pits which were most likely caused by rocks in the treads of tires. Only a very small percentage (10%) of the markers had any significant erosion of the marker casing.

These markers were removed in June, 1969 and were moderately covered with tire stain. This tire stain was removed in the laboratory with a mild ammonia soap solution which approximates tire wiping action during rain. The average reflectance was then increased to 0.14.

It is expected that these markers would continue to be efficient as nighttime delineators for another five years.

Test Area I I-80 Near Vacaville Between Lanes 1 and 2.

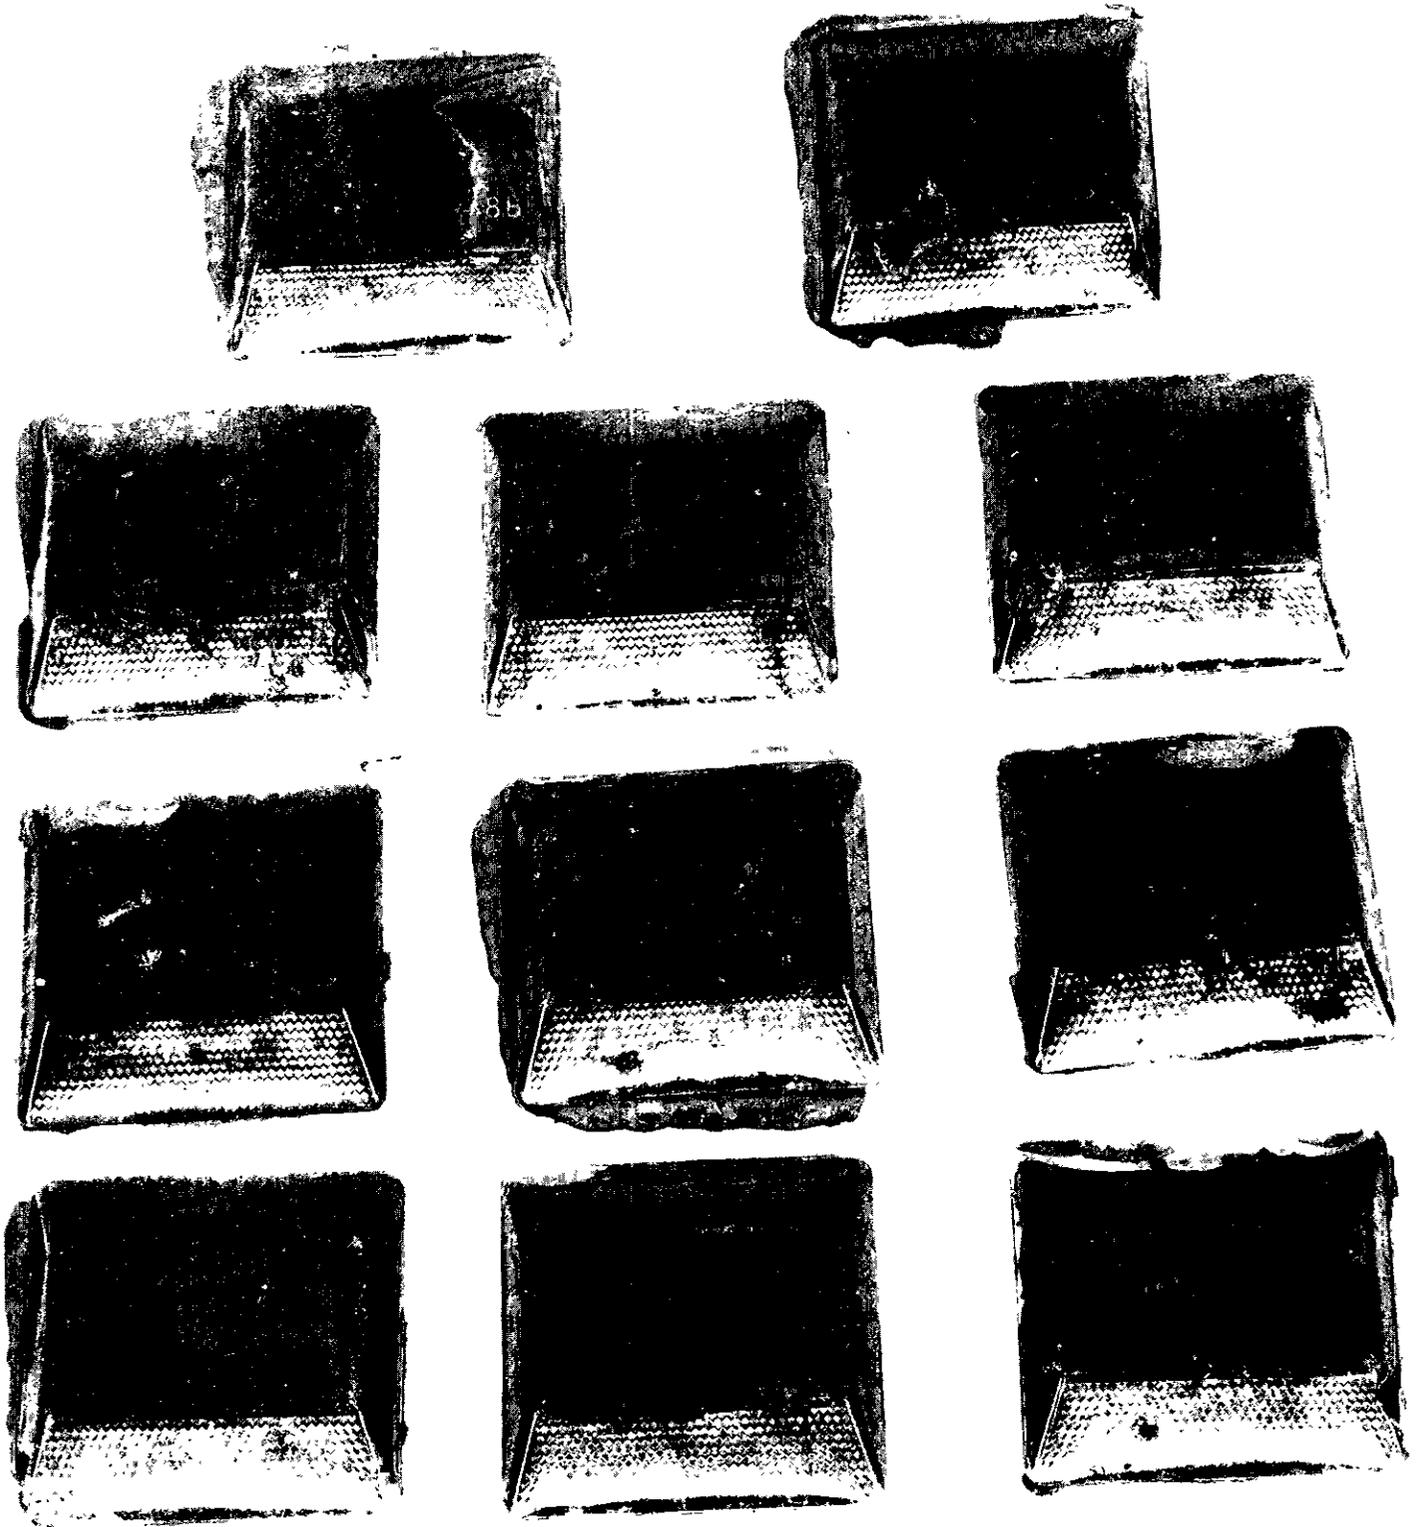
FIGURE 2

In spite of the fact these markers had a slightly higher average reflective (0.07) than the ones between Lanes #1 & #2, these markers showed slightly greater damage to the casings and lens area. As with most locations inspected, the markers in the low speed traffic lanes show greater deterioration than markers between lanes #1 and #2. Trucks and the heavier highway vehicles usually use #2 and #3 lanes of the roadway.

After these markers were cleaned in the laboratory, the average specific intensity increased to 0.14.

It is expected that these markers would also continue to be effective as nighttime delineators for another three to five years.

Test Area I I-80 Near Vacaville Between Lanes 2 and 3.

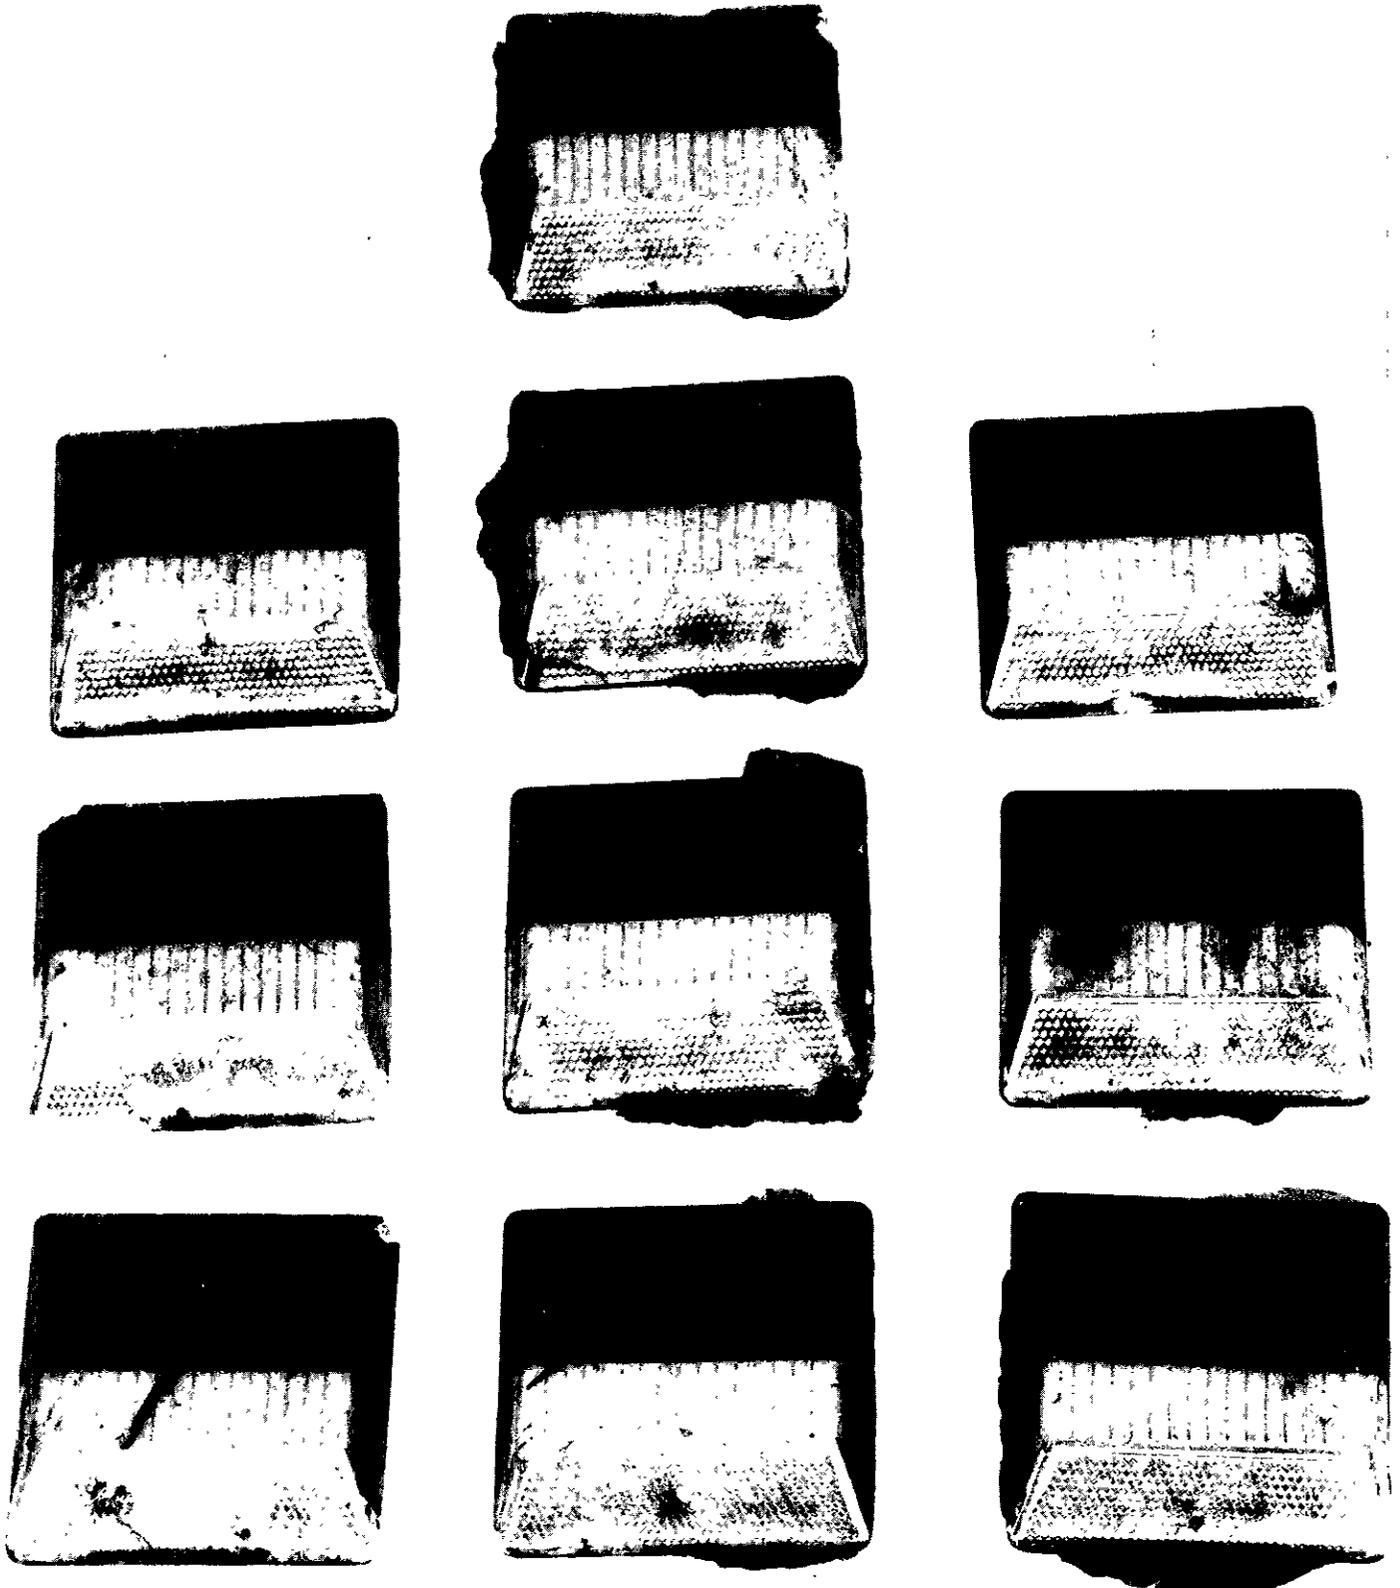
FIGURE 3

The photograph shows the condition of the markers after three years of road service. As can be seen, the lens damage was slight to moderate enabling the markers to remain effective nighttime delineators.

The average reflectance of these markers as measured in the laboratory, when new, had a specific intensity of 6.0. After three years service, the average value was 0.18.

Test Area 2 South Sacramento Freeway Between Lanes 1 and 2.

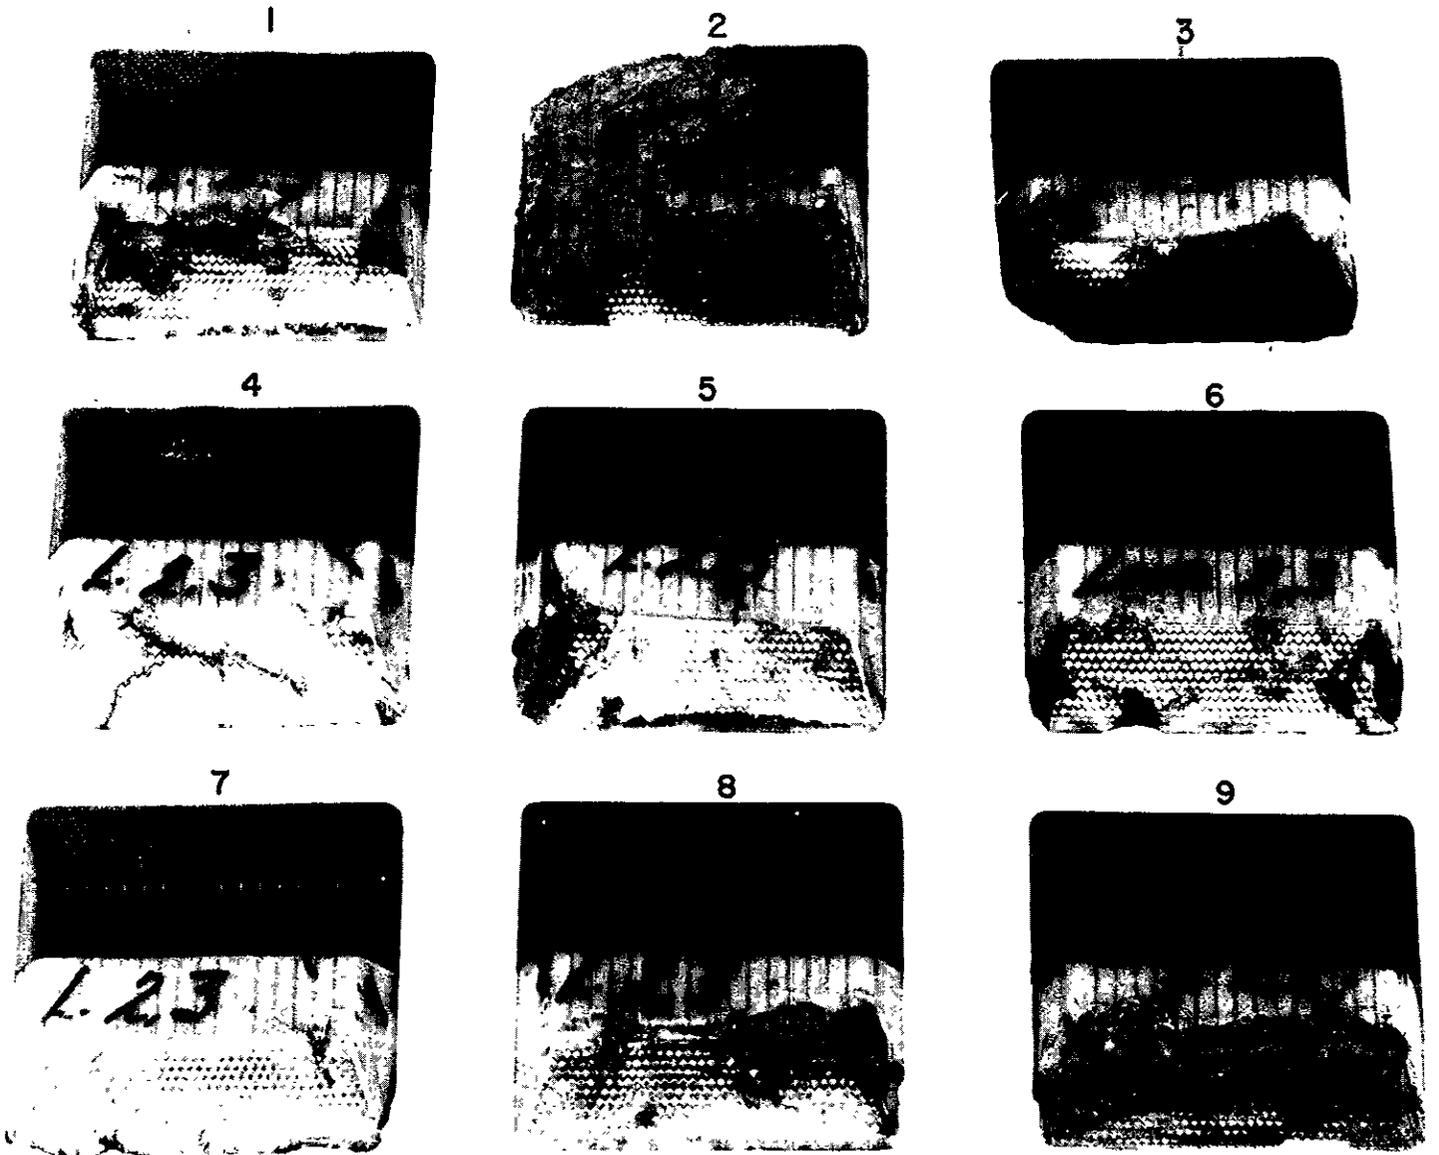
FIGURE 4

An important feature of this group of markers is the various degrees of damage. Marker (#7) had the least damage with marker #2 having the greatest damage. The following table lists the markers and their respective reflectance.

Marker #	Reflectance
1	0.07
2	0.00
3	0.01
4	0.09
5	0.10
6	0.10
7	0.17
8	0.02
9	0.00

This group of markers shows the type of damage usually seen under heavy traffic. Some markers may be nearly destroyed while adjacent markers will be in fair to good condition.

Test Area 2 South Sacramento Freeway Between Lanes 2 and 3.

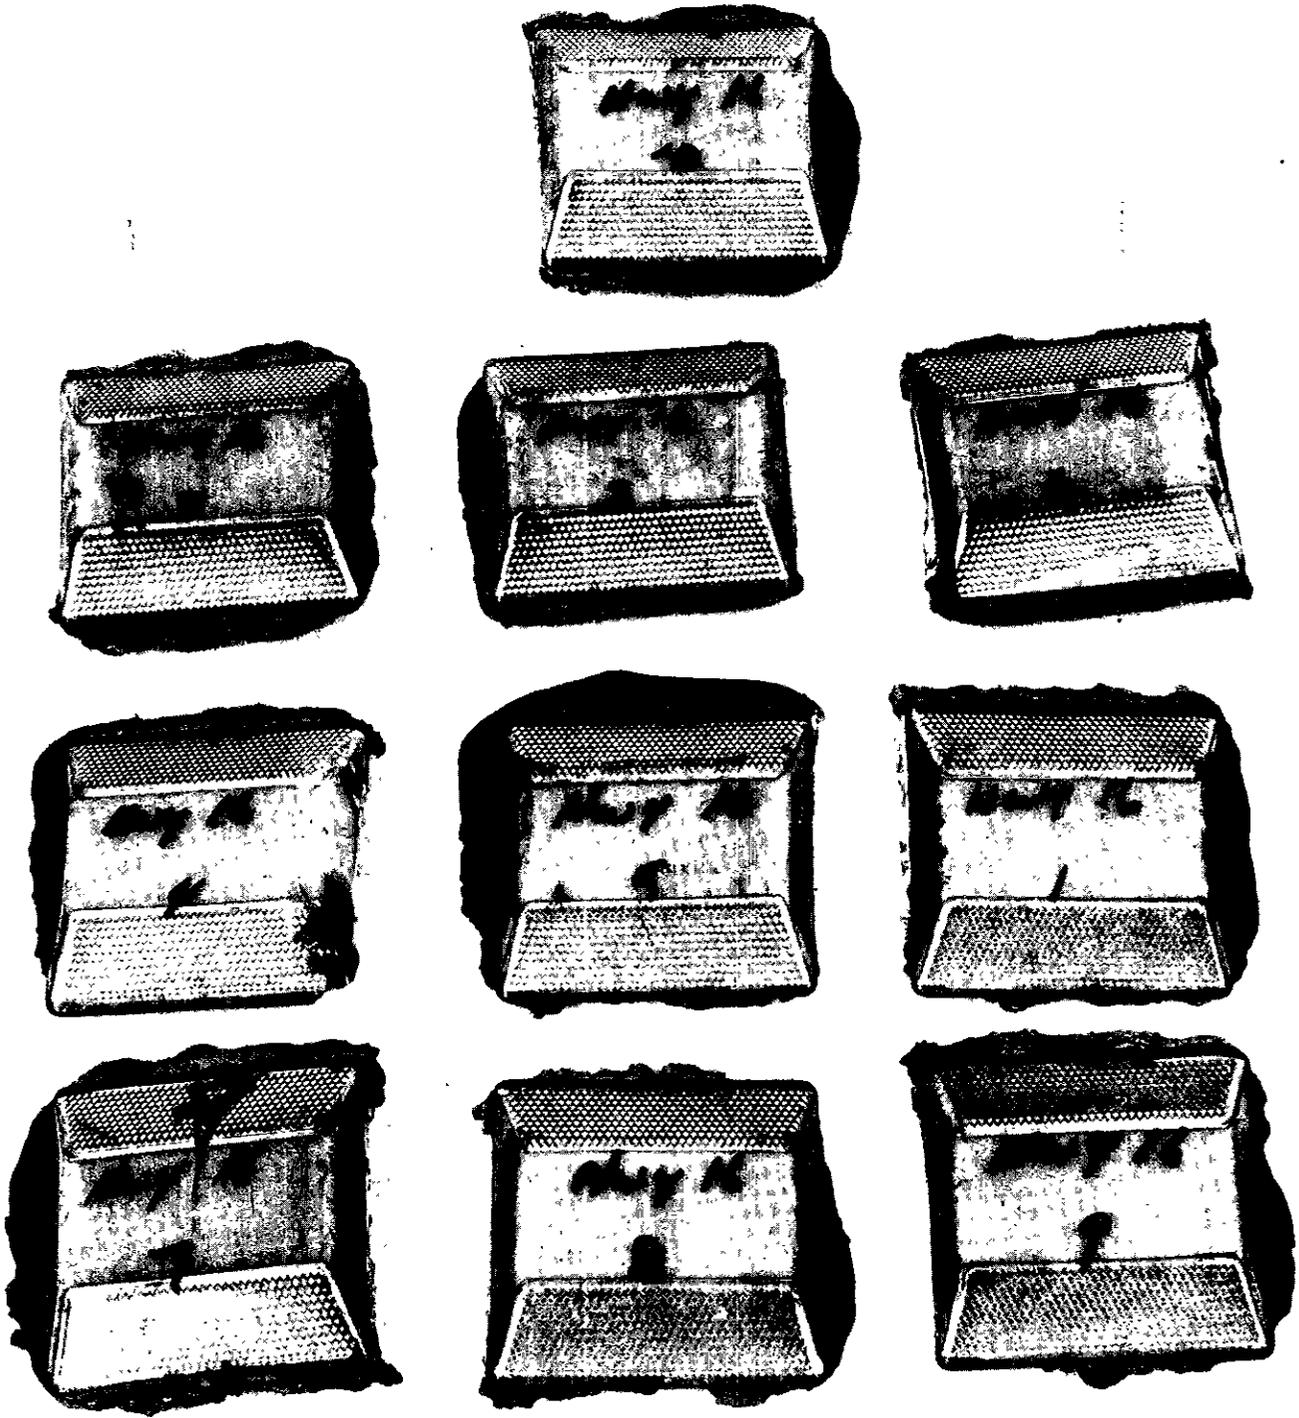
FIGURE 5

These markers were removed after two years service. After two years, the average specific intensity was 0.08 as measured in the laboratory. This low reflectance is caused by numerous small scratches in the lens surface.

As can be seen in the adjacent photograph, only one marker showed evidence of major case damage. All other lens areas are entirely intact.

It would be expected that these markers would continue to provide adequate nighttime delineation for an estimated service life of up to 10 years or more.

Test Area 3, Highway 16, 2-Lane 2-Way Road.

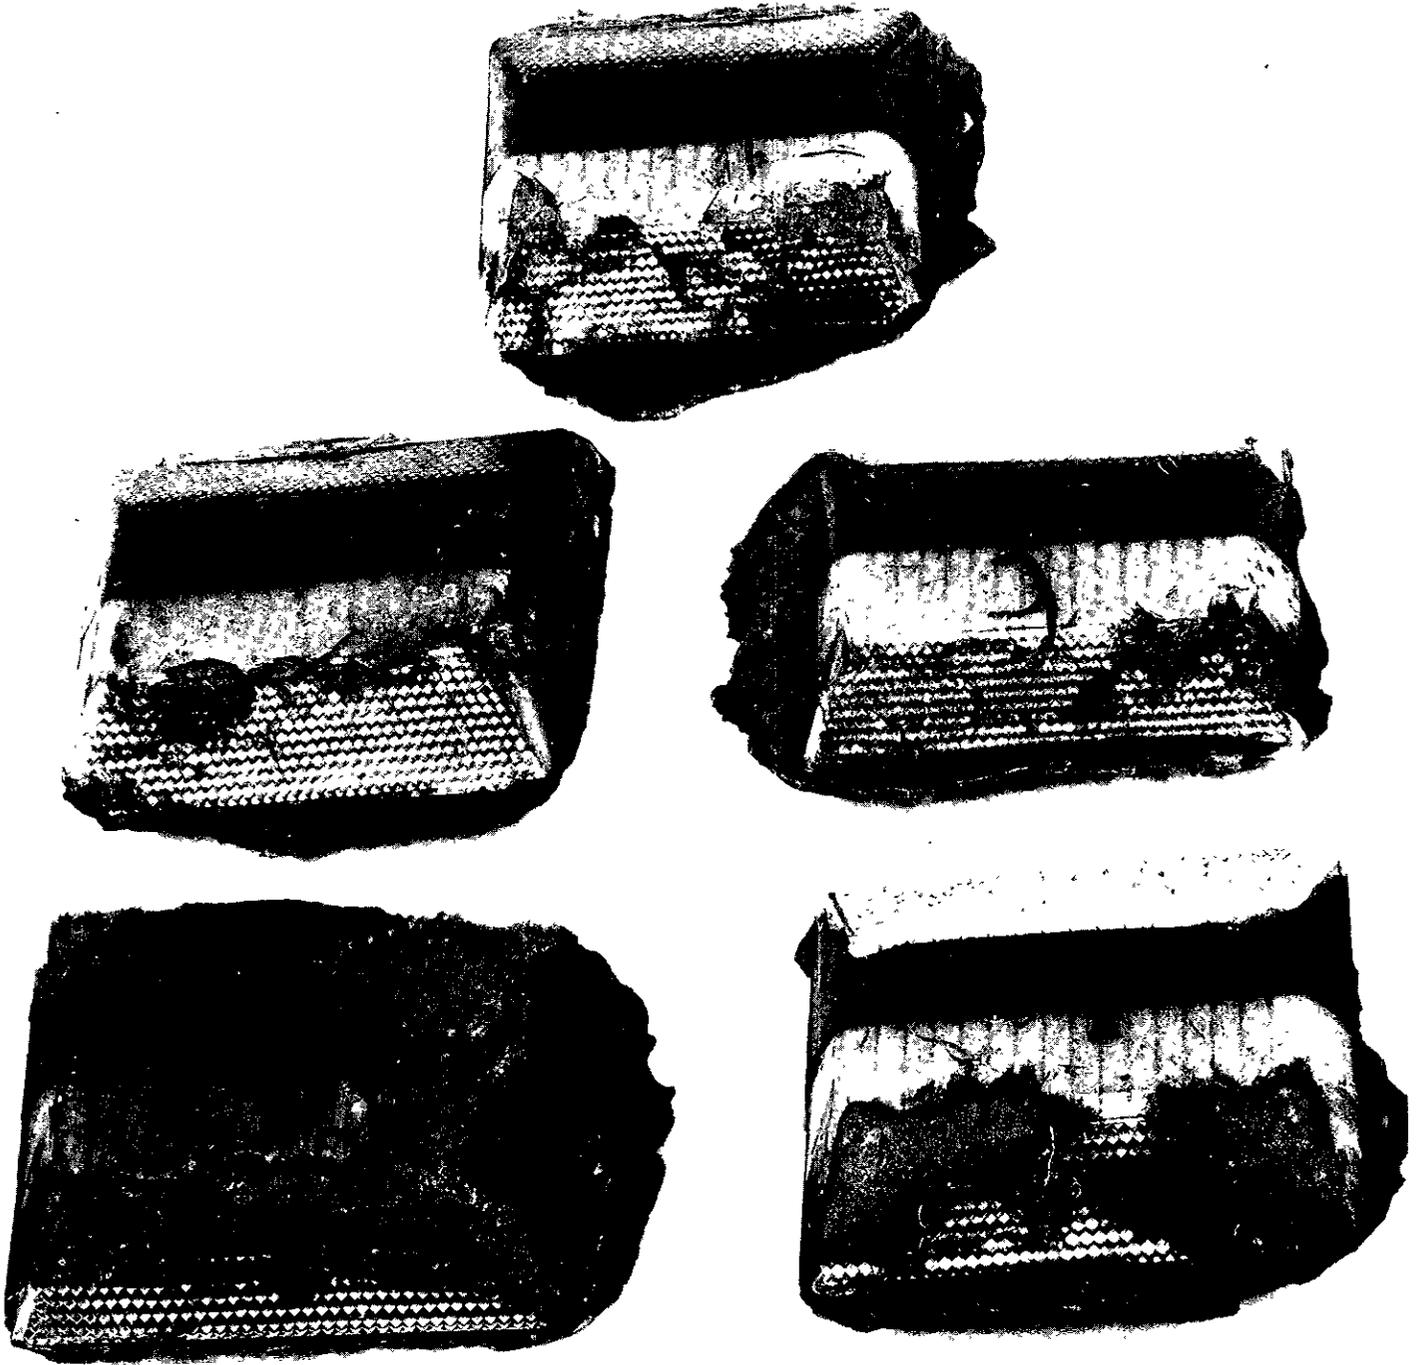
FIGURE 6

During nighttime observations in October 1969 it was observed that several markers in the westbound approach area of the Pioneer Bridge, in the outside lane, had lost most of their reflectance. It was decided to remove some of these acrylic cube corner markers for laboratory inspection.

Five adjacent markers are shown in the photo on the left. Four of the markers had a reflectance of 0.00 as measured in the laboratory. The marker at top center had a reflectance of 0.01.

This group of markers had been on the road approximately 2-1/2 years and showed the greatest wear and damage of any area under observation for such a period of time. These markers were removed from an area where the frequency of tire impacts is high. There is one off ramp near the area where the badly damaged markers were removed. The damage was severe enough to suggest that other factors, such as impact from a rim on a flat tire may have been responsible for part of the damage.

Pioneer Bridge West Bound Between Lanes 3 and 4.

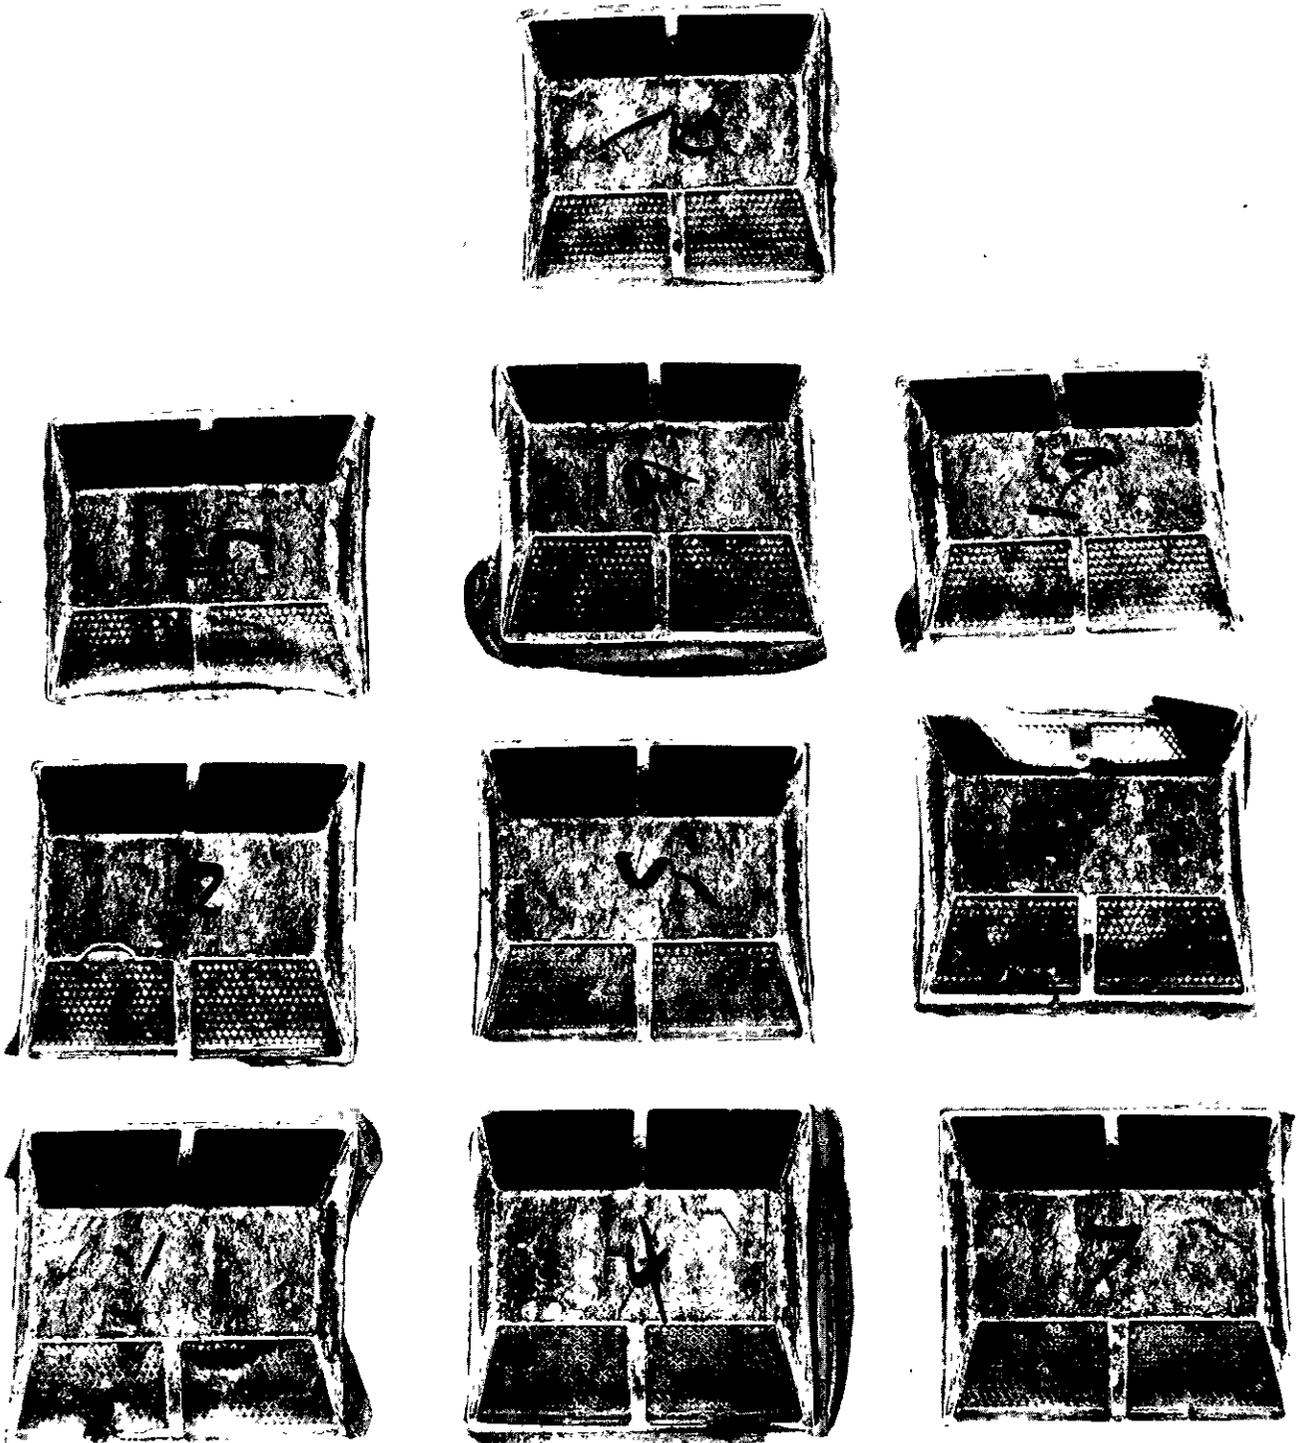
Figure 7a

- I. The ABS shell Stains more under traffic then the acrylic shell of Stimsonite.
- II. The angle of light for the picture caused the markers to appear darker.

The following lists the markers and their respective specific intensity:

<u>Marker No.</u>	<u>Specific Intensity</u>
1	0.18
2	0.11
3	0.20
4	0.12
5	0.16
6	0.09
7	0.11
8	0.08
9	0.19
10	0.15
Average	0.14

Test Area 6, South of Florin Road, South  
Sacramento Freeway, between lanes #1 & 2.

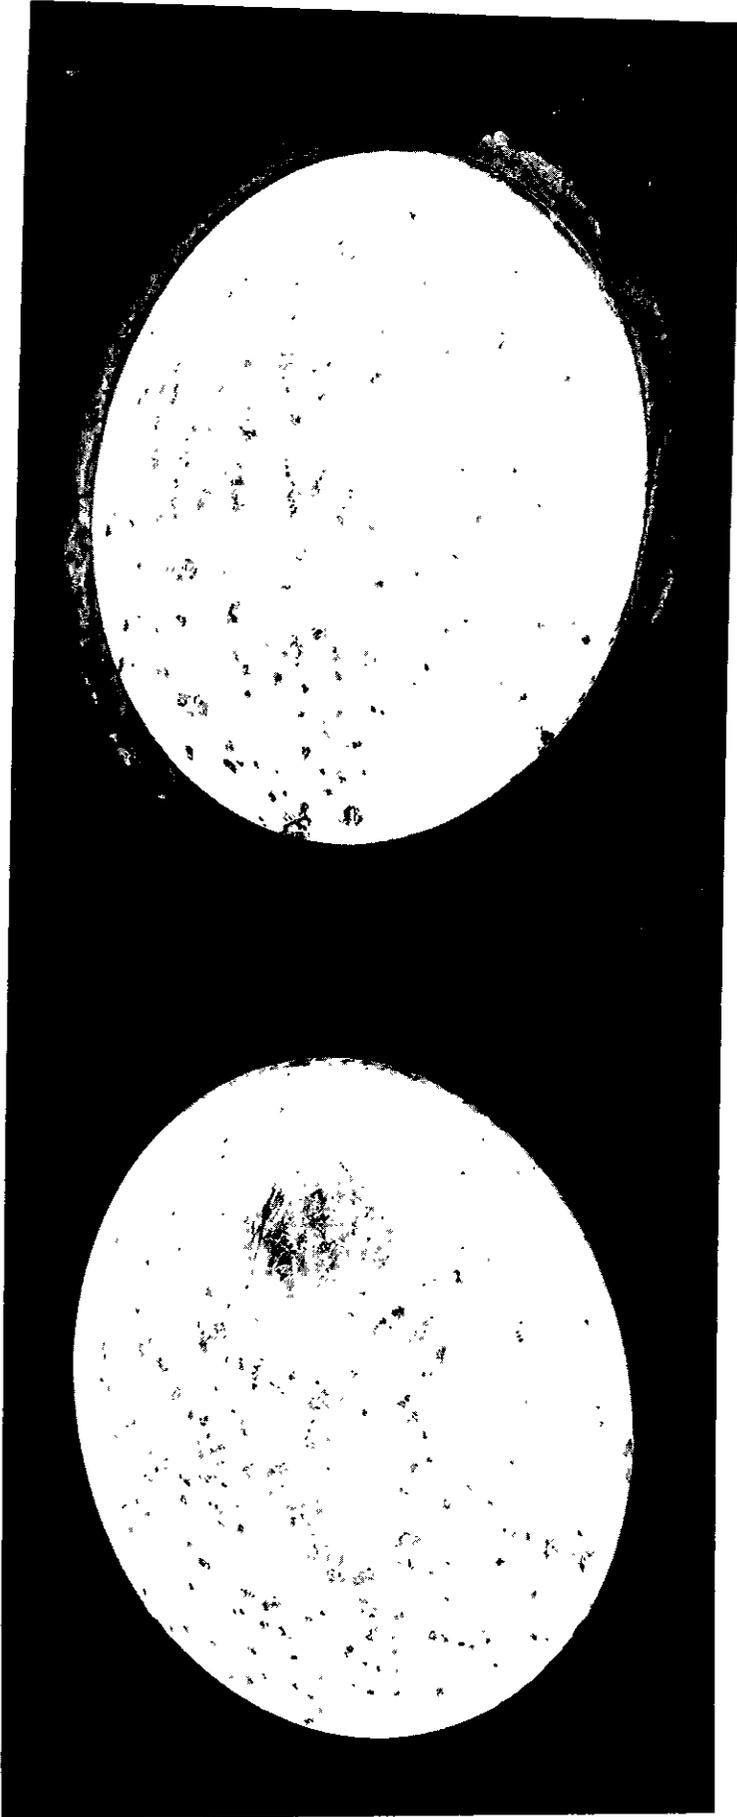
Figure 8

In the last marker report published in 1968 it was estimated that 5 to 8% of the surface of the ceramic marker would be pitted within 10 years. It was also predicted that the glaze would become frosted. This prediction has generally been valid although in some areas pitting has been more severe than expected. Under one-way traffic the pitting has occurred mostly on the leading edge of the marker. The body of the marker is white which provides adequate visibility in the daytime when clean. However, the pits rapidly collect dirt or tire stain which detracts from their visibility during daytime dry weather, and whether clean or dirty, delineates poorly in nighttime clear weather.

Ceramic Marker

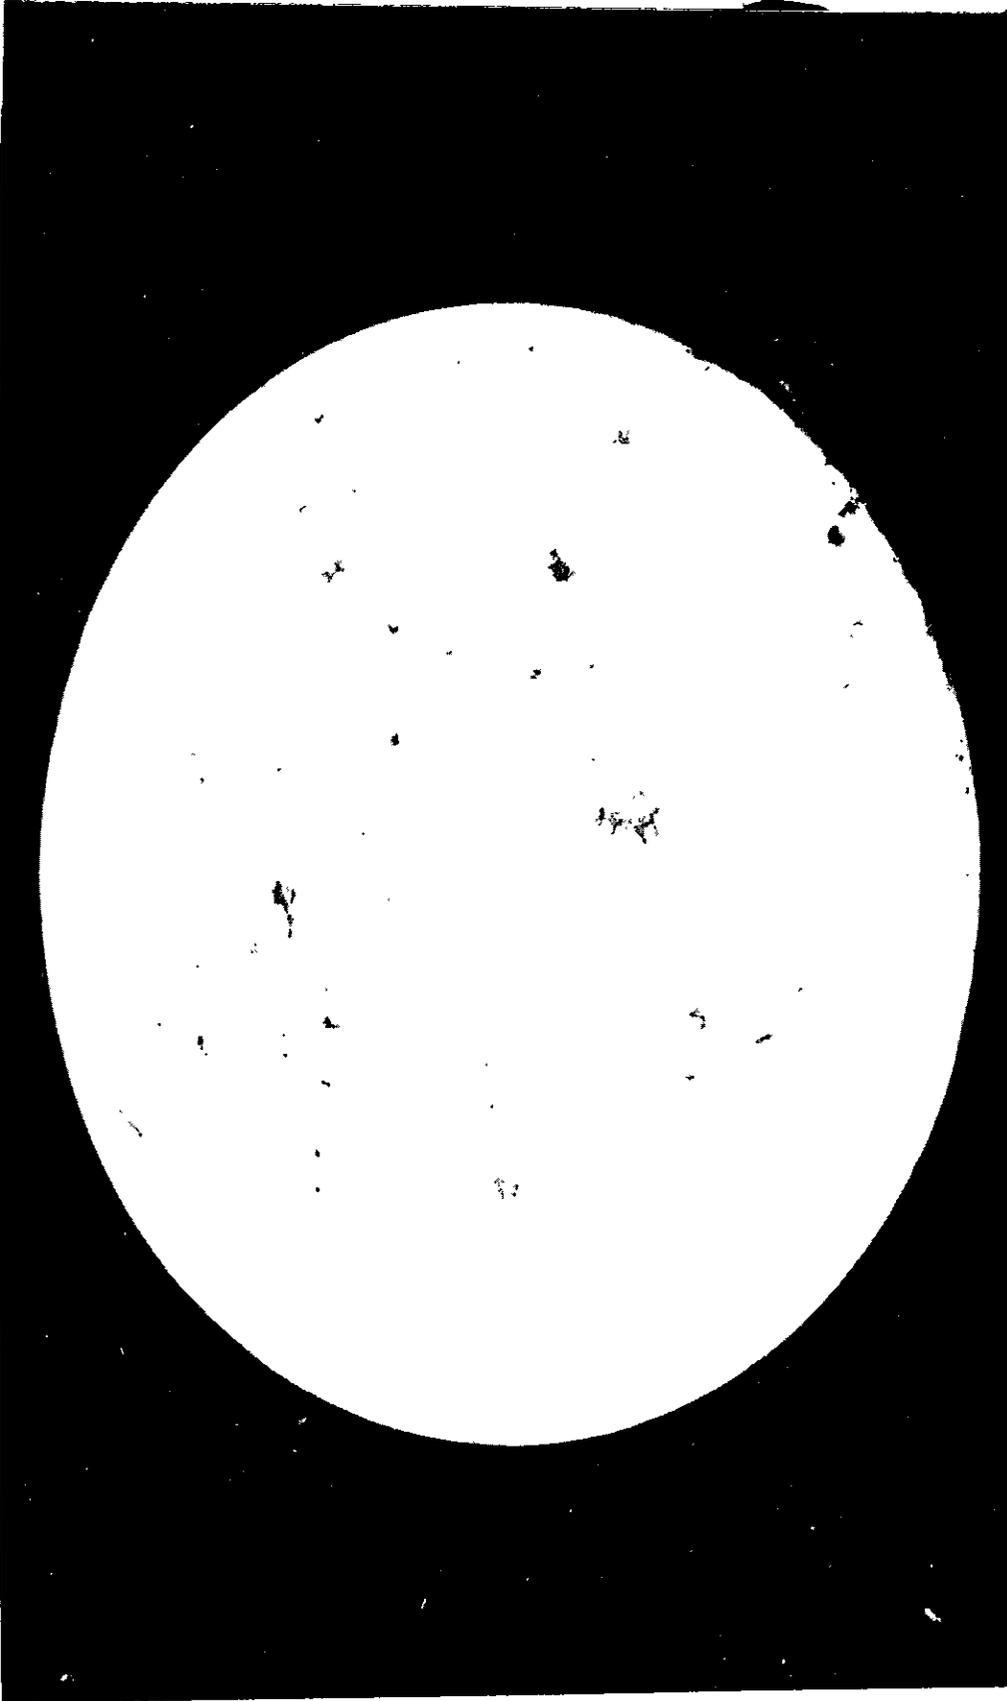
Figure 9

These markers were removed from US 99 a few miles south of the 47th Avenue test section on the South Sacramento Freeway. This is a 4 lane freeway with a traffic density of about 30,000. The damage to these markers is the most severe observed to date. The left marker was removed from a curve, the right marker from a tangent section. The pitting generally extends below the glaze and covers an estimated 12% of the total surface for the left marker and 6% of the right marker. One possible explanation for this damage is the use of studded tires which have been permitted since our initial evaluation of ceramic markers. This roadway probably carried a moderate amount of traffic which might be expected to use snow tires. Some imprints were observed on reflective markers in this area that looked like an imprint of a stud typically used in tires.

Ceramic Marker

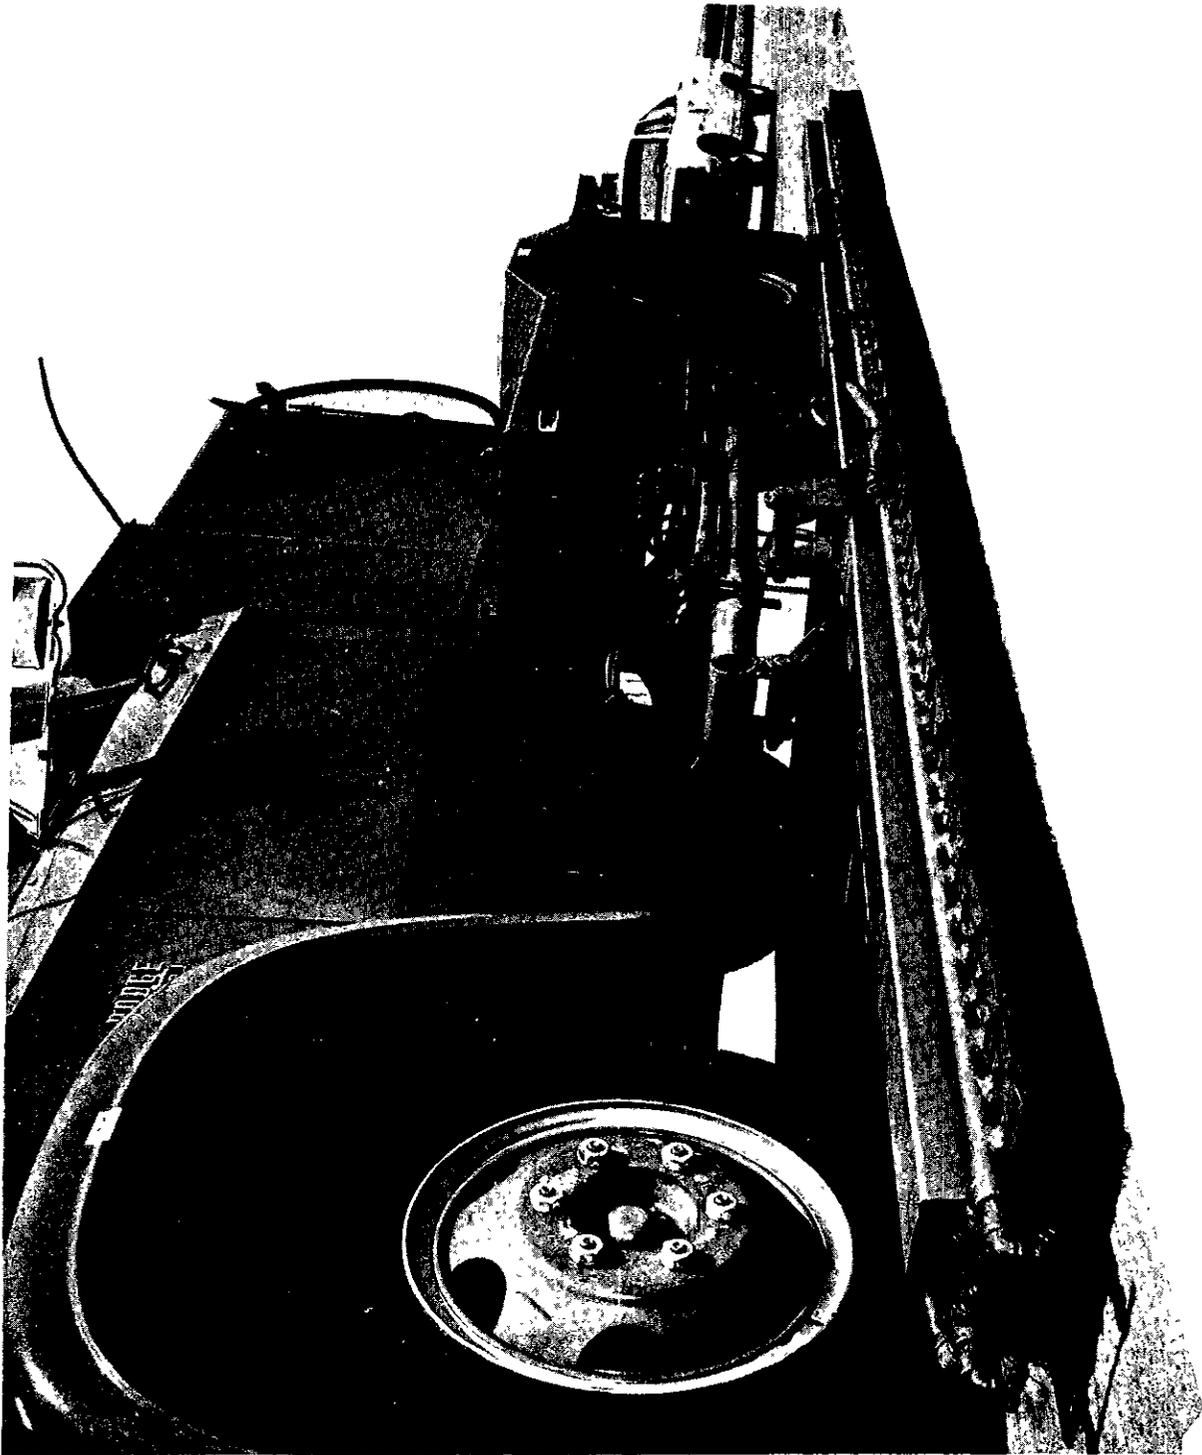
A traffic marker washer has been developed by the State of California Equipment Shops, see Figures 10 and 11. This consists of a brush 14" wide by 18' long with 4" nylon bristles which have been impregnated with an abrasive. This unit is mounted beside a 2 ton truck and a detergent water solution is supplied to the brush. Effective cleaning is obtained at speeds of 45 mph. This machine has been used in five districts.

FIGURE 10  
Marker Washing Device

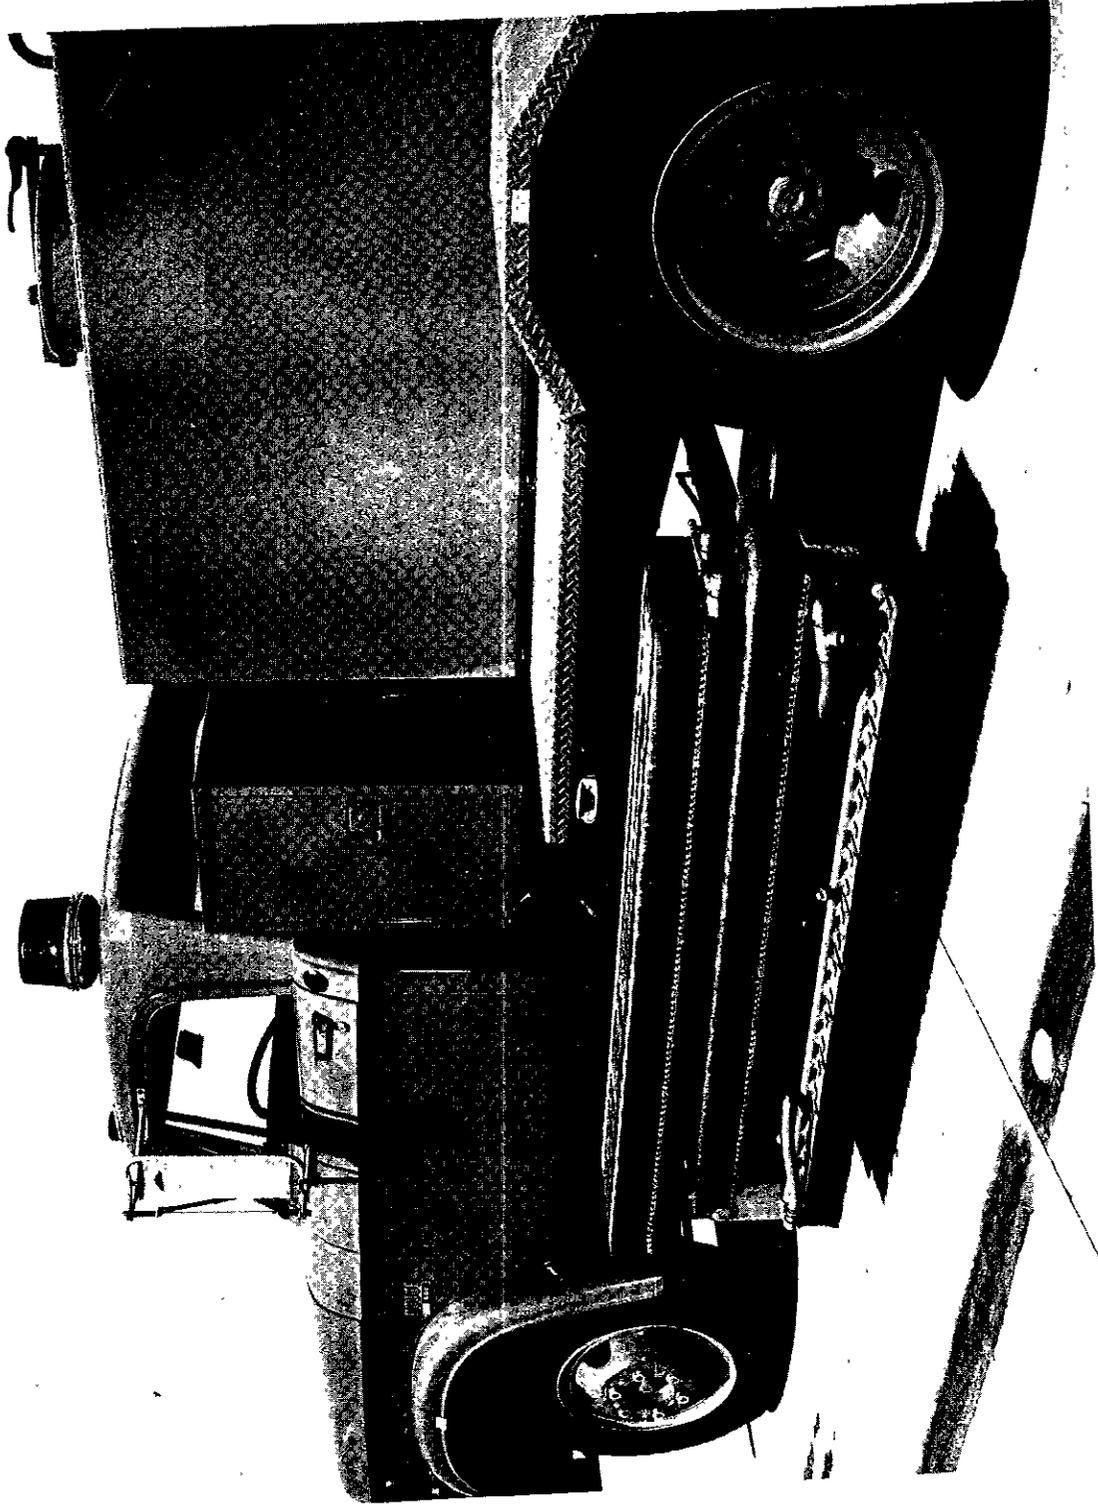
FIGURE 11  
Marker Washing Device  
(Folded for Transporting)

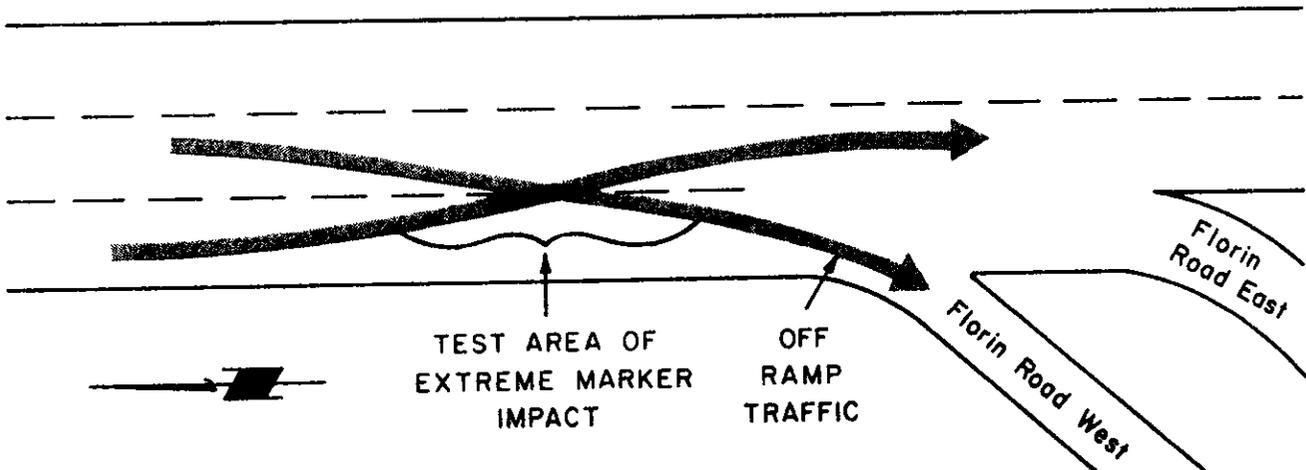
Most of the markers to be evaluated are placed on the South Sacramento Freeway. This is a six lane freeway carrying about 35,000 vehicles daily in each direction. One particular area has been of value in providing a test section which duplicates all except the most severe traffic conditions. This area is in the vicinity of the Florin Road off ramps where a three lane section narrows to two lanes forcing most trucks to make a lane change. See diagram.

This situation forces the through traffic in the #3 lane to cross over toward the #2 lane, and any traffic in the #2 lane that desires either off ramp access must cross over toward the #3 lane. Therefore, markers located within about 1000 feet of the Florin Road West off ramp are subjected to vehicles changing lanes in both directions, left to right and right to left.
