Development And Evaluation Of Raised Traffic Lane Markers,  
1968 to 1971

# HIGHWAY RESEARCH REPORT

## DEVELOPMENT AND EVALUATION OF RAISED TRAFFIC LANE MARKERS

71-20

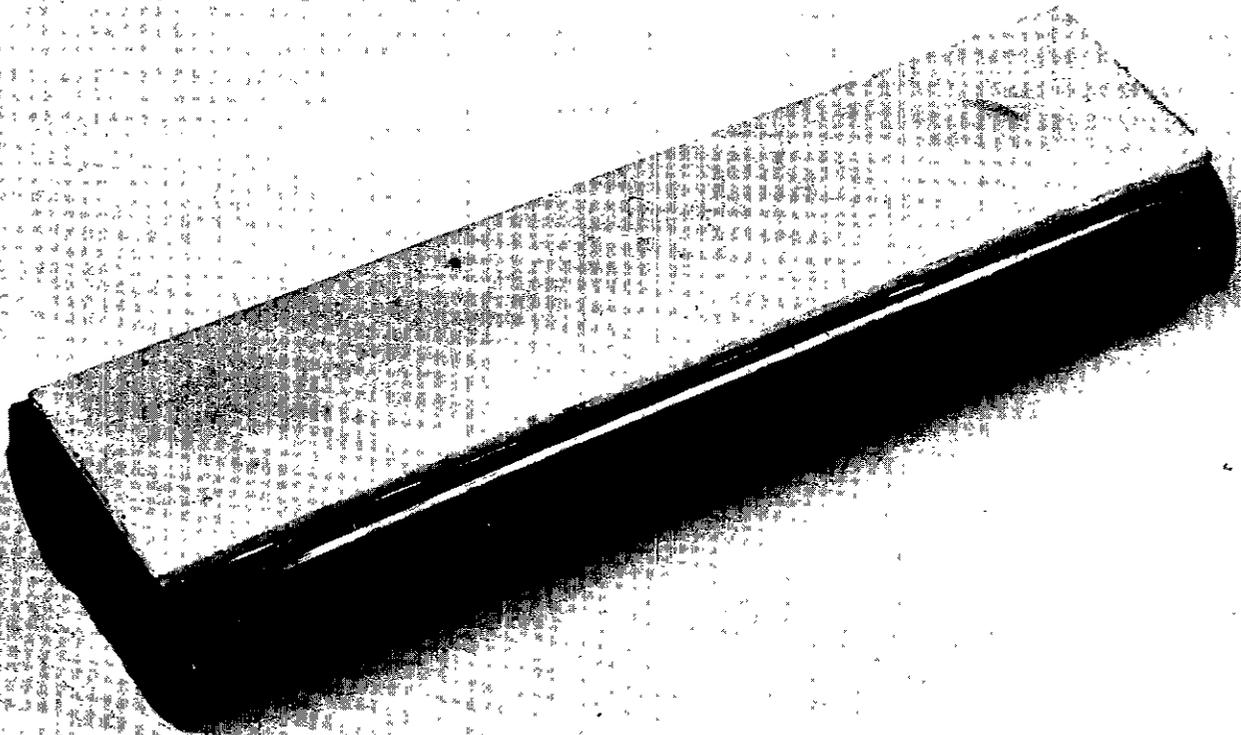
FIGURE 12

REFLECTORIZED TAPE ENCASED BETWEEN TWO  
4 INCH GLASS BARS

This unit consists of a highly reflective tape encased between two glass rods. The top covering is a fibre glass strip to improve impact resistance. It has good initial nighttime visibility with an approximate specific intensity of 4. Several of these markers were placed on freeway areas ranging from light to severe traffic conditions. Markers that were subjected to minimal lane changing showed good nighttime delineation for three years. However, markers that were subjected to continuous heavy lane changing and truck traffic showed a very limited durability of approximately six months. Marker failure was due to the glass rods breaking or severely chipping and total bond failure between the marker and epoxy adhesive.

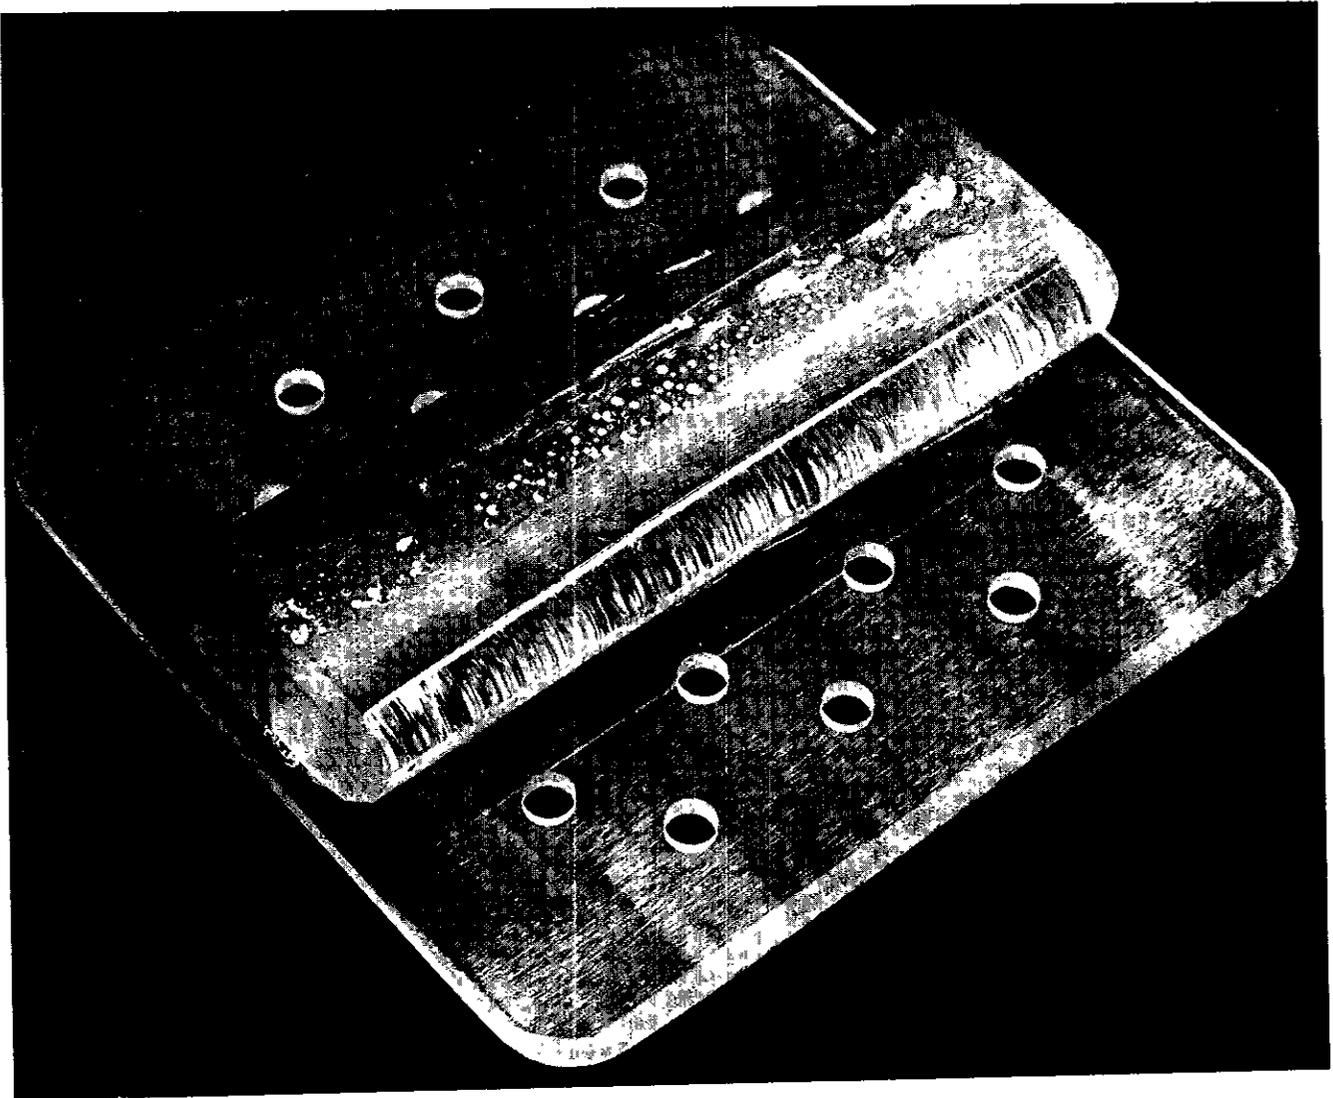
FIGURE 13

REFLECTORIZED TAPE ENCASED BETWEEN TWO  
4 INCH PLASTIC BARS

This unit consists of a highly reflectorized tape encased between two 4" plastic rods with a large plastic base to assist in adhesion to the road. The approximate specific intensity of this unit is 4-1/2. Eight of these markers were placed on the highway in an area of heavy lane changing and truck travel. Observations indicate marker durability of approximately six months under these conditions. Type of marker failure was similar to the four-inch glass rod unit, except about 90% of the failure was due to the marker breaking off the plastic base.

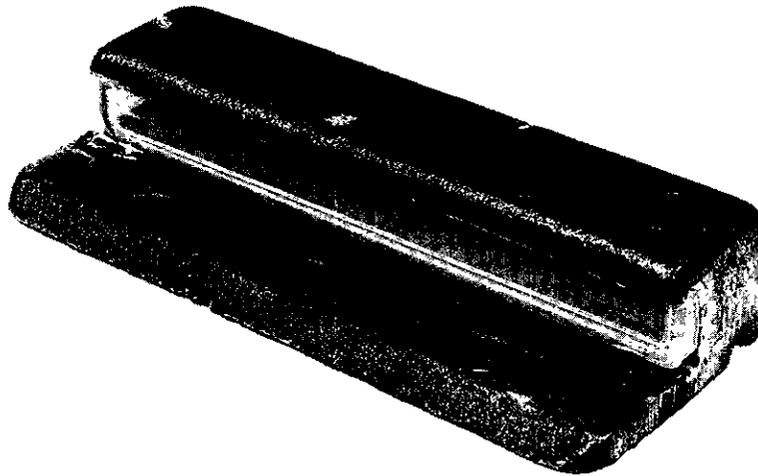
FIGURE 14

METAL CASE WITH REPLACEABLE REFLECTORIZED ELEMENT

The body of this marker is made of either cast iron or aluminum and is designed so that the reflective element can be replaced. Observations of a test installation showed that the markers provided good initial nighttime delineation (approximate specific intensity of 2,) but became invisible after only a few months because of accumulated dirt on the surface of the lens area. Because of the recessed lens, tire scrubbing action during rain is ineffective in cleaning the marker. Thus after field exposure, dirt accumulation remained on the lens area, and the marker became ineffective.

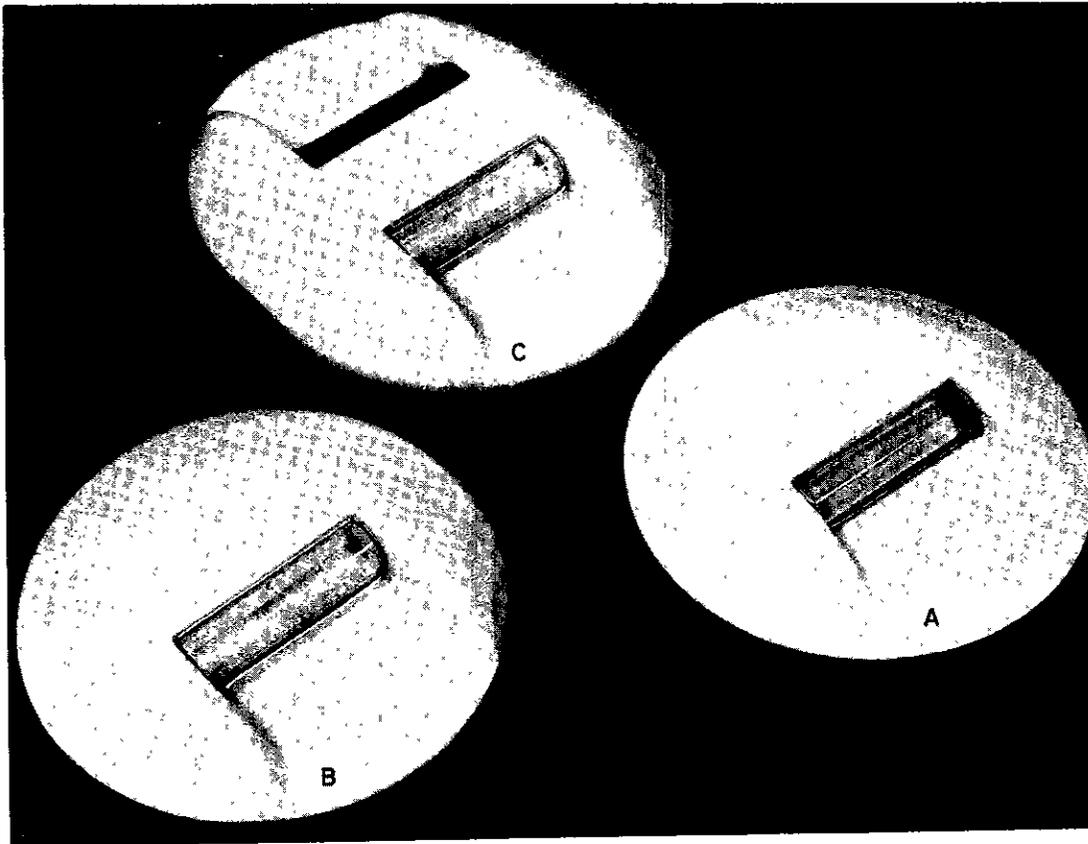
FIGURE 15

CERAMIC DAYTIME MARKERS WITH A REFLECTIVE  
ELEMENT CONSISTING OF AN ENCASED REFLECTIVE TAPE

All four types of units have been placed in test installations on the highway. The unit in Picture A was not satisfactory for nighttime visibility due to breakage of the glass rods which occurred after several months of service. The model with the quarter-round acrylic rod is still under test. The daytime visibility of all types is about that of a regular ceramic marker. There has been some cracking of the ceramic marker due to the configuration needed to hold the reflective elements but this is not as serious as with a similar unit previously tested.

Units (B) and (C) have been recently installed and evaluation is not complete at this time.

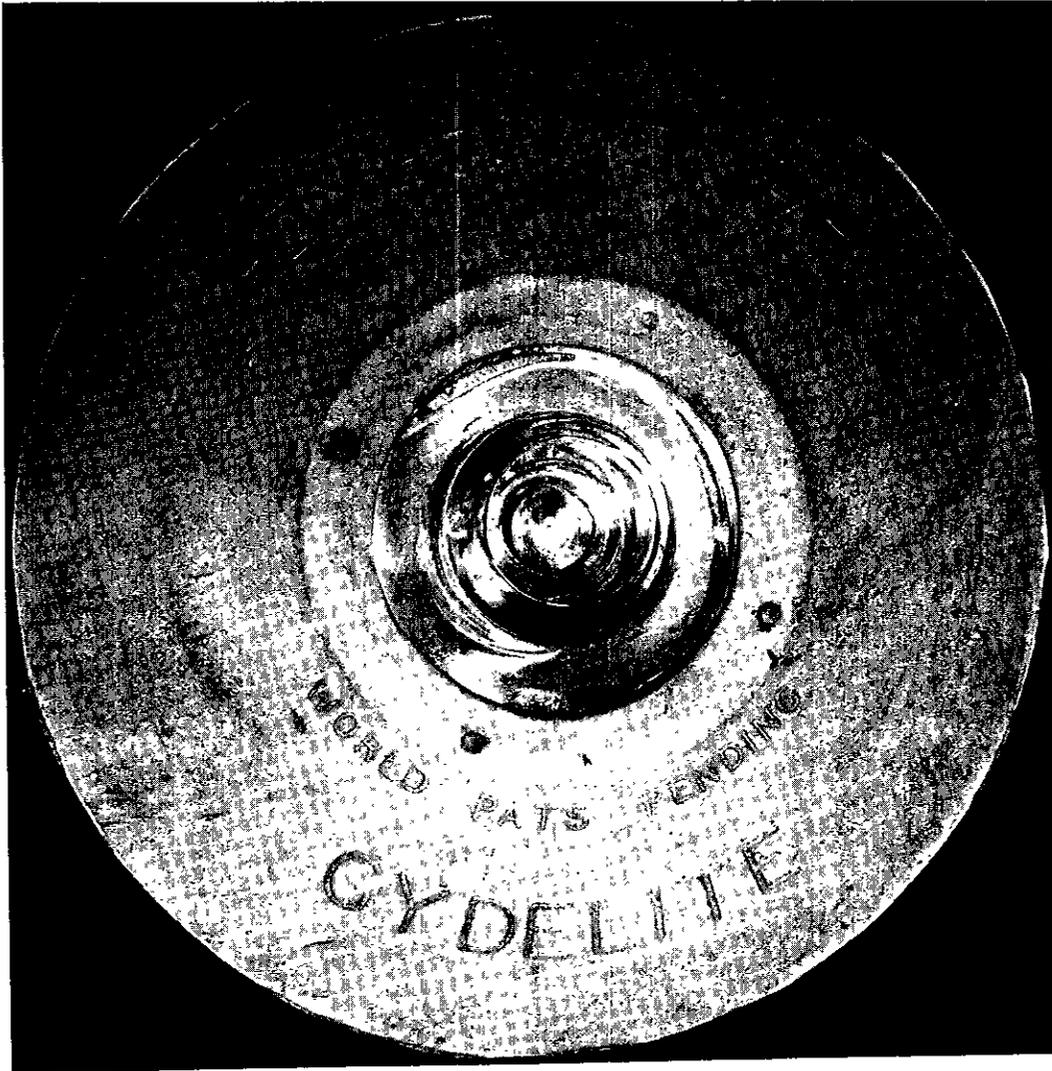
FIGURE 16

GLASS-DOMED UNIT ENCASED IN RUBBER BASE

These markers consist of a glass dome encased in rubber. A similar unit with a plastic base has been tested by the laboratory and was unsatisfactory. It was thought that the rubber base might possibly have given more impact resistance to the glass dome and increased its life. However, highway test installation indicated breakage of the glass domes after a service life of a few months. The resulting marker was ineffective for nighttime delineation. Initial nighttime reflectance of this marker was considerably less than the standard acrylic cube corner reflective marker now in use. Rubber materials stain considerably during the hot dry summer months.

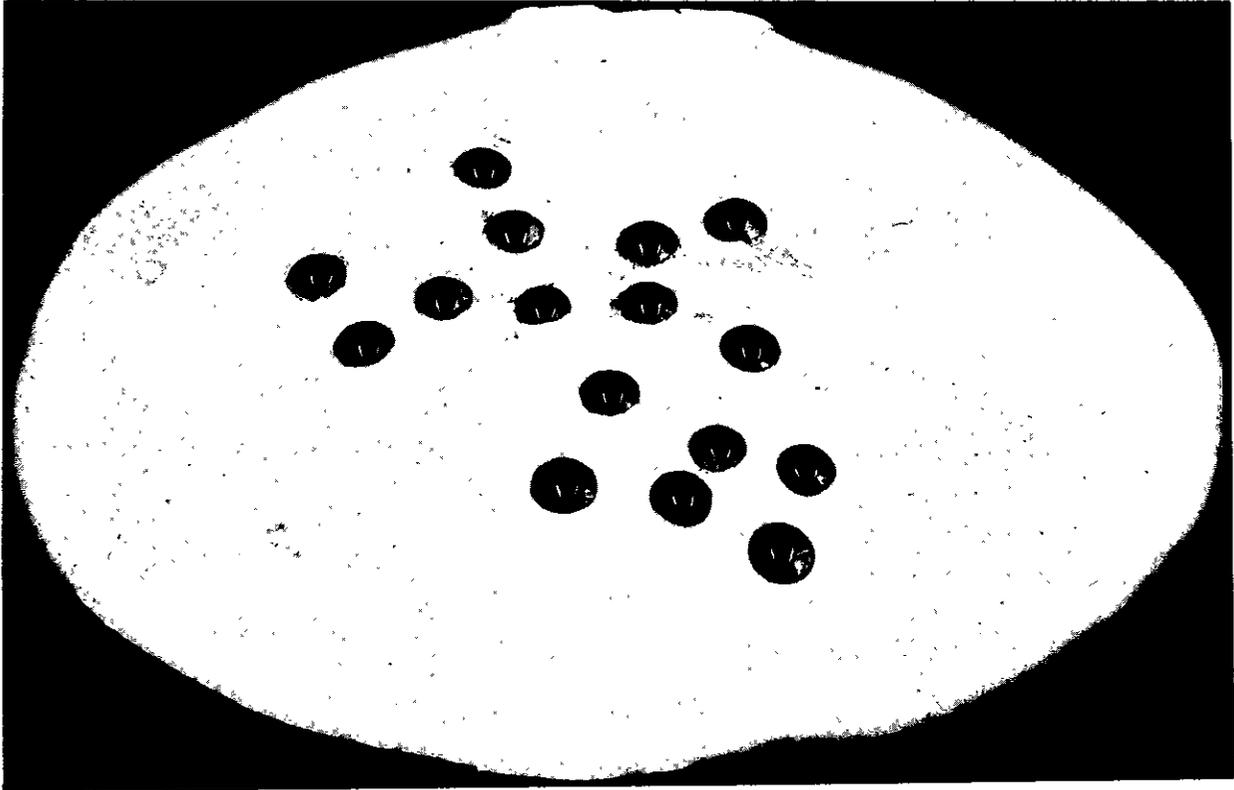
FIGURE 17

EPOXY MARKERS WITH GLASS BEADS  
(Cast in Place)

About 1/2 mile of these cast in place beaded epoxy markers were placed on the South Sacramento Freeway in 1966. The markers were formed by first extruding a 1/8" x 4" diameter pad of white epoxy adhesive on the roadway. Fifteen to twenty 1/4" coated glass beads were then dropped into the adhesive. The coating on the imbedded portion of the beads was intended to improve the reflectance of the bead. Before the beads are visible, the coating on the exposed surface must first be worn off by traffic.

Reflection of the unit was extremely low when new and the delineation of the markers were essentially nil immediately after installation. After three years service, beads were cracked or etched by traffic so that the markers were barely visible at night. Daytime visibility was poor due to tire stains on the epoxy surface.

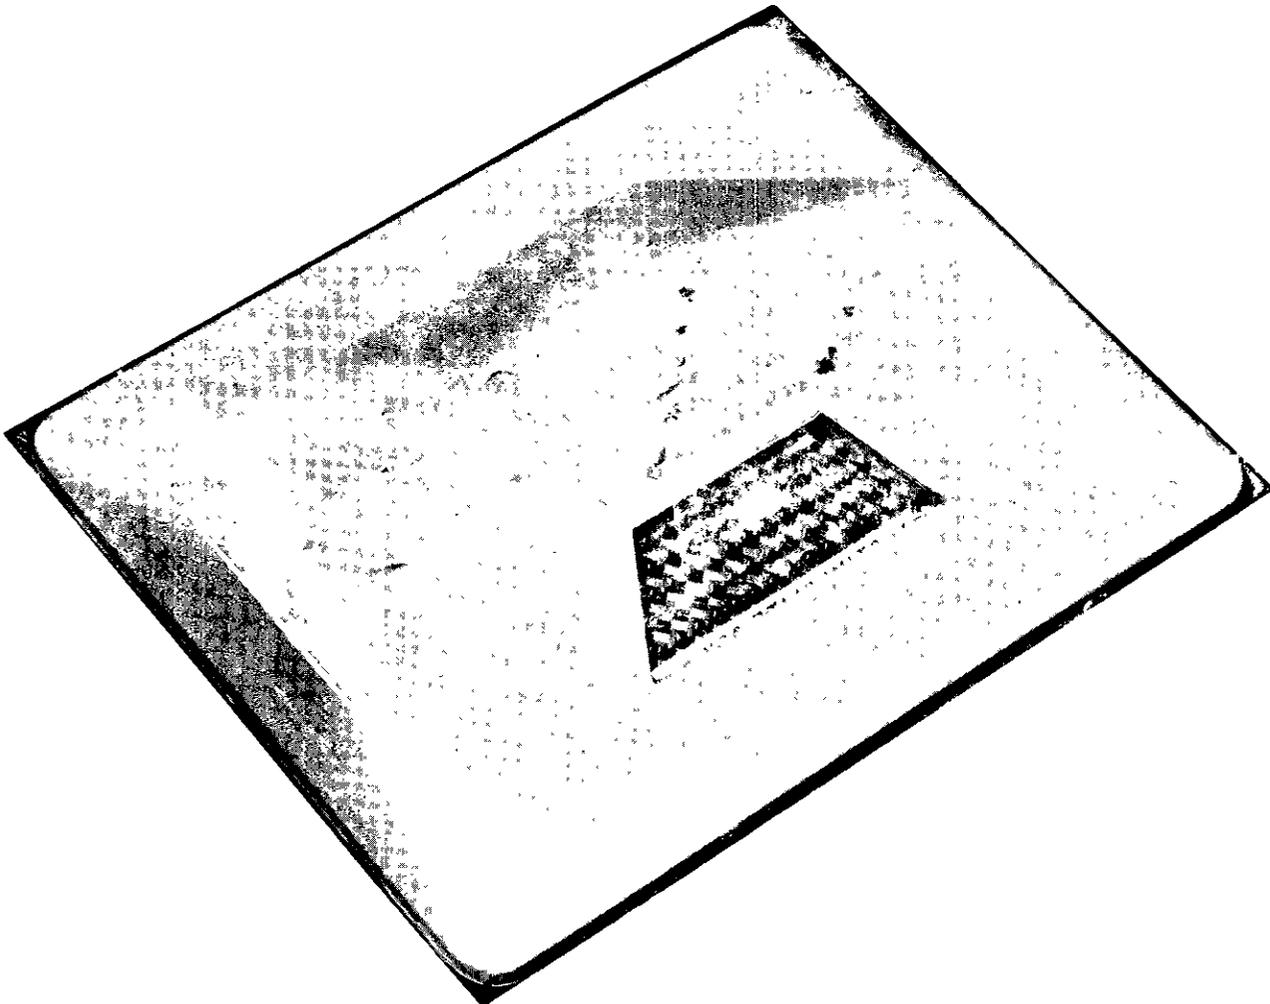
FIGURE 19

REFLECTORIZED UNIT CONSISTING OF AN EPOXY FILLED ACRYLIC SHELL

A test installation of these markers was placed on the South Sacramento Freeway in June 1967. (Area 1). These markers provided good delineation for two years after which time the plastic casings began to separate from the epoxy filler. Approximately 50% of the markers installed experienced loss of the casing. In many instances, the reflectorized unit remained attached to the filler, still providing nighttime delineation. However, without the casing they began to deteriorate rapidly.

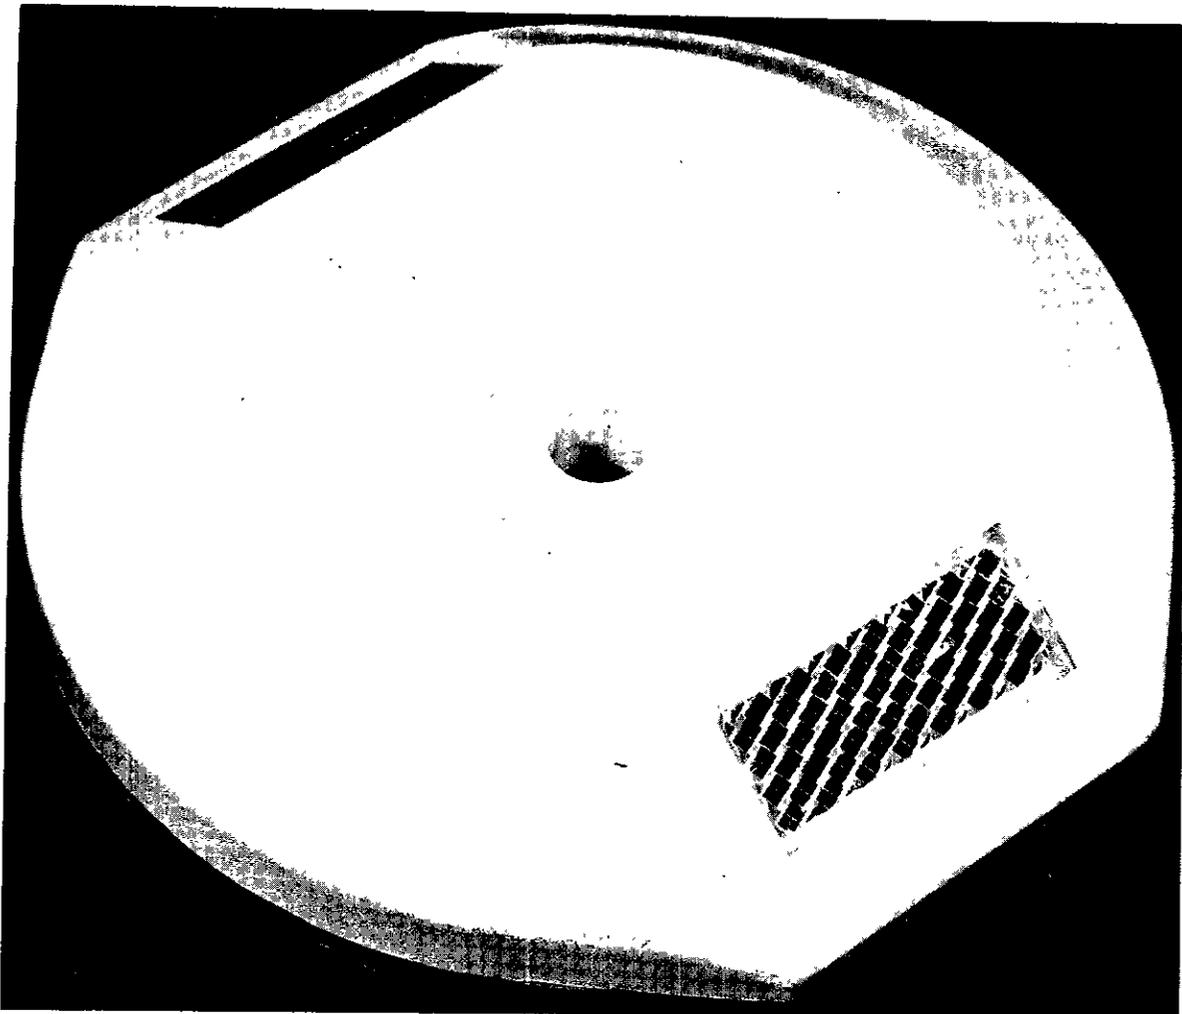
FIGURE 21

PLASTIC MARKER WITH REPLACEABLE REFLECTIVE  
ELEMENTS AND CONTAINING NO FILLER

This unit has replaceable reflective elements; however, the marker has to be removed from the roadway due to the elements being replaced through the bottom of the marker. These markers were each supplied with their own adhesive pad on the bottom. Several markers were placed in a test installation and within 48 hours all markers were either displaced or missing from their original positions, due to failure of the adhesive pad.

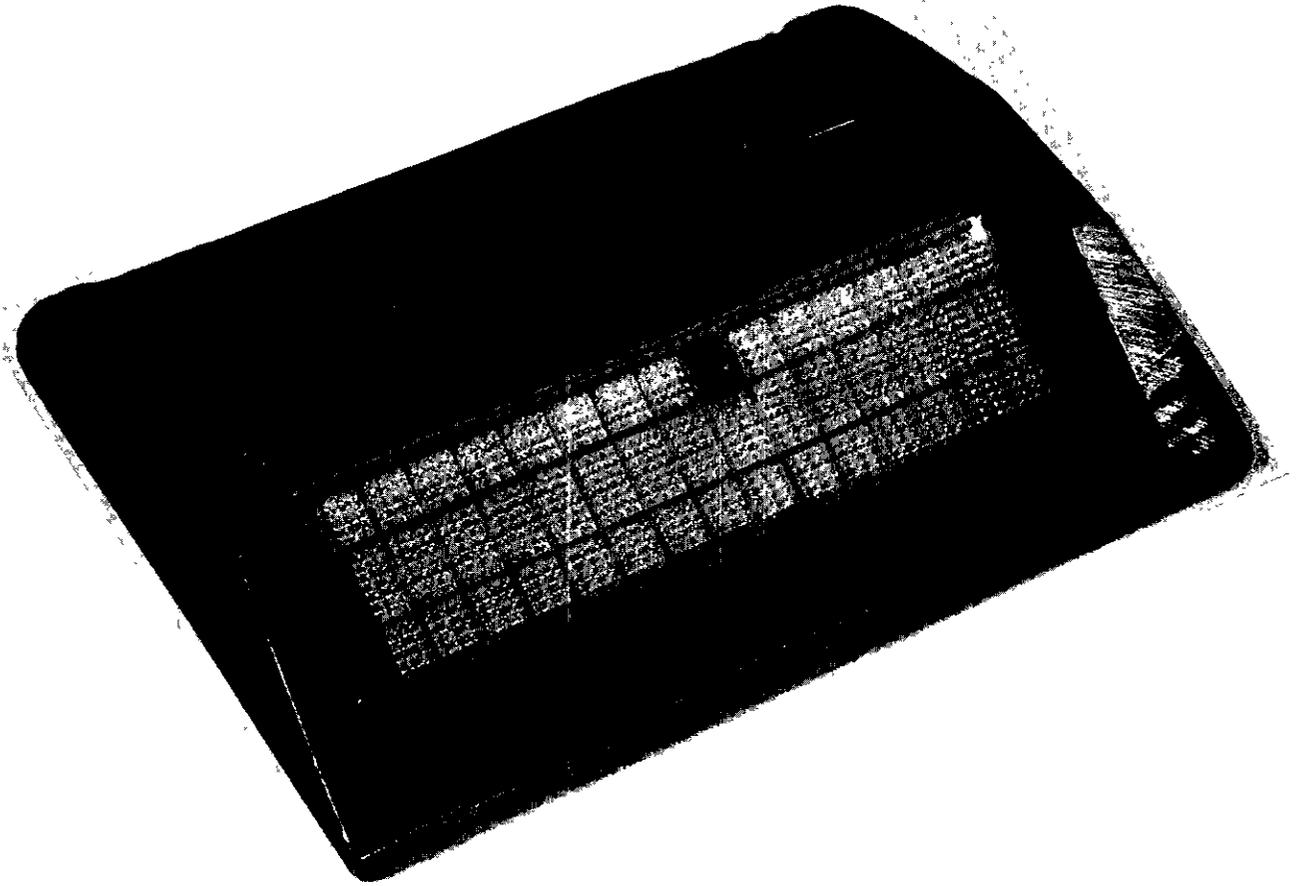
FIGURE 22

MODIFIED SNOWPLOW MARKER FOR USE IN SNOW FREE AREAS

A snowplow marker, as in Figure 24, was modified for use on the South Sacramento Freeway. The runners of the marker were cut off so that they could be installed on the roadway without the necessity of cutting slots in the PCC. Five Modified Snow-Plow Markers were installed to test this design for feasibility of replaceable elements. After one year of service with the original elements, nighttime observations indicate fair to good delineation. Lens damage to these units after one year is moderate to severe. No reflective readings have been taken on these markers. This design needs some improvement to provide a good nighttime marker with a replaceable lens.

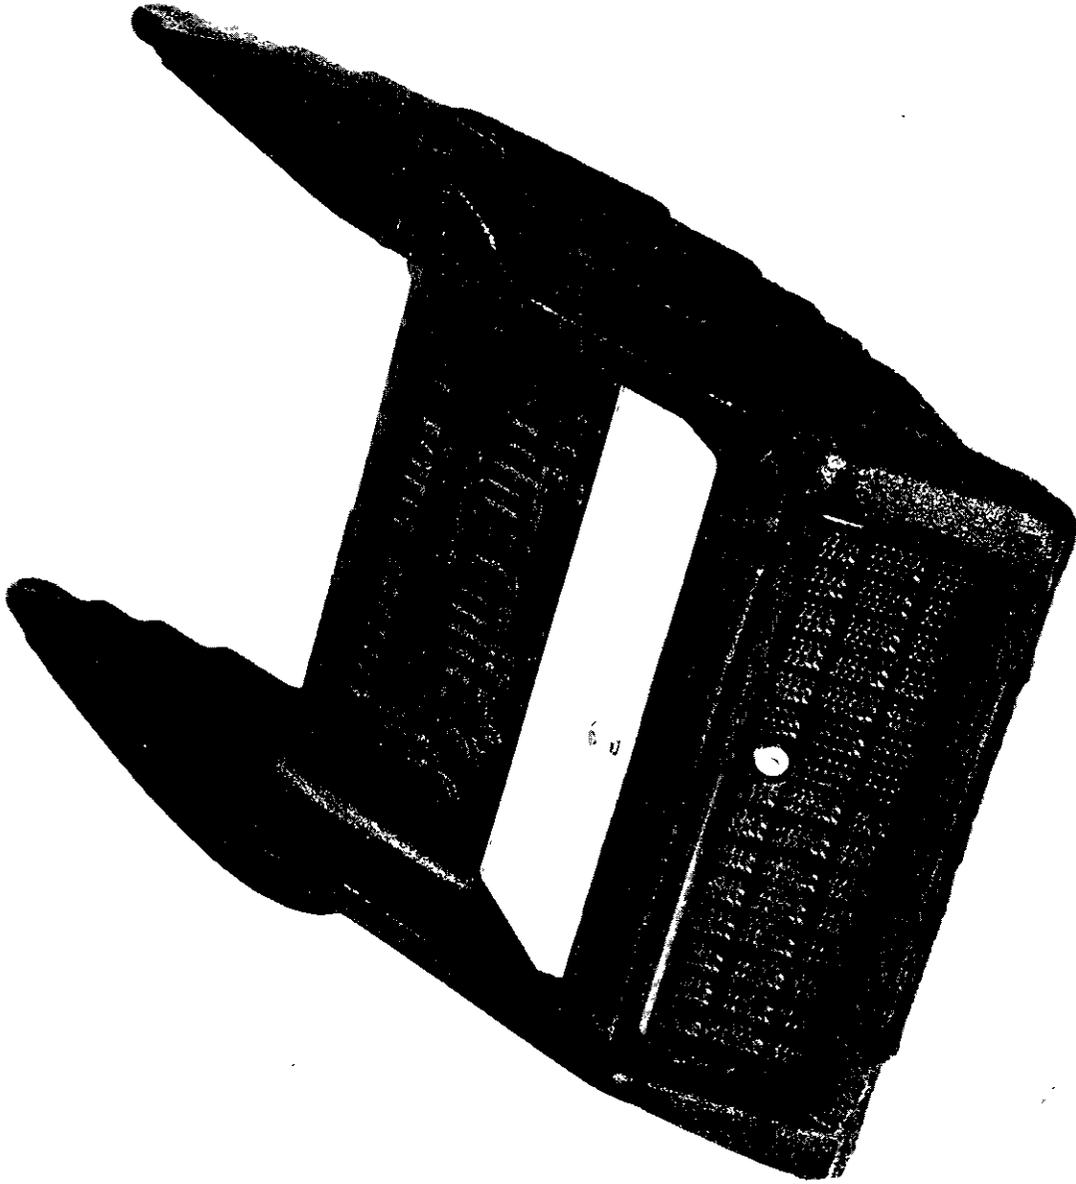
FIGURE 24  
SNOWPLOW MARKER WITH REPLACEABLE REFLECTIVE ELEMENTS.

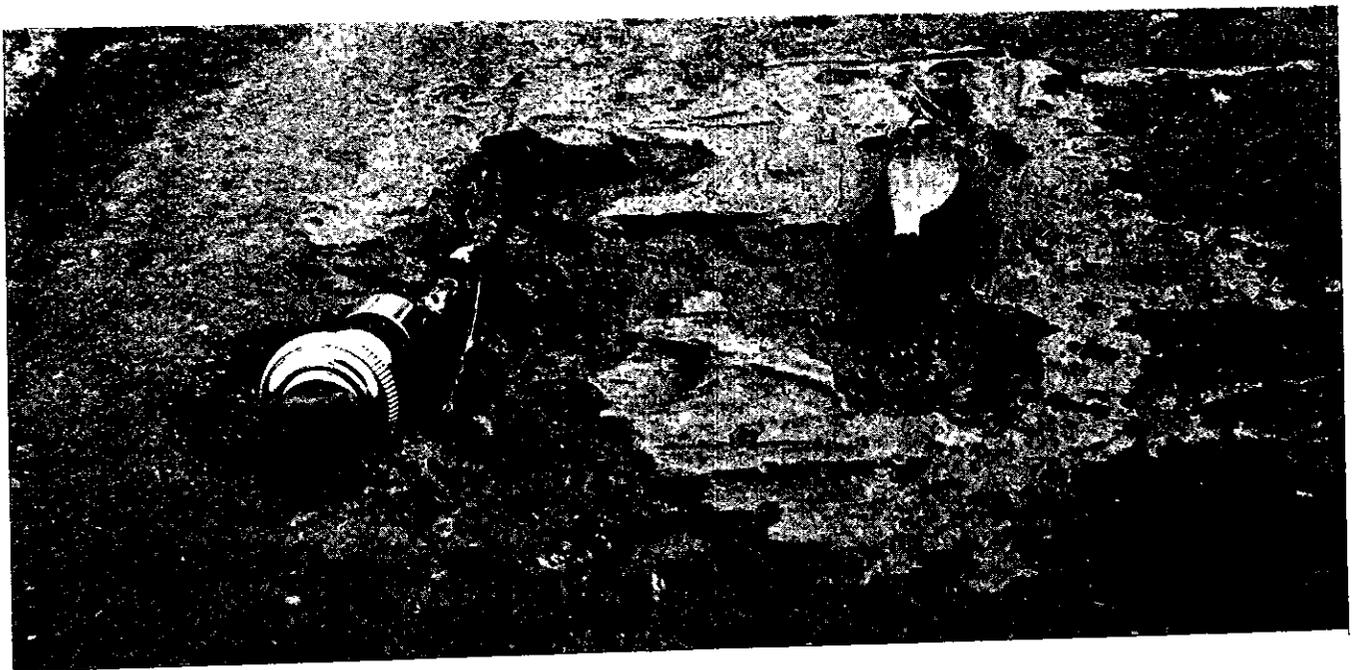
FIGURE 25

These snowplow markers were installed on Interstate 80 near Soda Springs. They were subject to snowplow action within 6 hours after placement and after 24 hours all were missing mostly by failure of road surface. (see text)

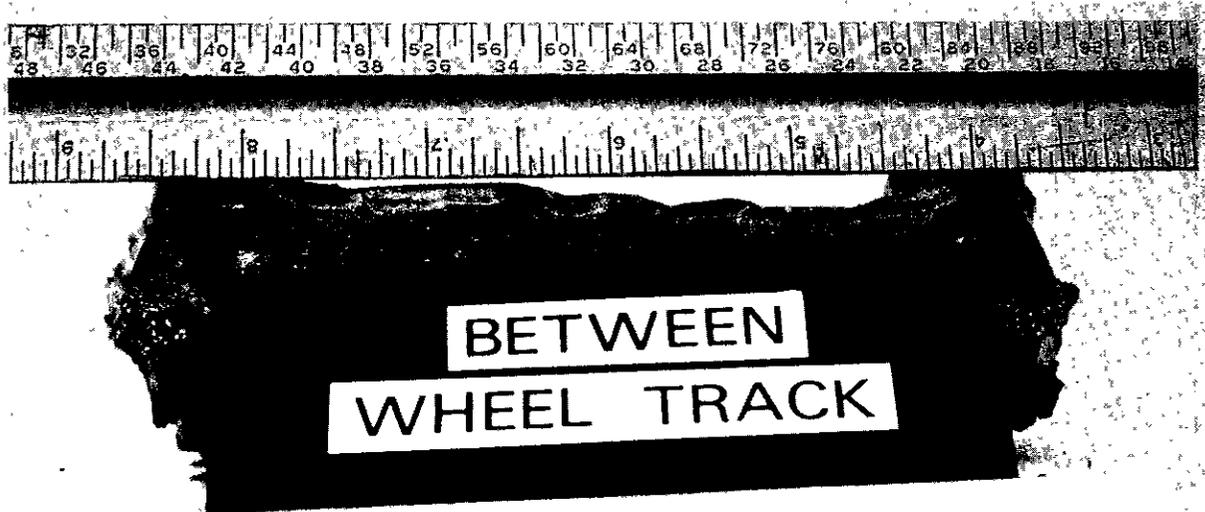
FIGURE 26

Snowplow marker placed between the wheel track of lane #3 of the South Sacramento Freeway. This marker was subjected to 4 to 5 passes with the motor grader and suffered severe damage to the top surface. (No reflective elements were used for this test.)

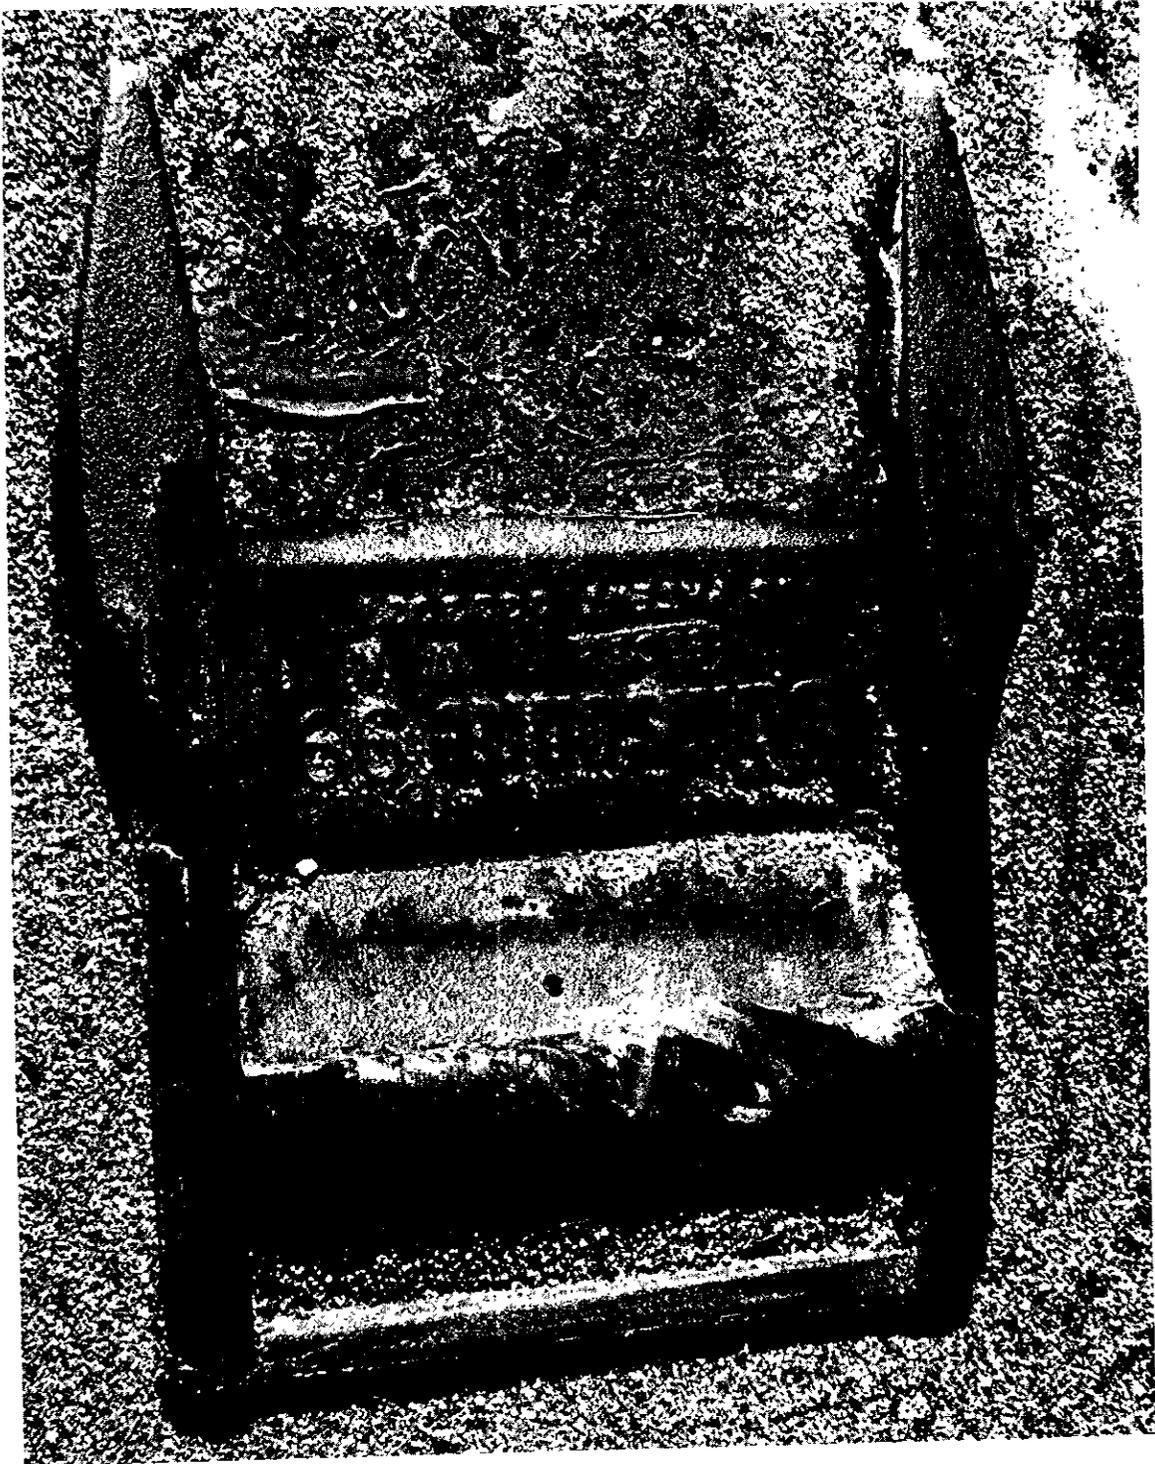
FIGURE 27

Snowplow marker placed on the South Sacramento Freeway showing the condition after 4 to 5 passes with a motor grader. Note cracked casing. (No reflective elements were used during this test.)

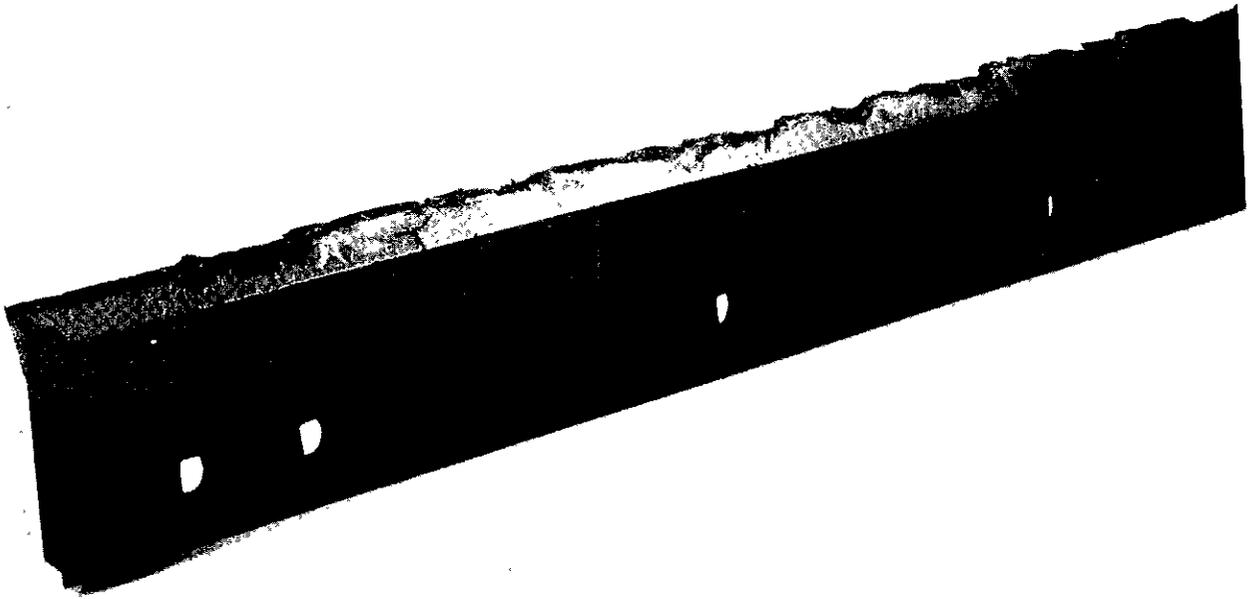
FIGURE 28

Snowplow blade used in testing of snowplow markers. This picture shows the condition of the blade after only 5 passes over the test installation which consisted of approximately 6 markers.

These tests indicated that the Stimsonite 99 markers will not withstand the type of plow action used which was intended to duplicate the most severe conditions that would be encountered when trying to remove packed ice on high elevation California mountain passes. The damage to the grader blade was excessive.

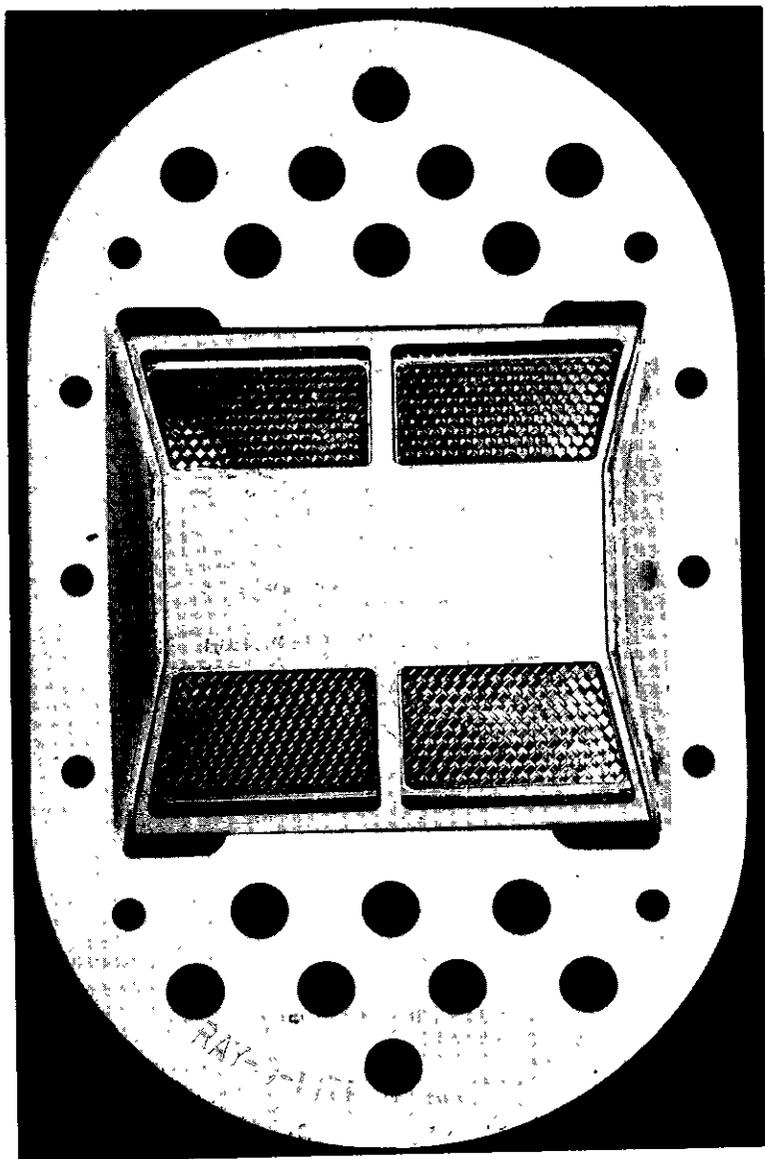
FIGURE 29

MARKER FOR SEVERE TRAFFIC AND LIGHT SNOW AREAS

Some markers of this design were placed in snow areas; however, they were removed by snowplows or with jack hammers when it was found that raised markers generally were a hazard to snowplows operating under conditions of heavy snow fall.

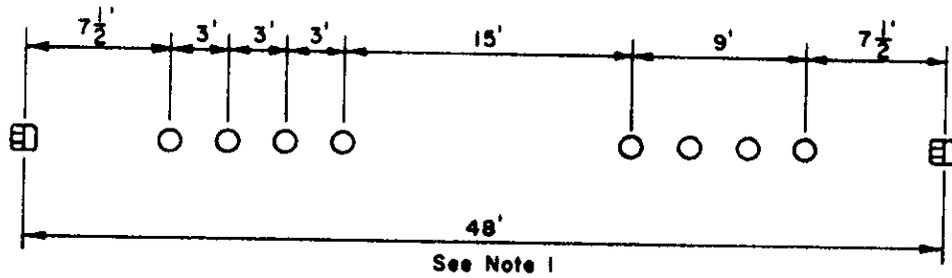
California Freeway Marking Pattern

LANE LINE ON FREEWAYS
