Effects of Fabrication Procedures and Weld Melt-Through on Fatigue Resistance of Orthotropic Steel Deck Welds

Report No. CA08-0607

December 2008

Department of Structural Engineering
University of California, San Diego
La Jolla, CA 92093

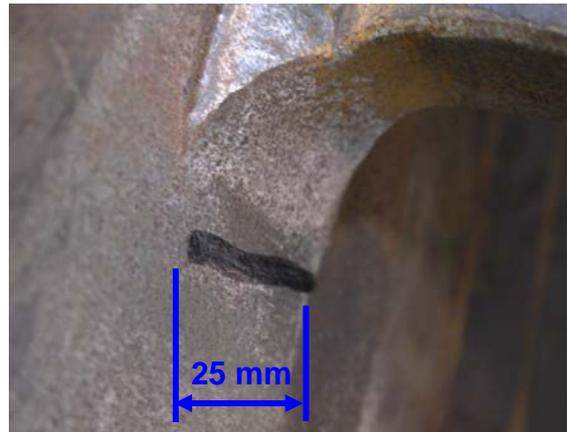
Figure 4.9 Specimen 1: Fatigue Crack at D3-R2-East

(a) Inner Surface of Rib

(c) Photo 9

(d) Photo 10

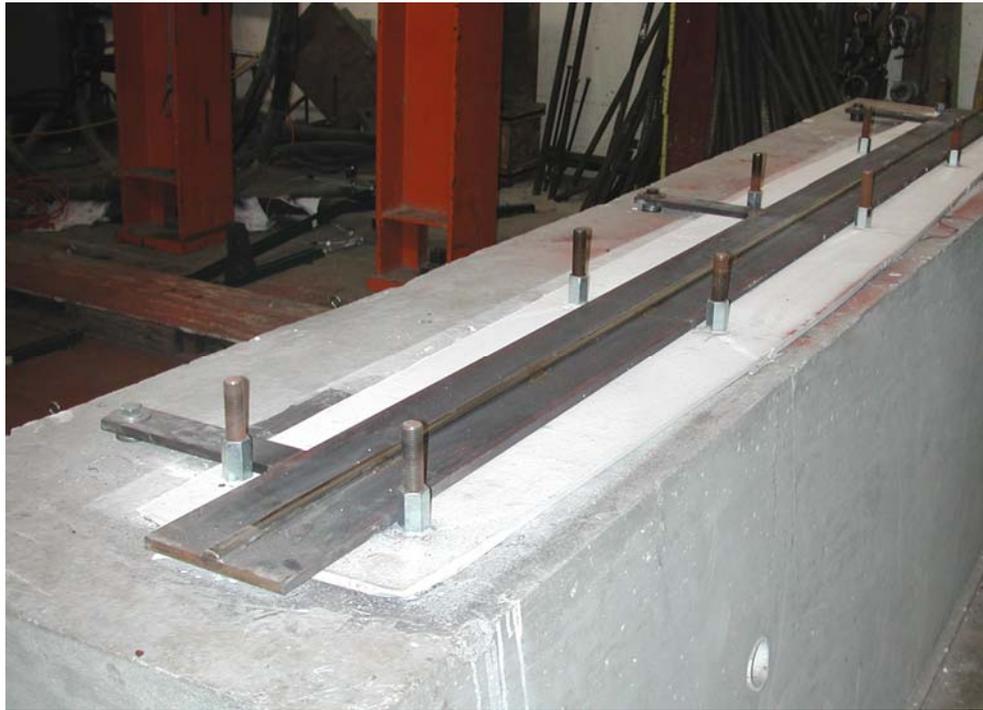
Figure 4.17 Boundary Condition Modifications

(a) Removal of End Stiffener Plates

(b) A Half-Circular Rod beneath Base Plate

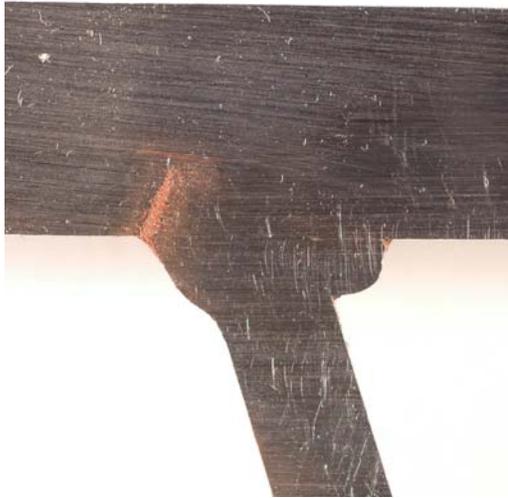
Figure 5.18 Typical Crack Pattern at Rib-to-Deck PJP Welds

(a) Crack from Weld Toe

(b) Crack from Weld Root

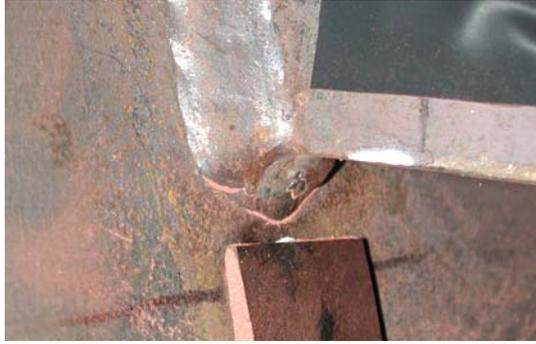
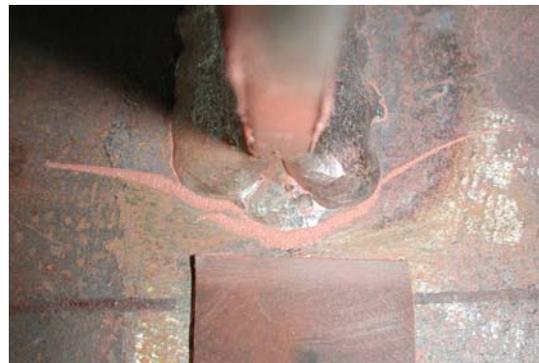
Figure 5.31 Specimen 4: Cracks at Rib-to-Bulkhead Welded Joint (D1-R2-East)

(a) 1 million cycles

(g) 6 million cycles

(h) 6 million cycles (different view)
