GEOTECHNICAL DESIGN REPORT

ROUTE: 07-LA-1-PM 82.8/83.3

File: 07-LA-01-PM51.6/KP83.07
EA 07-4L2201
Escondido Beach Landslide

Subject: Geotechnical Design Report

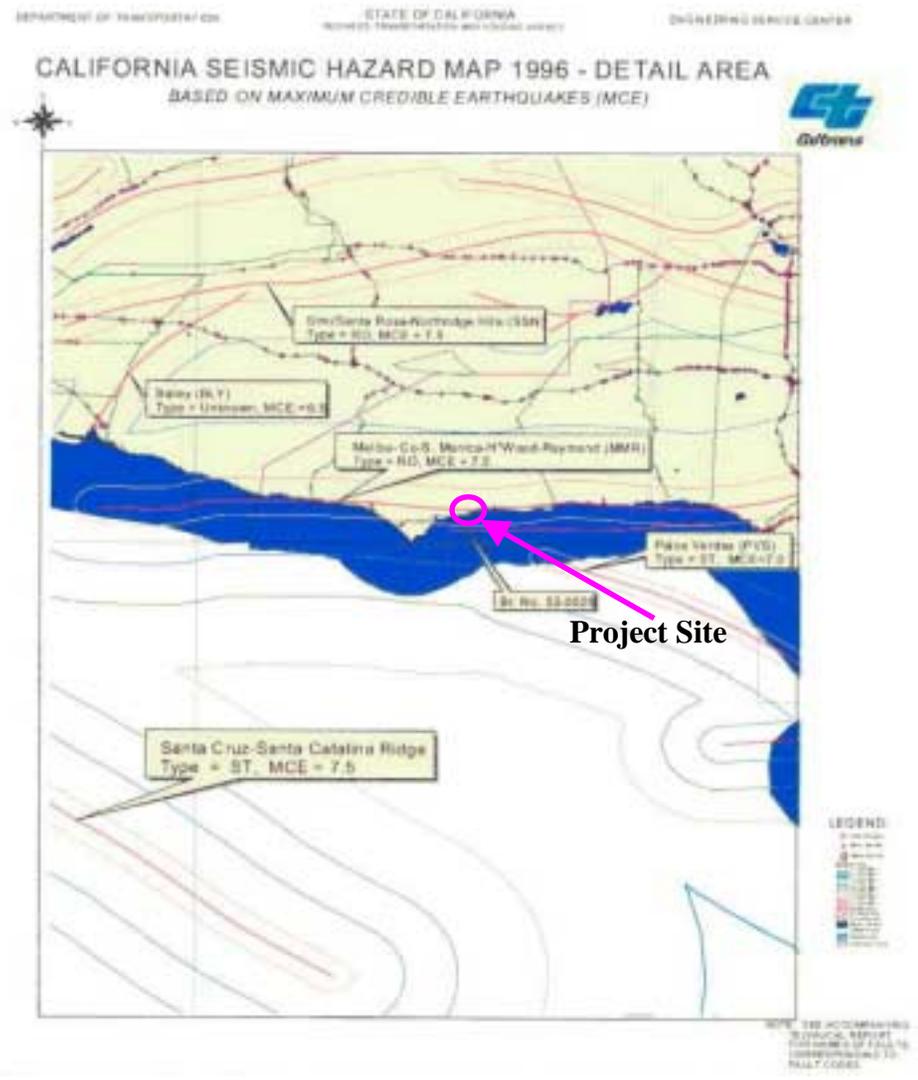
Figure 4b: Faults in the Project Vicinity

The nearest seismic source is Malibu Coast-Santa Monica-Hollywood-Raymond (MMR) Fault (Figure 4b). Based on the 1996 Caltrans Seismic Hazard Map (CSHM), this reverse/oblique fault is located about 0.7 km north from the project site. The Malibu Coast Fault is a reverse/oblique fault with probable magnitudes of 7.5 (M_w) and slip rate of 0.3 mm/y. Based on the Caltrans' current policy of taking the Peak Bedrock Acceleration (PBA) from Reverse/Oblique fault as equal to 110% of that from Strike Slip (ST) fault with the same MCE and distance, and in accordance with the attenuation by Sadigh et al (1997), the design PBA at the site should be taken as 0.8g.

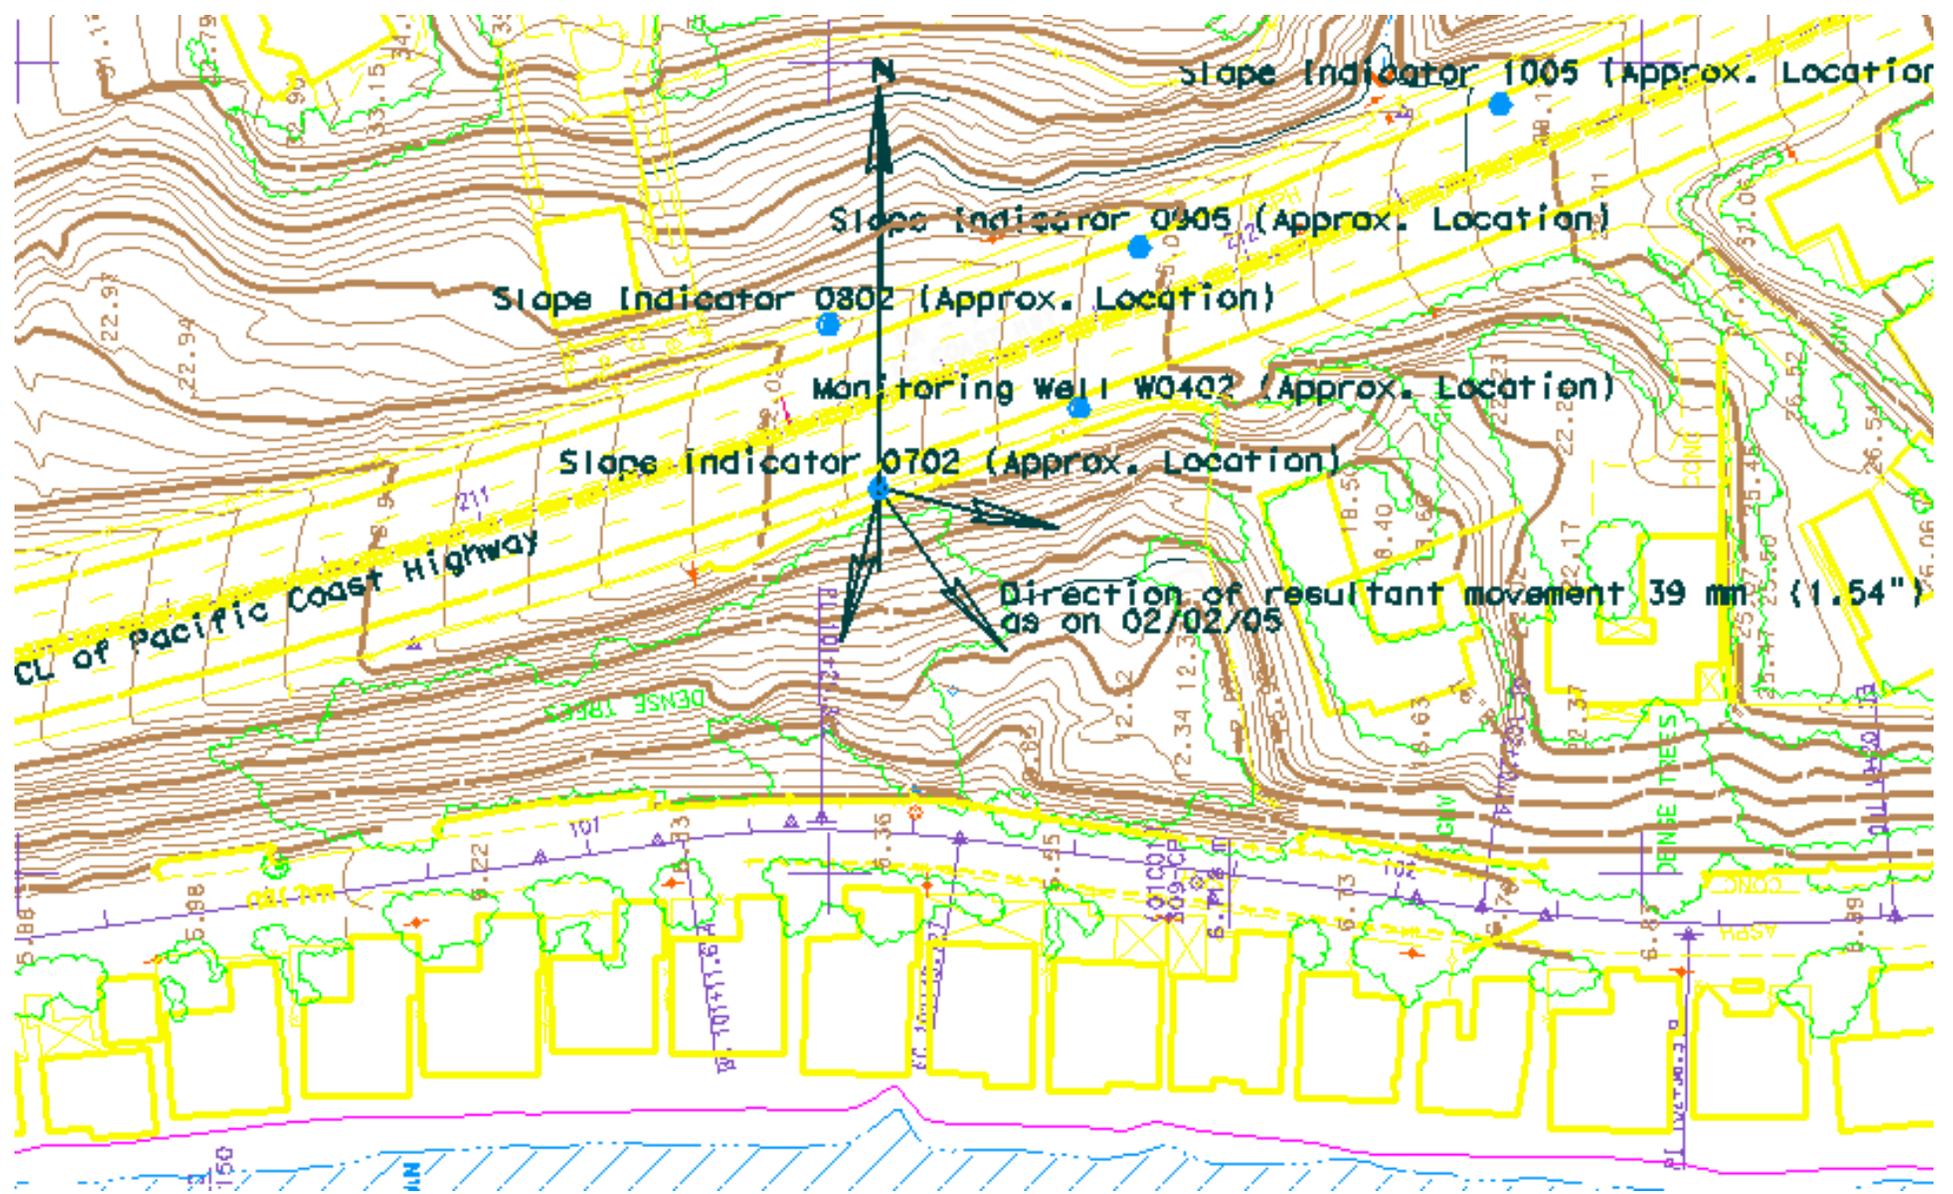
Figure 6: Location of Field Instrumentation
"Caltrans improves mobility across California"

In April-June 2002, the Caltrans Ventura Regional Survey Office installed thirteen survey monuments. In addition, two slope indicators and one water level monitoring well were installed at the highway level in July 2002 (Table 1). In February 2005 two additional slope indicators were installed on the westbound shoulder of the highway. These were installed within the zone of the slope failure that occurred during the winter storms of December 2004 to February 2005. A location map of the existing instrumentation is shown on Figure 6.

Slope Indicator Data Analysis prior to December 2004: Based on the available data from SI_07_02 and SI_08_02 it appeared that movement was occurring along a planar surface with a steep head scarp at or just below the highway elevation (Figure 6a). The slope inclinometer data did not suggest deep-seated movement. The highway fill constructed during the emergency repair of March-April 1978 moved down and outwards along with the highly disturbed Modelo Formation materials on the down-slope side. Instability at the

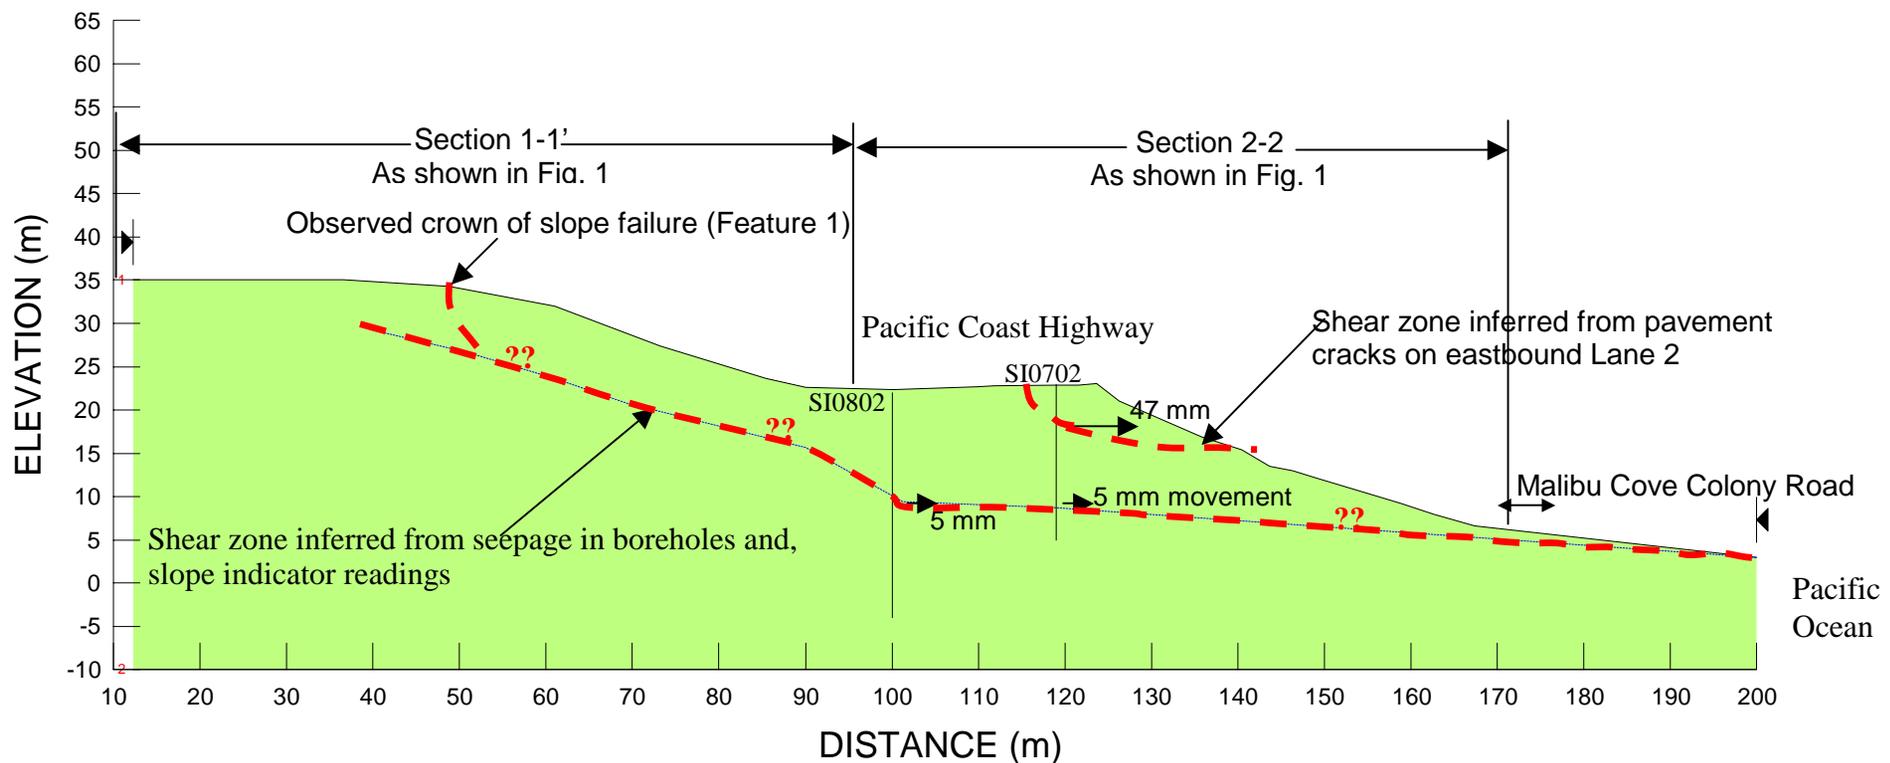
Figure 7a: Cross Section

Water level in monitoring well W4_02 fluctuated between 14.8 m, and 11.4 m below pavement level between July 2002 and May 2005. A cross section and idealized soil profile prepared on the basis of the survey data and boring logs is shown in Figure 7a and 7b
