Evaluation Of Compaction Grouting

DIVISION OF STRUCTURES AND ENGINEERING SERVICES
TRANSPORTATION LABORATORY
RESEARCH REPORT

FINAL REPORT

EVALUATION OF COMPACTION GROUTING
07-Ora-57 PM 21.5/22

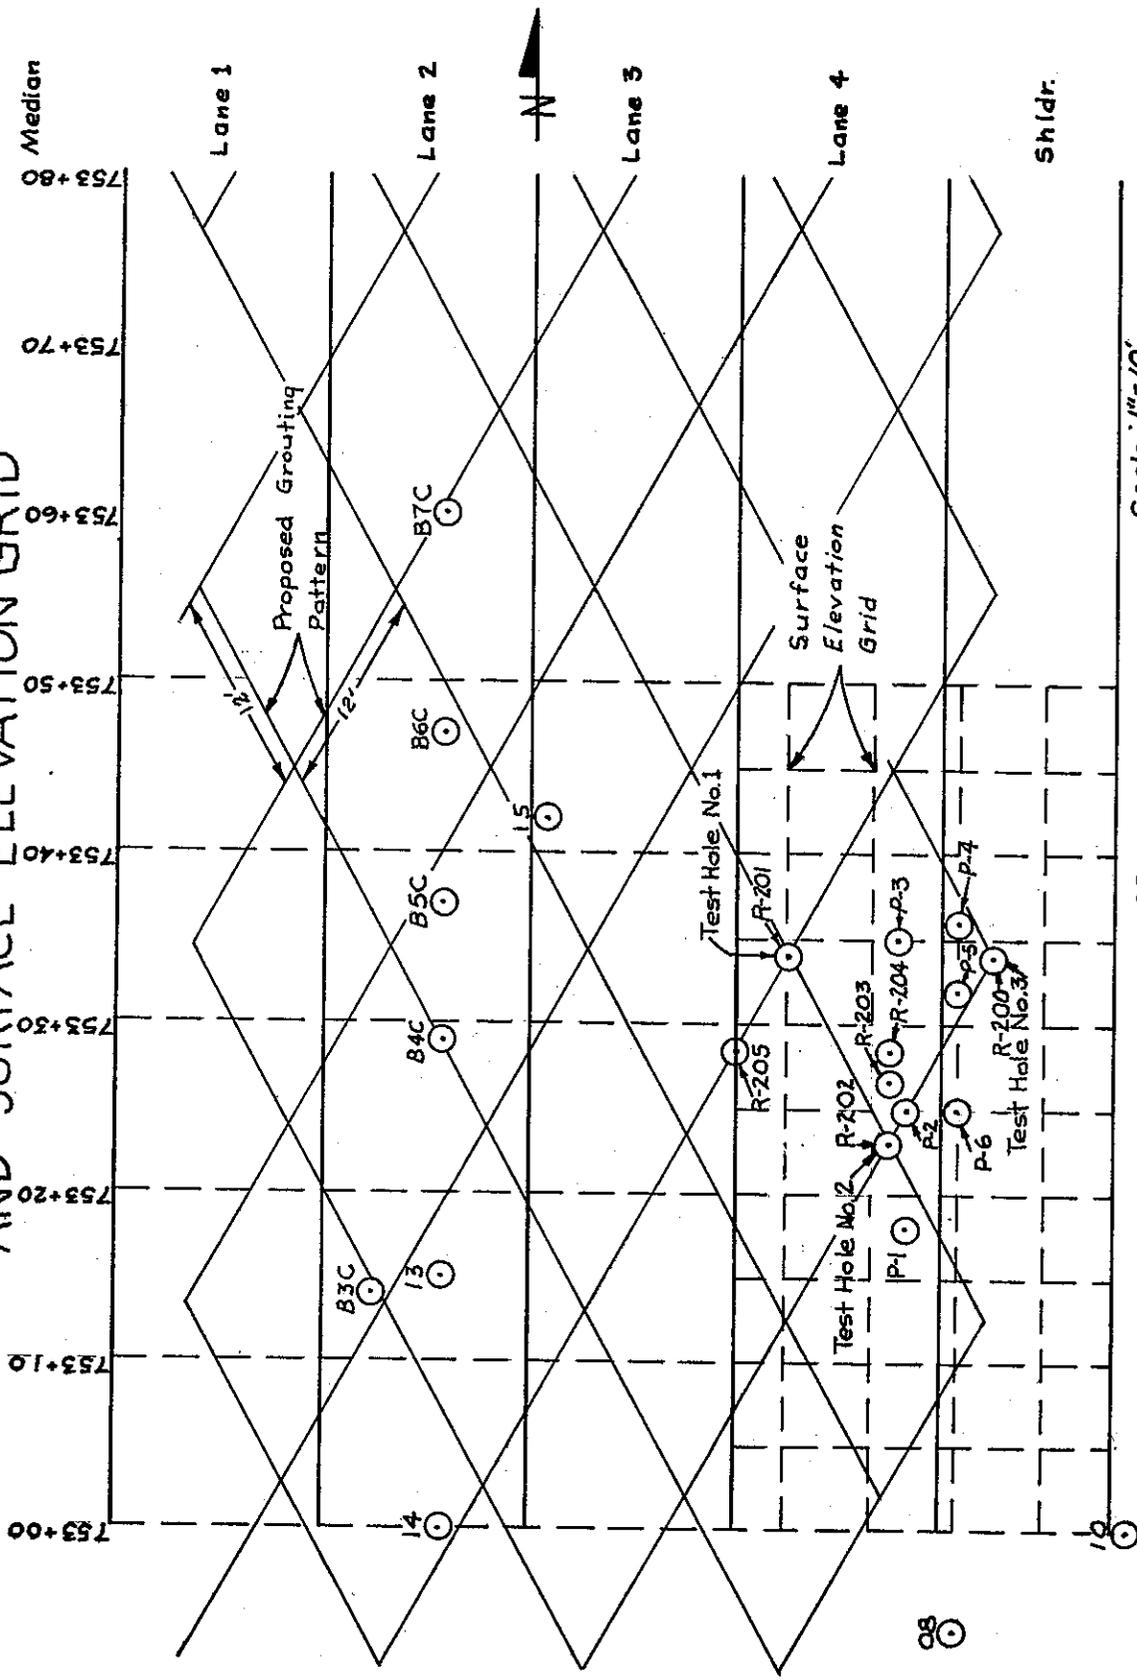
Fig. 8

Initial grouting began on August 30, 1974 using Maintenance mud-jacking equipment but this operation was unsuccessful. The operation moved down station before the grouting could resume with different equipment at a later date. The new grid pattern is that which is presented on Figure 8. The operation resumed in April 1975, using the equipment described above.

suggested for boring R-204 over boring R-203. Both borings are located within the test grid. Boring R-203 is located 3.8 ft from grout test hole 2 (boring R-202) and boring R-204 is 5.5 ft out from grout test hole 2 and possibly within the influence of all three grout test holes (refer to Figure 8). No before density measurements were obtained for the grout test holes (borings R-200, R-201 and R-202).

LAYOUT OF TEST GROUTING PATTERN AND SURFACE ELEVATION GRID

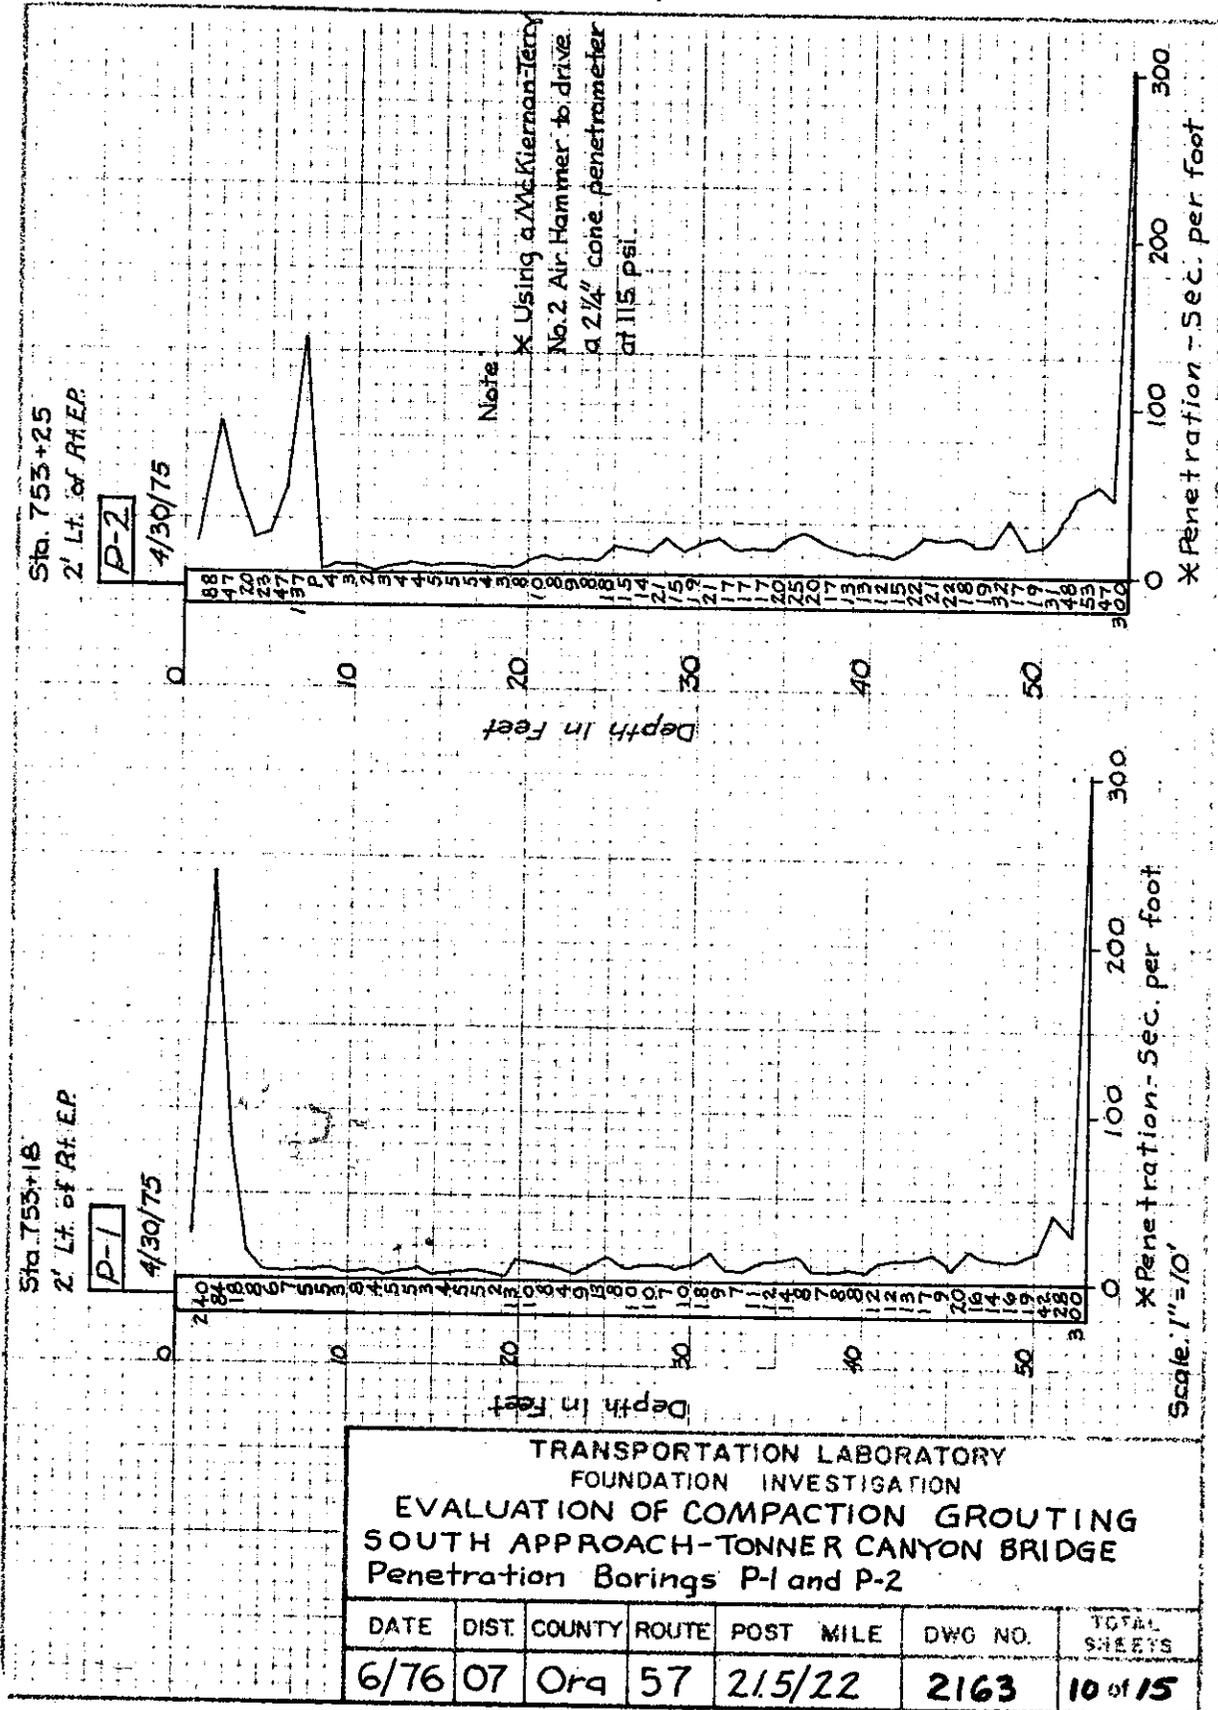
Fig. 11

To evaluate compaction grouting, 2-1/4-inch Cone Penetrometer measurements were taken near the shoulder adjacent to the grouted holes subsequent to the grouting operation (Figure 8) and are identified as borings P-1 through P-6. They are also presented on Figures 10, 11 and 12. These measurements were compared with penetrometer readings taken before grouting which are identified by penetration borings B3C through B7C shown on Figure 2. The comparison of these penetrometer readings proved inconclusive in indicating an improvement in soil densification. However, the measurements before grouting were obtained prior to planning this study and were located about 10 feet closer to centerline than the boring in the actual test area. The follow-up data were more representative of the shoulder area. This information proved a poor comparison because a greater degree of confinement was available nearer the center of the embankment. It was assumed initially that these measurements could provide a before condition for relative density.

TRANSPORTATION LABORATORY FOUNDATION INVESTIGATION						
EVALUATION OF COMPACTION GROUTING SOUTH APPROACH-TONNER CANYON BRIDGE						
Penetration Borings P-1 and P-2						
DATE	DIST.	COUNTY	ROUTE	POST MILE	DWG NO.	TOTAL SHEETS
6/76	07	Ora	57	21.5/22	2163	10 of 15

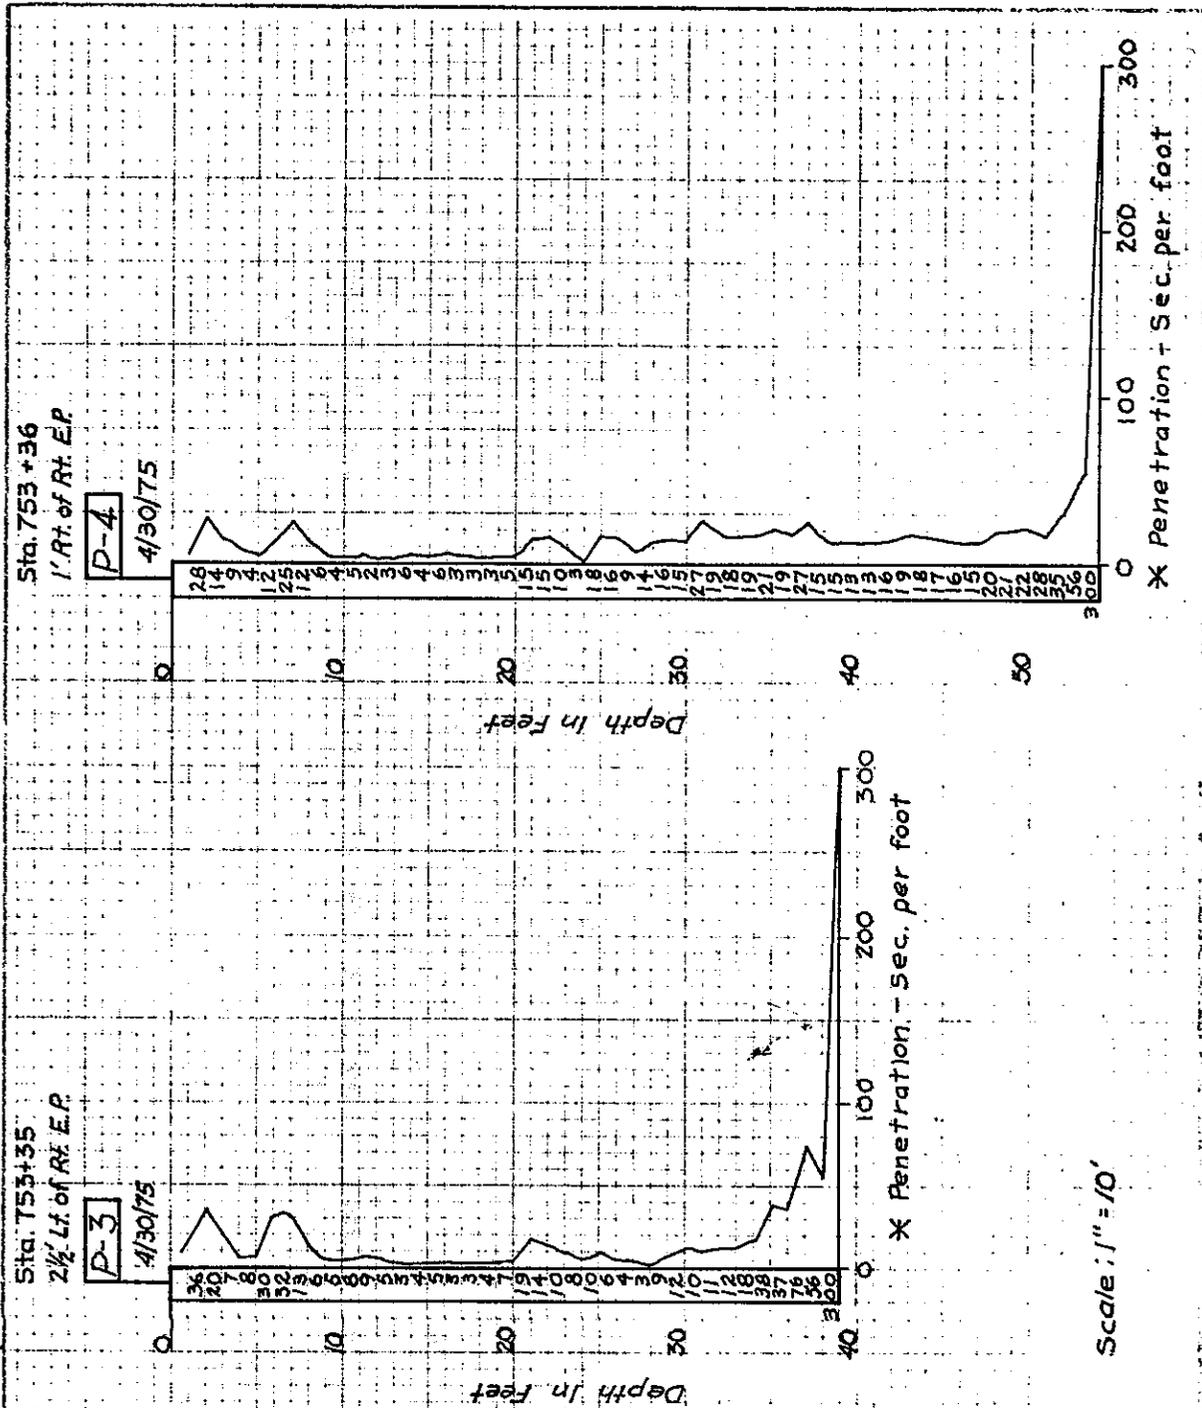
Fig. 12

TRANSPORTATION LABORATORY
FOUNDATION INVESTIGATION
EVALUATION OF COMPACTION GROUTING
SOUTH APPROACH-TONNER CANYON BRIDGE
Penetration Borings P-3 and P-4

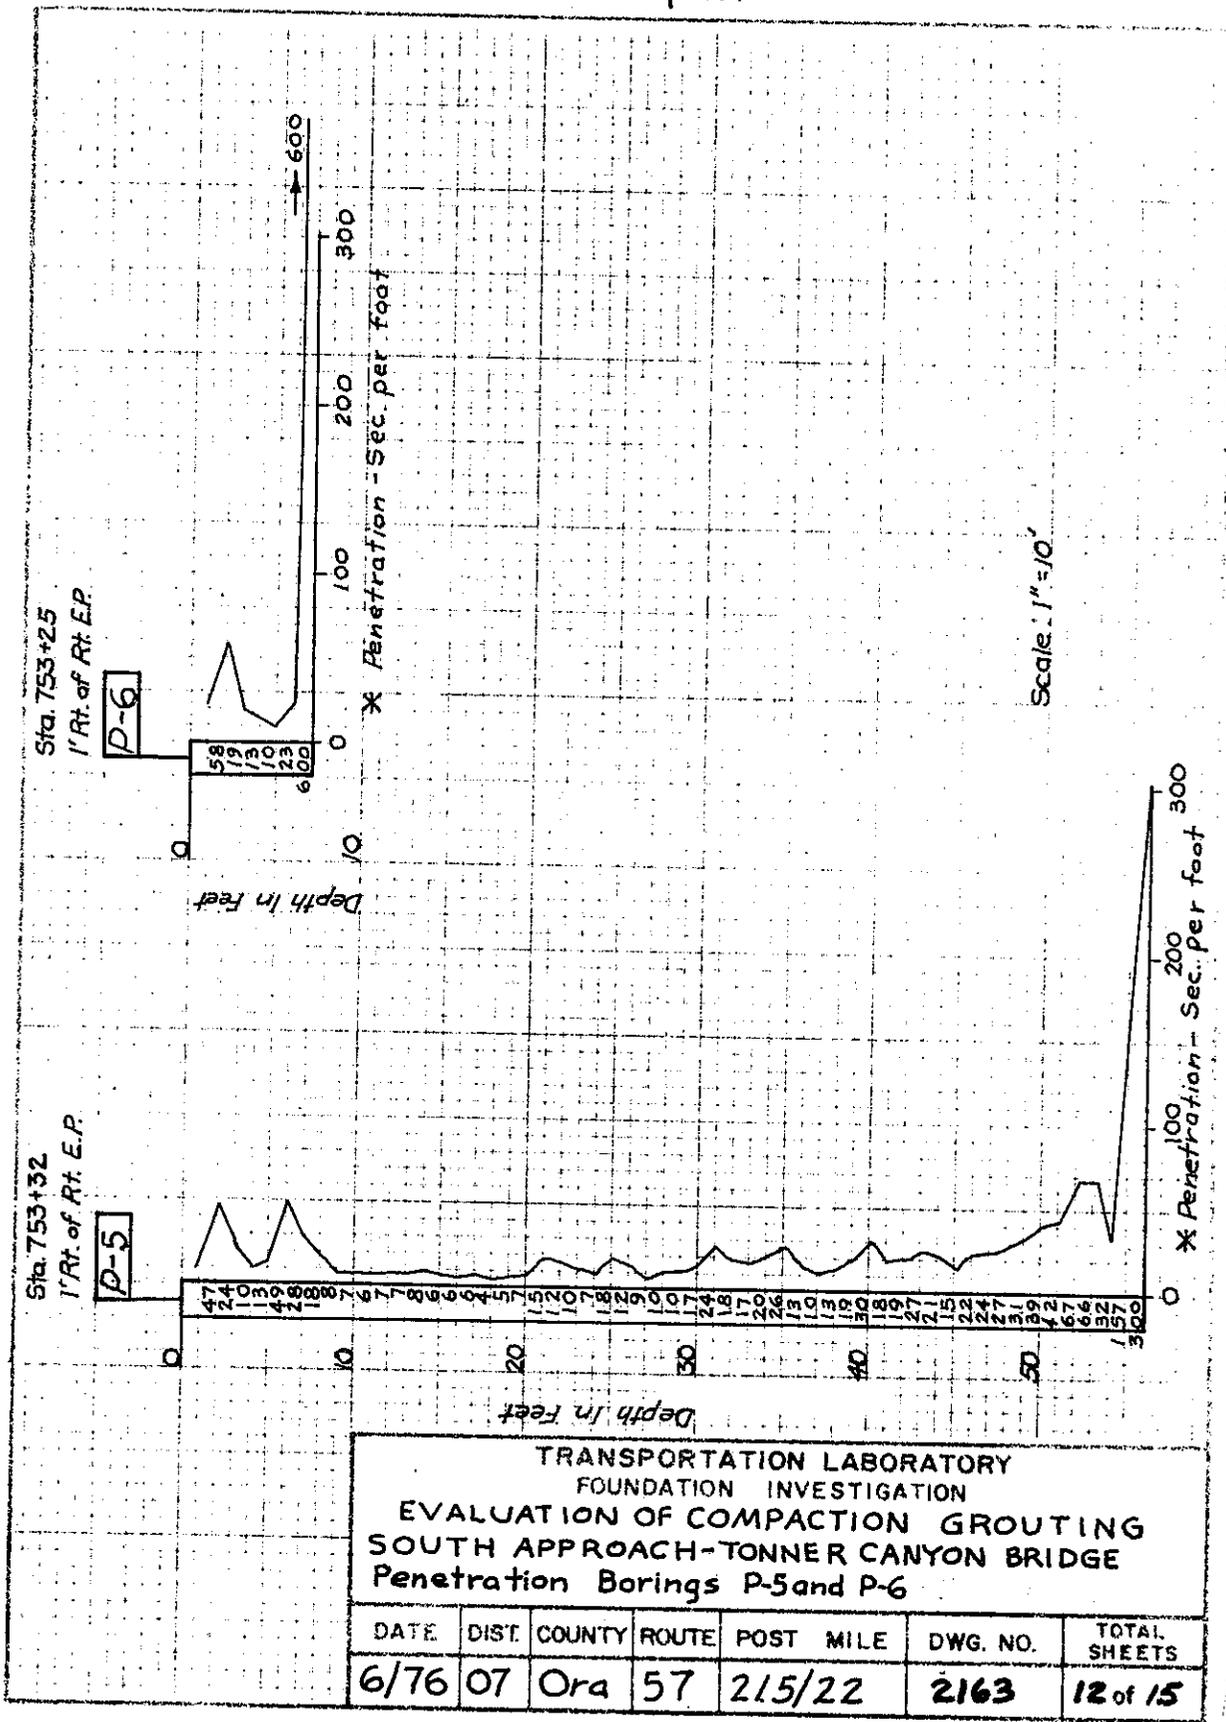
TRANSPORTATION LABORATORY
FOUNDATION INVESTIGATION
EVALUATION OF COMPACTION GROUTING
SOUTH APPROACH-TONNER CANYON BRIDGE
Penetration Borings P-5 and P-6
